April 10, 2007

SUBJECT: Safety Recall 07S51: Certain 2001 - 2004 Model Year Ford Escape Vehicles Equipped with Anti-Lock Brakes – ABS Module Connector Inspection

CERTAIN 2001 THROUGH 2004 MODEL YEAR ESCAPE VEHICLES EQUIPPED WITH ABS — ABS MODULE CONNECTOR INSPECTION AND REPAIR

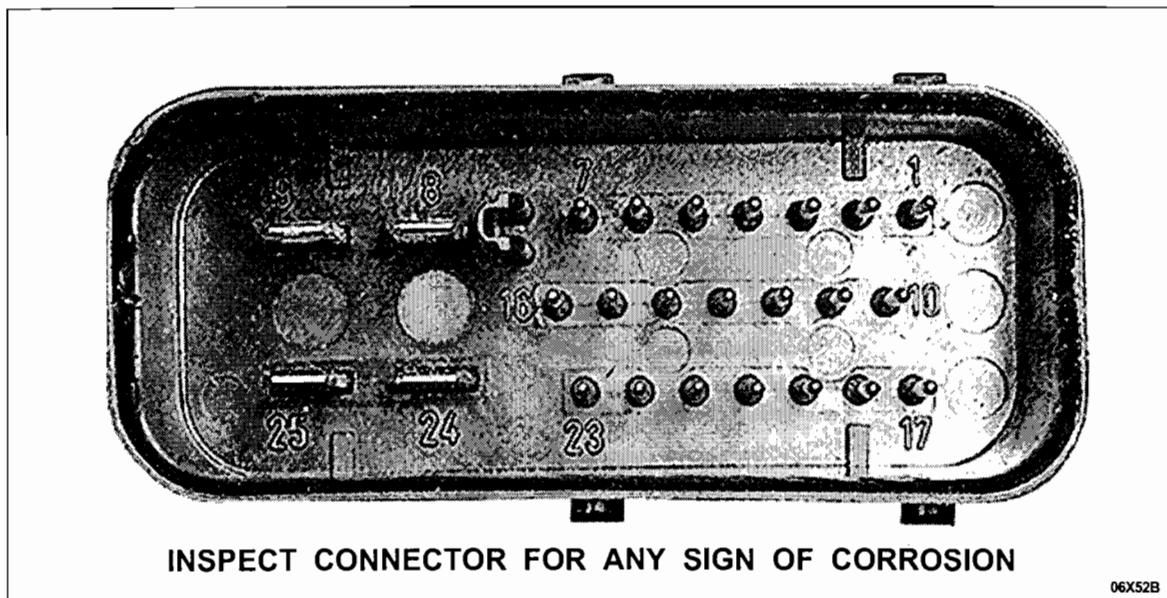
FIGURE 2

Disconnect the ABS module 25-pin connector by sliding the lock mechanism out (towards the passenger side of the vehicle) and pulling the connector off the module.
3. Disconnect the speed sensor harness, then remove the 2 harness retainers from the studs and position the harness above the air cleaner assembly to provide access for inspection.
4. Inspect the ABS module connector pins for corrosion. See Figure 2.
 - If corrosion is present, perform Labor Operation B.

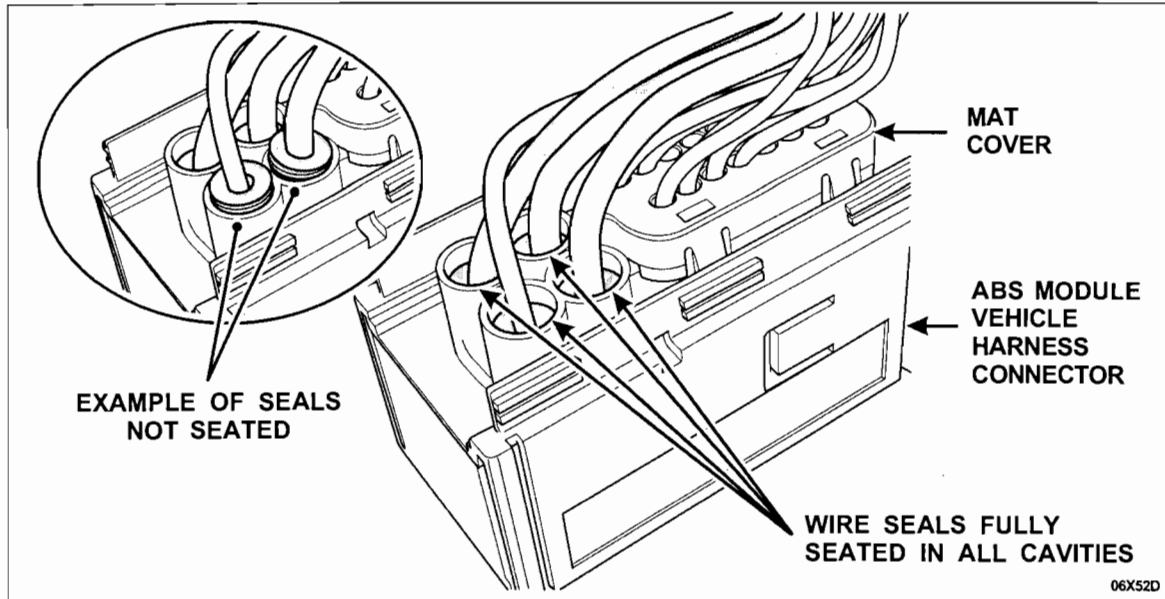
FIGURE 4

6. Verify the wire seals are present on the 4 heavier gauge wires. See Figure 4.

8. **Perform Labor Operation C if any seals are missing or if the number on the mat cover is not "054".**
9. Verify all 4 wire seals are fully seated in the cavities. Each seal should sit approximately 1-2 mm (1/16 in) below the top of the round cavity. See Figure 4.
 - **If seals are not seated properly, perform Labor Operation D.**
10. **Perform Labor Operation A if:**
 - The module is not corroded.
and
 - All seals are present.
and
 - All seals are fully seated.
and
 - The number on the mat cover is "054".

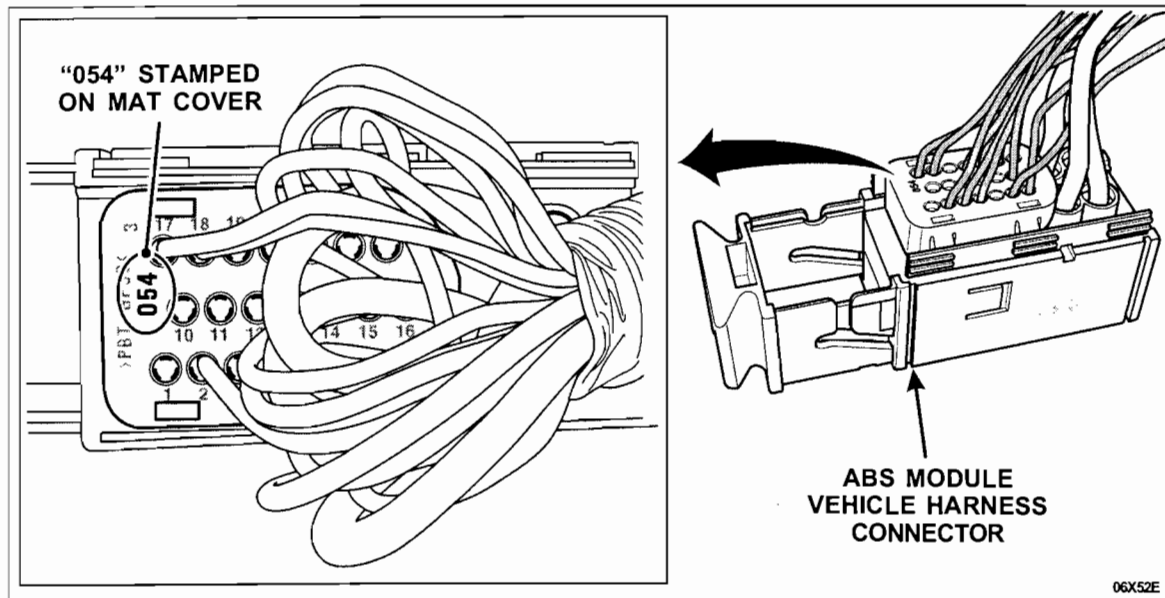
FIGURE 5

7. Verify the numbers "054" are stamped on the slide-lock end of the mat cover (wipe the mat cover clean if necessary to view). See Figure 5.

NOTE: Mat covers with any other number will be missing plugs in the unused pin locations.

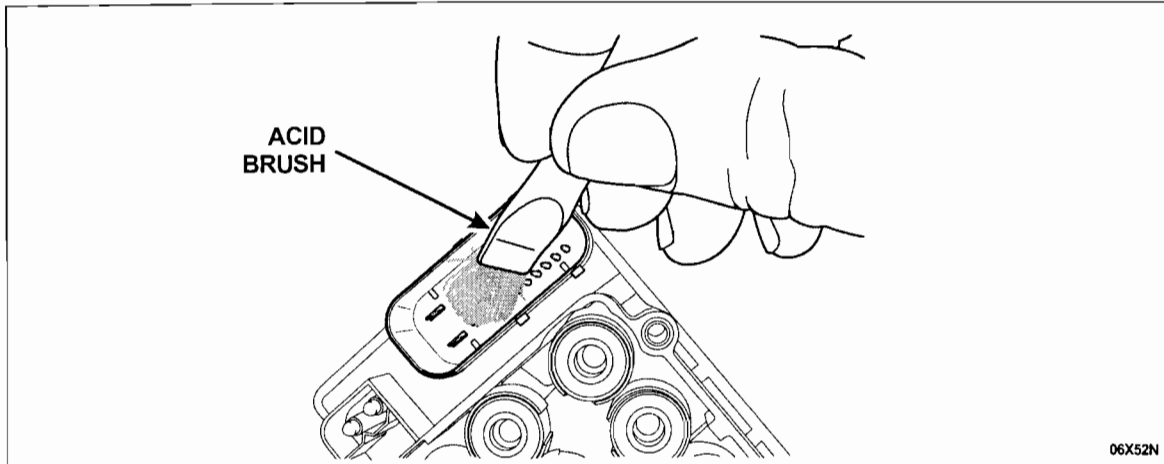
FIGURE 14

NOTE: The object is to clean the base of the connector cavity to remove corrosion and contamination between the pins, **NOT** the corrosion on the terminals.

Using the specified cleaning brush, vigorously brush the base of the module cavity around and in between the 4 large module connector terminals. See Figure 14.
