TO: All Mazda Dealership General Managers, Service Managers, and Parts Managers

DATE: August 2008

SUBJECT: 2001-2004 Mazda Tribute Anti-Lock Brake System Voluntary Safety Recall 4507C
RENOTIFICATION

2001-2004 TRIBUTE - ABS MODULE ELECTRICAL CONNECTOR [RECALL 4507C]

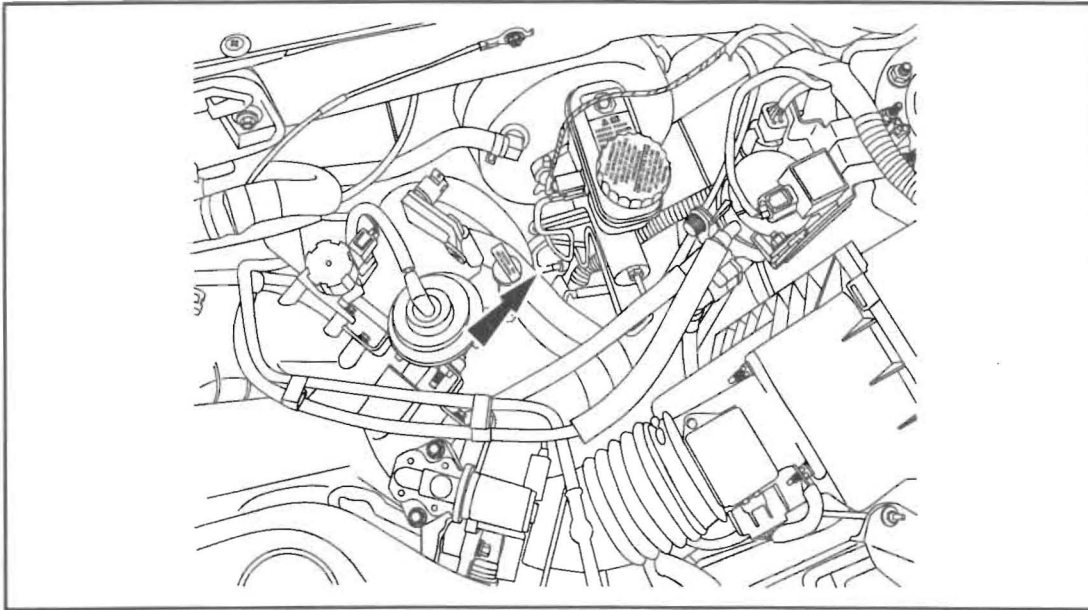
4507C6

1. Record customer's pre-set radio stations.
2. Disconnect negative battery cable.
3. Locate ABS module connector under brake master cylinder.

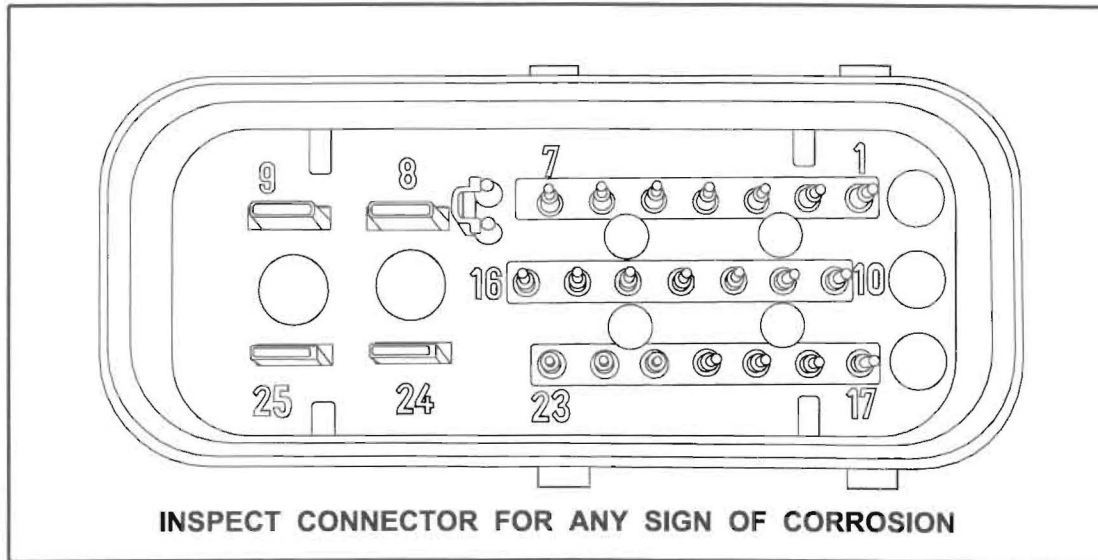
4507Cv

6. Inspect the ABS module connector pins for corrosion.
- If corrosion is present, proceed to "REPAIR PROCEDURE B".

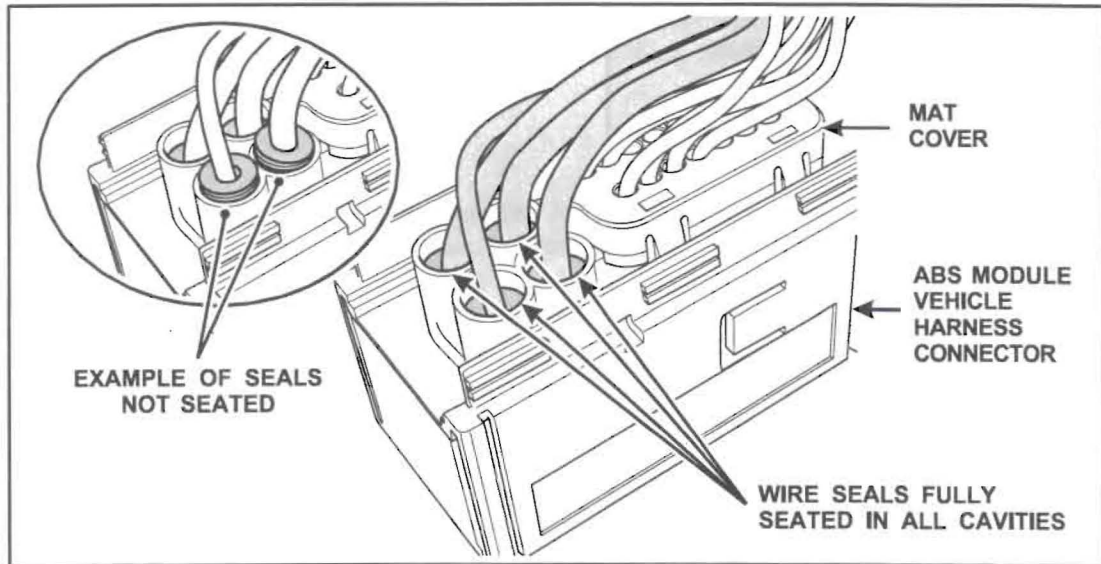
8. Verify the wire seals are present on the four (4) heavier gauge wires.

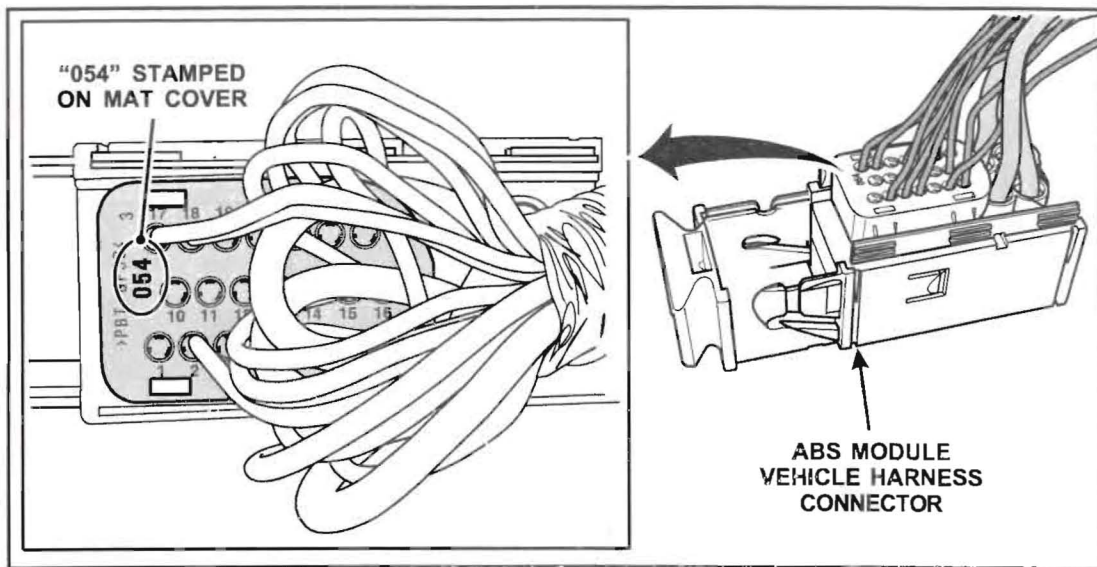
9. Verify the number "054" is stamped on the slide-lock end of the mat cover (wipe mat cover clean if necessary to view).

NOTE: Mat covers with any other number will be missing plugs in the unused pin locations.

- If the module is not corroded, **AND** all the wire seals are present, **AND** all the wire seals are fully seated, **AND** the number on the mat cover is "054", proceed to "REPAIR PROCEDURE A".
- If any of the wire seals are missing, **OR** if the number on the mat cover is not "054", proceed to "REPAIR PROCEDURE C".
- Verify all four (4) heavier gauge wire seals are fully seated in the cavities. Each seal should sit approximately 1-2 mm (1/16 in) below the top of the round cavity. If any of the wire seals are not seated properly, proceed to "REPAIR PROCEDURE D".

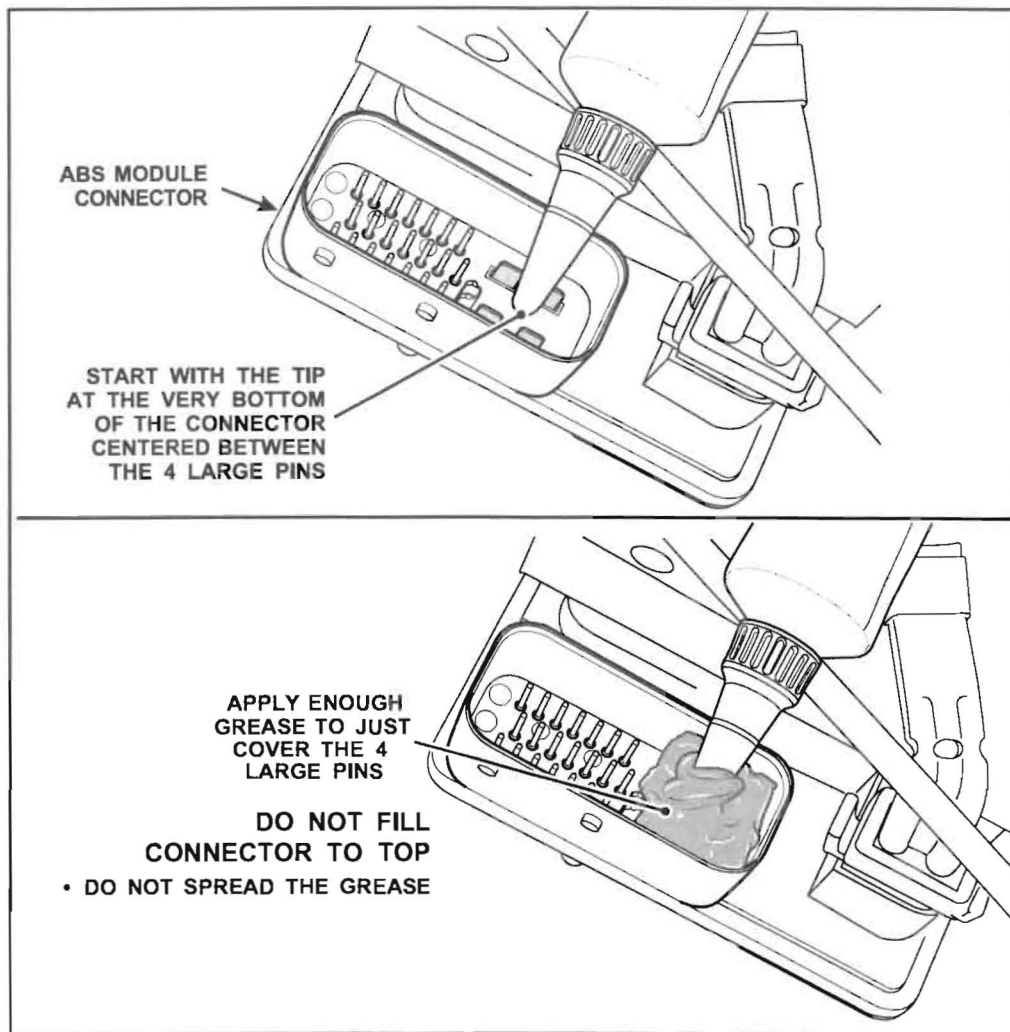
NOTE: DO NOT spread the grease around the connector. Applying an excess amount of grease into the connector cavity will cause a "hydro lock" condition which will not allow the connector to fully seat or lock in place.

- With the tip of the applicator tube snipped off, position the end of the tip between the four (4) large flat pins at the bottom of the ABS module connector. Squeeze out enough grease to just cover the four (4) flat pins.

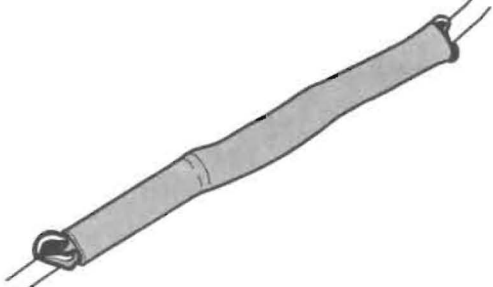
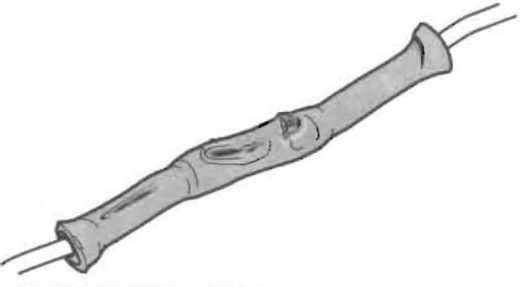
| <p>CORRECT CRIMP USING CRIMP TOOL</p> <ul style="list-style-type: none">• Wires crimped very securely.• No loose or broken wires.• Splice connector intact. | <p>INADEQUATE CRIMP USING IMPROPER TOOL</p> <ul style="list-style-type: none">• Broken splice connector.• Possible loose connection. |
| <p>CORRECTLY MELTED HEAT SHRINK TUBING USING FLAMELESS HEAT GUN</p> <ul style="list-style-type: none">• Tubing melted smooth across entire length.• Adhesive flow at both ends providing waterproof seal. | <p>INADEQUATELY MELTED HEATED SHRINK TUBING</p> <ul style="list-style-type: none">• Tubing charred from overheating.• Ends not fully melted.• No adhesive flow at ends, not waterproof. |

IMPORTANT SERVICE INFORMATION: When performing the service pigtail installation, it is critical that the crimp tool and flameless heat gun be used. USING DIFFERENT TOOLS MAY RESULT IN A POOR REPAIR.

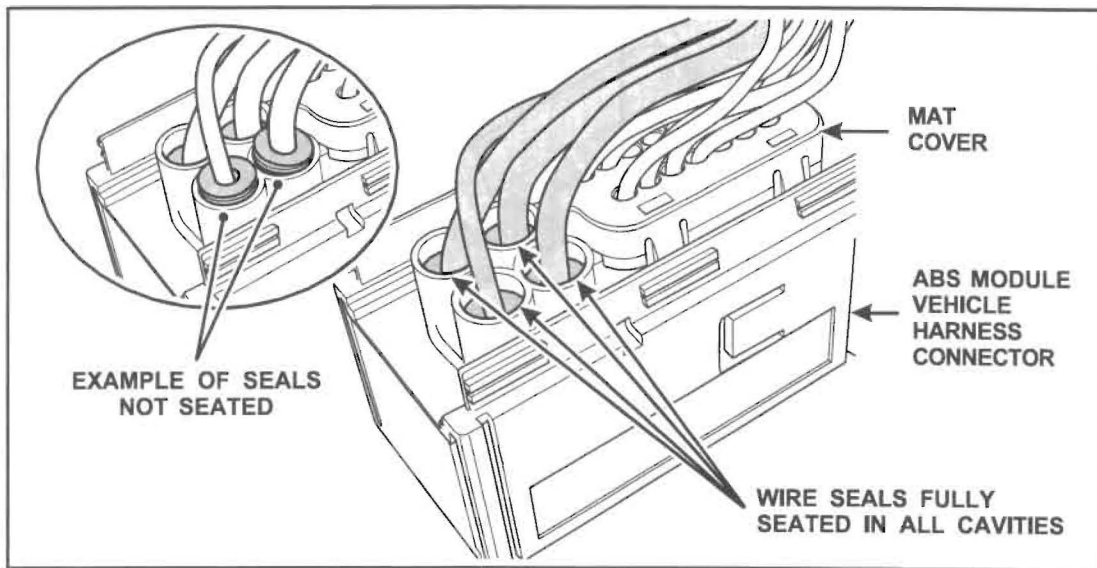
4507Ce

1. If the seals are not fully seated, reseal any seals not fully seated with a blunt tool.

NOTE: DO NOT use anything sharp such as a screwdriver, awl or punch that could penetrate the seal and allow moisture to enter the terminal.
