SUBJECT: 2001-2004 Mazda Tribute Anti-Lock Brake System Voluntary Safety Recall 4507C

2001-2004 TRIBUTE - ABS MODULE ELECTRICAL CONNECTOR [RECALL 4507C]

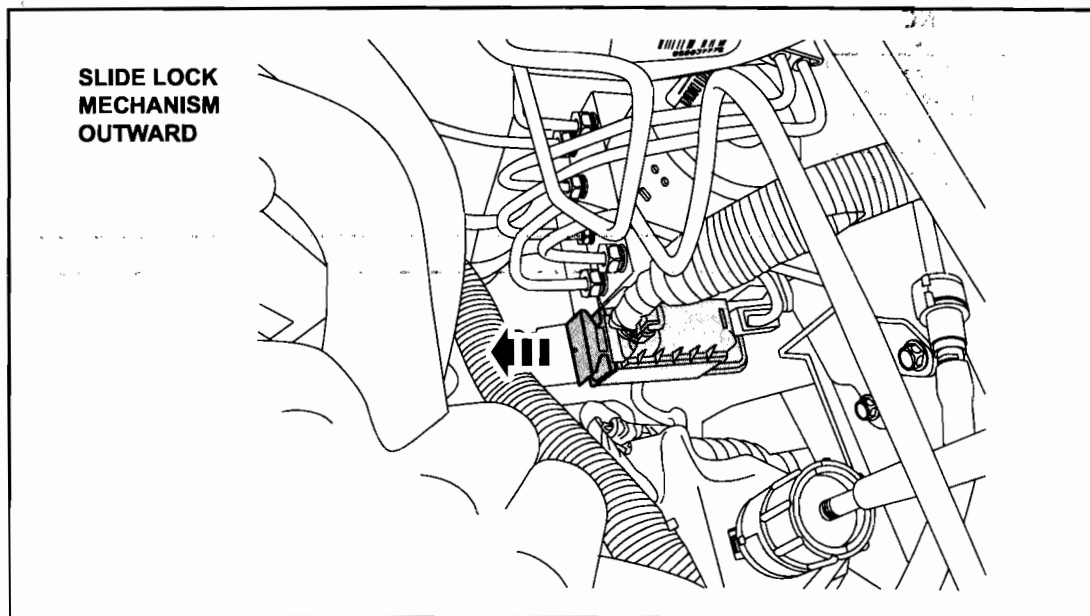
4507Cr

NOTE: When disconnecting the ABS module connector, be sure the blue connector lock stays engaged with the harness connector and does not remain in the module. Remove it from the module if necessary and make sure the white O-ring seal is properly installed.

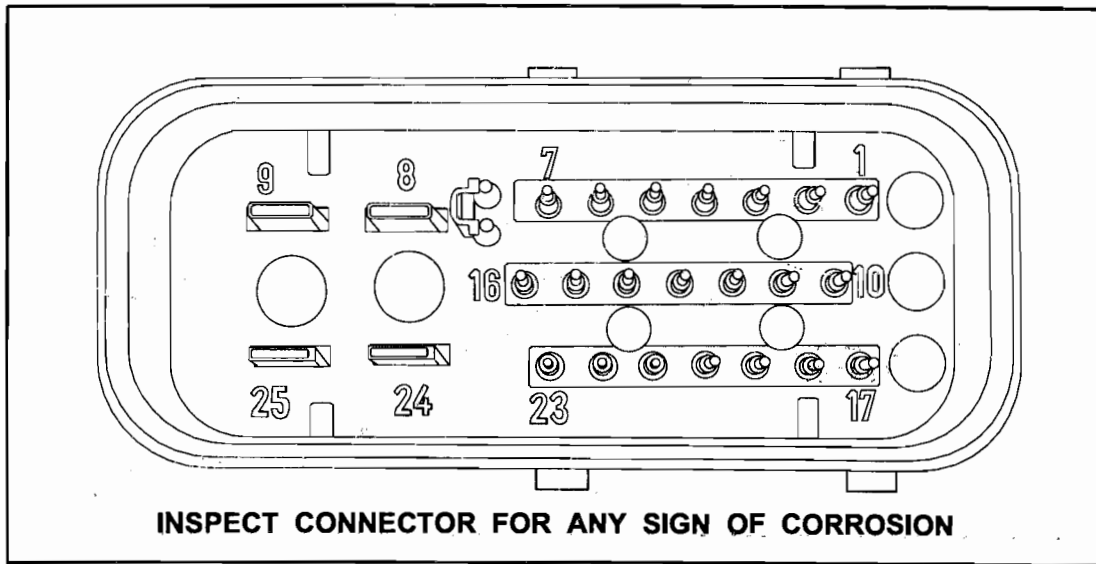
4507Cv

6. Inspect the ABS module connector pins for corrosion.
 - If corrosion is present, proceed to "REPAIR PROCEDURE B".

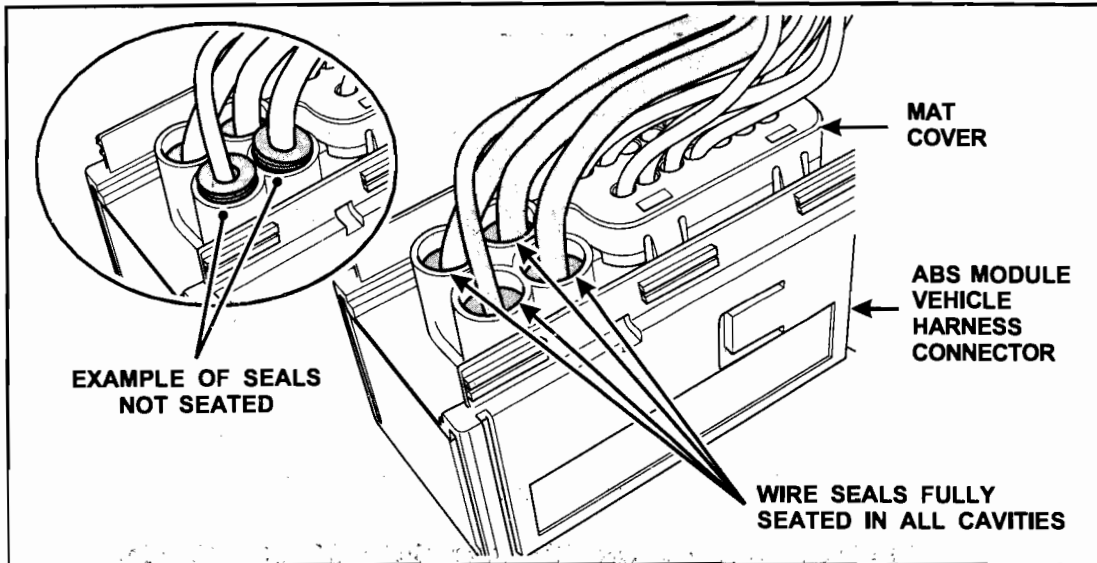
4507Cc

8. Verify the wire seals are present on the four (4) heavier gauge wires.

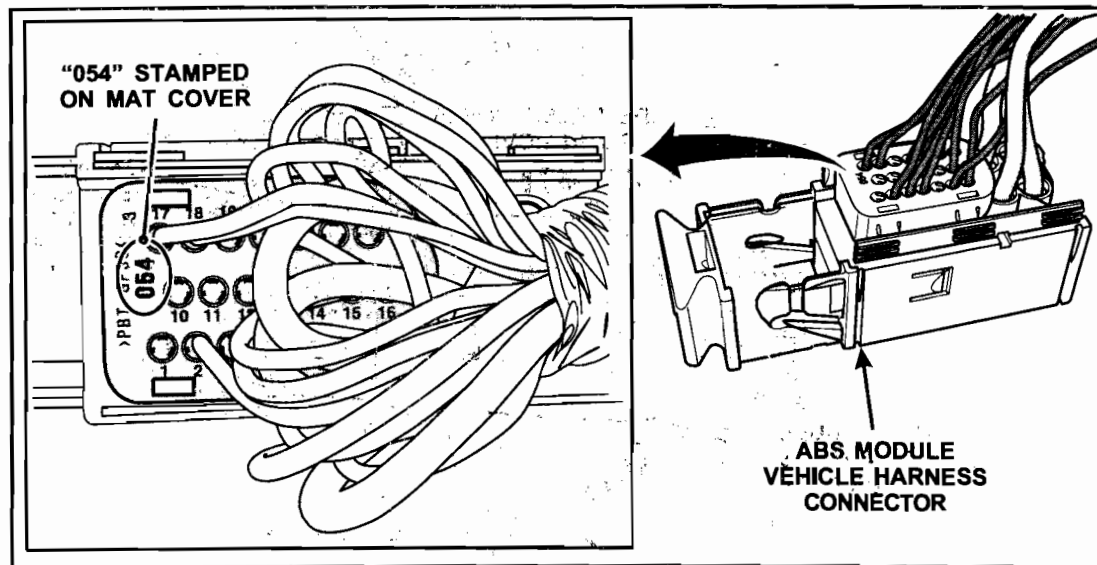
4507Cd

9. Verify the number "054" is stamped on the slide-lock end of the mat cover (wipe mat cover clean if necessary to view).

NOTE: Mat covers with any other number will be missing plugs in the unused pin locations.

- If the module is not corroded, **AND** all the wire seals are present, **AND** all the wire seals are fully seated, **AND** the number on the mat cover is "054", proceed to "REPAIR PROCEDURE A".
- If any of the wire seals are missing, **OR** if the number on the mat cover is not "054", proceed to "REPAIR PROCEDURE C".
- Verify all four (4) heavier gauge wire seals are fully seated in the cavities. Each seal should sit approximately 1-2 mm (1/16 in) below the top of the round cavity. If any of the wire seals are not seated properly, proceed to "REPAIR PROCEDURE D".

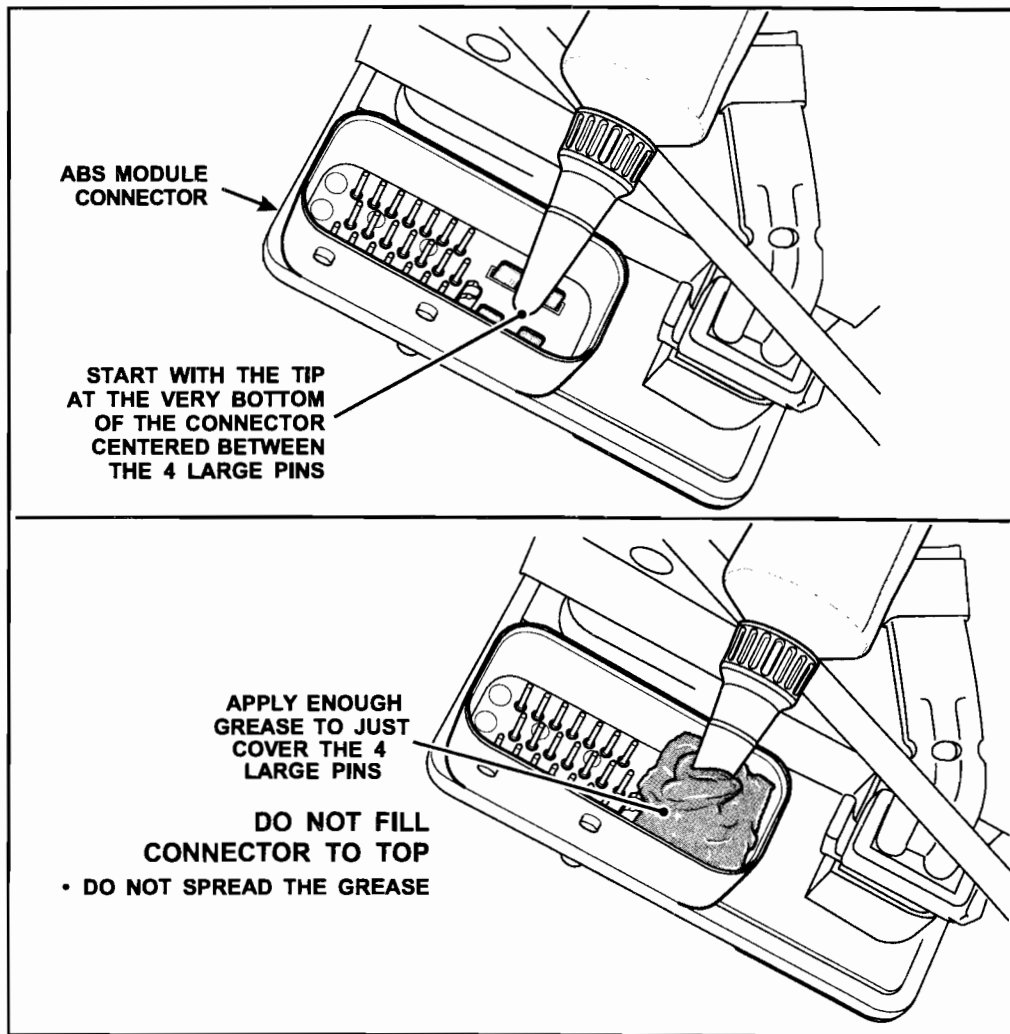
4507Ch

NOTE: DO NOT spread the grease around the connector. Applying an excess amount of grease into the connector cavity will cause a "hydro lock" condition which will not allow the connector to fully seat or lock in place.

1. Reinstall dress cover and use electrical tape to secure the cover at the same location where the original tie strap was removed. Apply dielectric grease to the ABS module connector, position and connect the harness as follows:

- With the tip of the applicator tube snipped off, position the end of the tip between the four (4) large flat pins at the bottom of the ABS module connector. Squeeze out enough grease to just cover the four (4) flat pins.

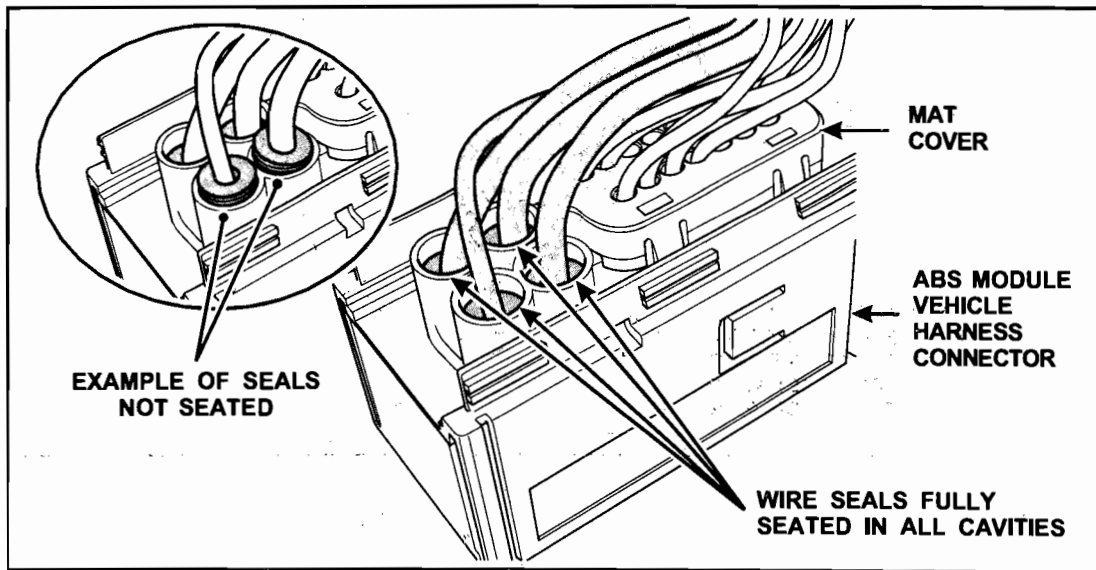
1. If the seals are not fully seated, reseal any seals not fully seated with a blunt tool.

NOTE: DO NOT use anything sharp such as a screwdriver, awl or punch that could penetrate the seal and allow moisture to enter the terminal.
