**To: Repair Facilities**  
**Subject: Front frame inspection and repair**

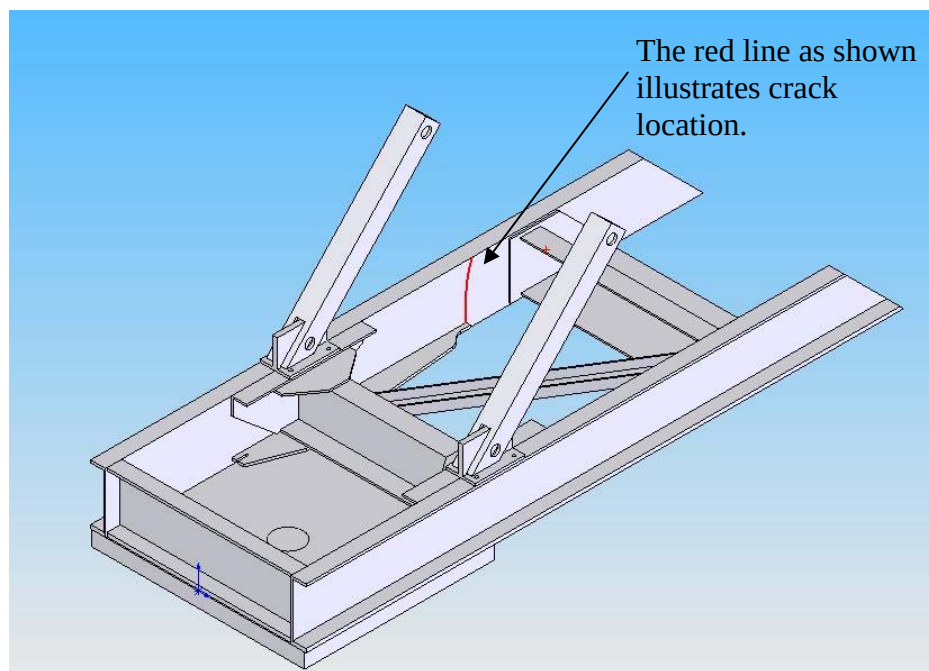
**Potential Crack Location**

A crack may develop in a weld termination in the right front frame rail of the front frame, and eventually propagate through the frame. If undetected, the crack will grow to the point of failure. See Figure B for a detail of the crack location.

A reinforcement upgrade has been developed that will prevent the crack from occurring. In cases where cracking has occurred complete replacement of the front frame may be warranted. Polar will be covering the cost of the required upgrades.
