GROUP
Campaign

MODEL
Sportage

NUMBER
070

SAFETY RECALL CAMPAIGN: SPORTAGE COOLING FAN BLADE REPLACEMENT

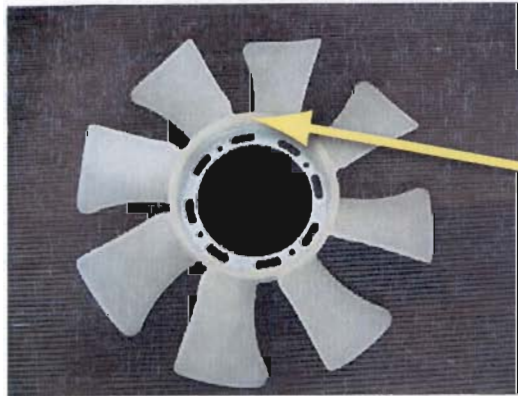
New Cooling Fan

This bulletin provides information related to a safety recall campaign to replace the Cooling Fan Blade. 2002MY Sportage vehicles produced from 5/15/2001~10/2/2002 may experience fan blade cracking due to the heating and cooling of the plastic materials used for the fan blade. During normal engine operation the centrifugal force generated by the fan rotation can cause cracks and fan blade separation from the hub. Kia is replacing the fan blade with a version manufactured with improved material characteristics.

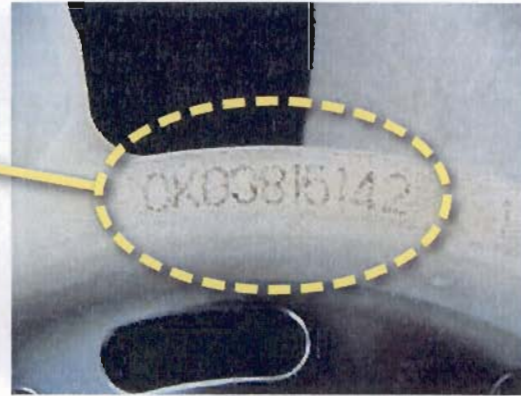
P/N: 0K038 15142
(Part number location)

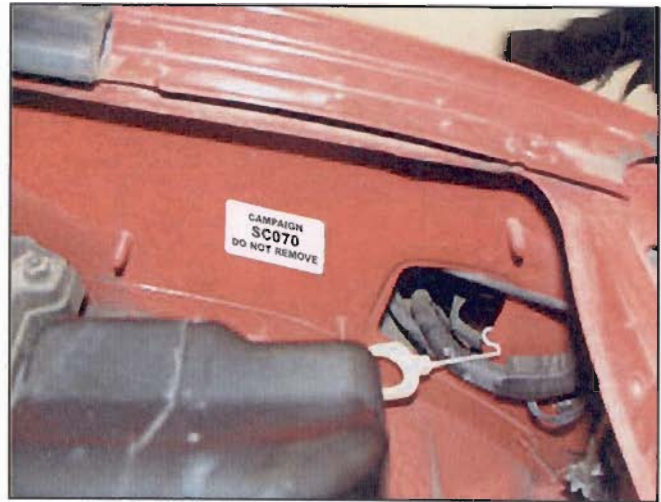
1. Open hood and inspect for SC070 Campaign Completion Label in the engine compartment next to the air cleaner/resonator.
 - If label exists, NO FURTHER ACTION IS REQUIRED.
 - If label DOES NOT EXIST, continue to Repair Procedure.
