SAFETY RECALL BULLETIN

AUTOCAR SAFETY RECALL A-0701 NHTSA RECALL 07V-184

SUBJECT: LOOSE STEERING COLUMN FASTENERS

AFFECTED: CERTAIN AUTOCAR WX (LEFT, RIGHT, AND DUAL DRIVER STATION) AND WXLL (LEFT AND DUAL DRIVER STATION) MODEL VEHICLES BUILT BETWEEN 03 OCT 2006 AND 21 MAR 2007, VIN RANGE 204526 TO 205372

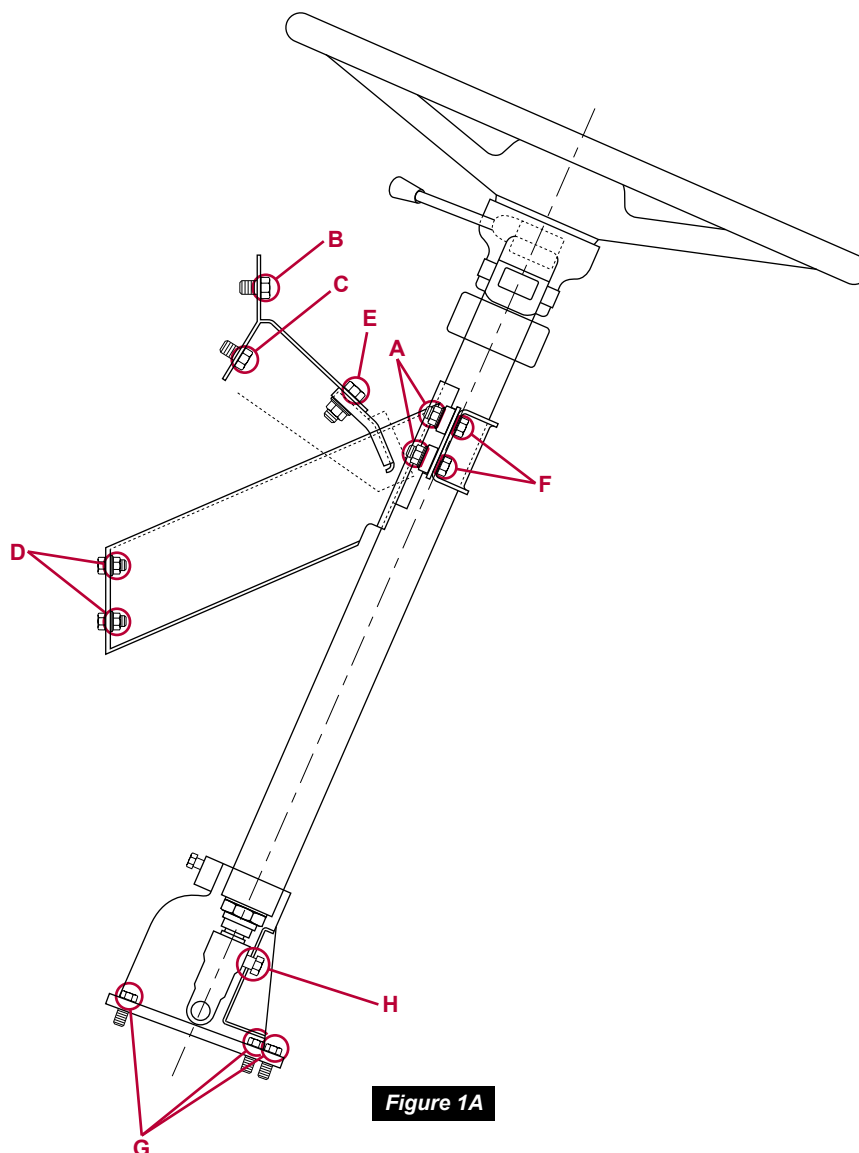
Figure 1A

Several steps in this repair procedure will reference the threaded fasteners securing the steering column to the mounting brackets, and securing the mounting brackets to the cab. The following fastener identification illustration (*Figure 1A*) has been provided to assist in locating each fastener as referenced by the repair procedure.

STEP 5: Using a 9/16" open-ended wrench, remove the (2) hex nuts (*Figure 1A, fastener A*) securing the diagnostic connector to the steering column (*Figure 5*).

STEP 6: Using a 1/2" socket, torque the (2) hex head cap screws (*Figure 1A, fastener B*) to 13 ft-lbs (± 2 ft-lbs) (*Figure 6*).

STEP 7: Using a 1/2" socket, torque the (2) hex head cap screws (*Figure 1A, fastener C*) to 13 ft-lbs (± 2 ft-lbs) (*Figure 7*).

STEP 8: Using a 1/2" socket, torque the (4) hex nuts (*Figure 1A, fastener D*) to 13 ft-lbs (± 2 ft-lbs) (*Figure 8*).

STEP 9: Using a 5/8" socket, torque the (2) hex head cap screws (*Figure 1A, fastener E*) to 55 ft-lbs (± 5 ft-lbs) (*Figure 9*).

STEP 10: Using a 9/16" socket, torque the (4) hex head cap screws (*Figure 1A, fastener F*) to 35 ft-lbs (± 3 ft-lbs) (*Figure 10*).

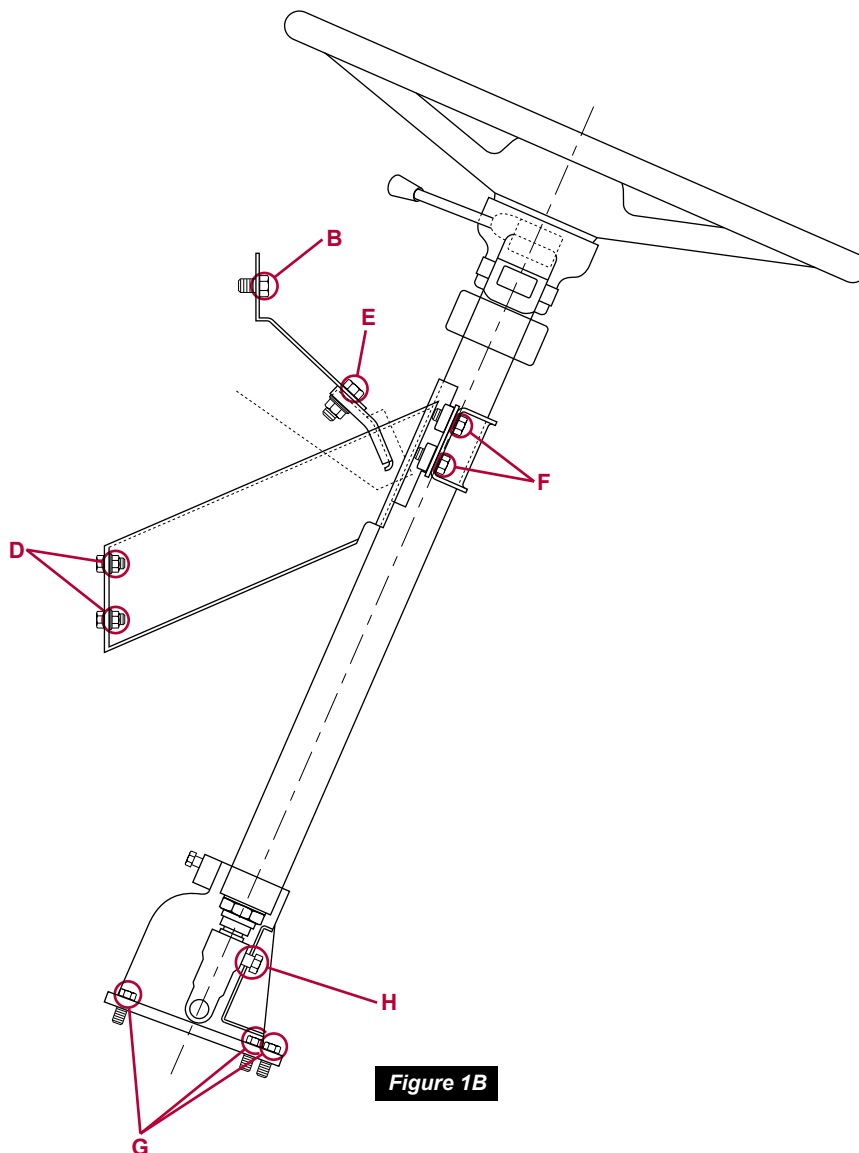
Figure 1B

Several steps in this repair procedure will reference the threaded fasteners securing the steering column to the mounting brackets, and securing the mounting brackets to the cab. The following fastener identification illustration (*Figure 1B*) has been provided to assist in locating each fastener as referenced by the repair procedure.

STEP 5: Using a 1/2" socket, torque the (2) hex head cap screws (*Figure 1B, fastener B*) to 13 ft-lbs (± 2 ft-lbs) (*Figure 19*).

STEP 7: Using a 5/8" socket, torque the (2) hex head cap screws (*Figure 1B, fastener E*) to 55 ft-lbs (± 5 ft-lbs) (*Figure 21*).

STEP 11: Using a 1/2" socket, torque the (4) hex head cap screws (*Figure 1B, fastener G*) to 18 ft-lbs (± 2 ft-lbs) (*Figure 23*).

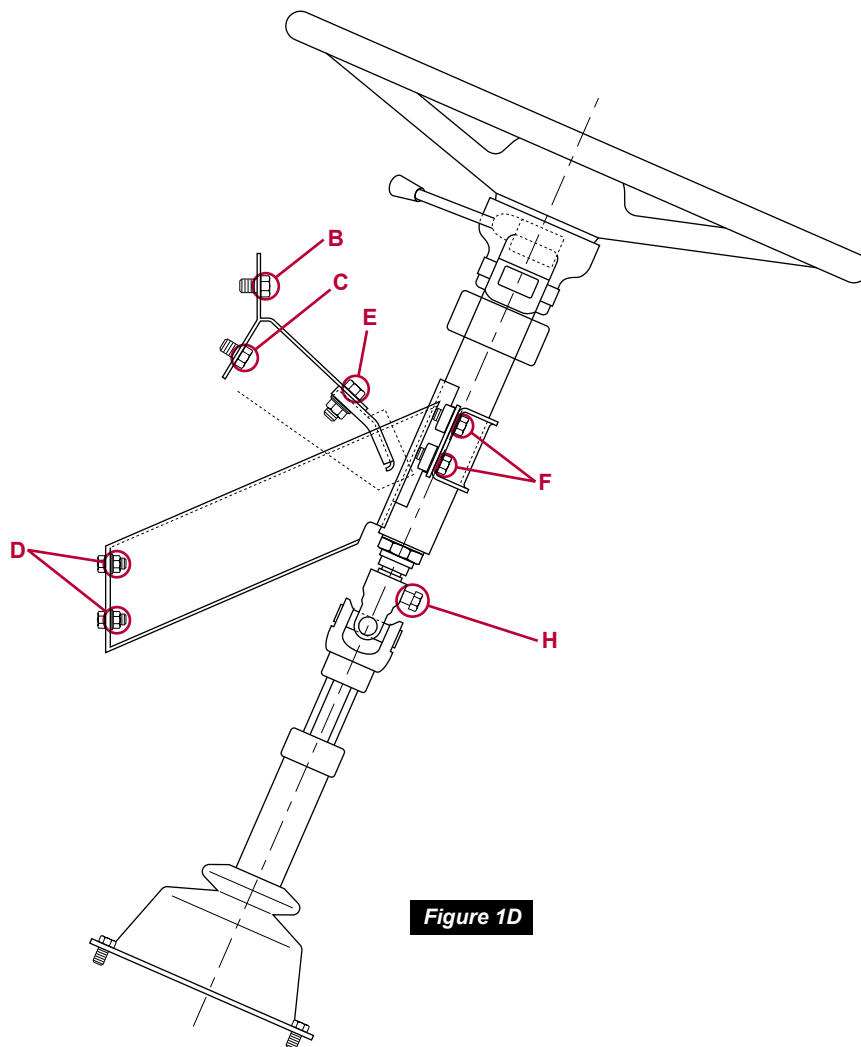
Figure 1D

Several steps in this repair procedure will reference the threaded fasteners securing the steering column to the mounting brackets, and securing the mounting brackets to the cab. The following fastener identification illustration (*Figure 1D*) has been provided to assist in locating each fastener as referenced by the repair procedure.

STEP 4: Using a 1/2" socket, torque the (2) hex head cap screws (*Figure 1D, fastener B*) to 13 ft-lbs (± 2 ft-lbs) (*Figure 43*).

STEP 5: Using a 1/2" socket, torque the (2) hex head cap screws (*Figure 1D, fastener C*) to 13 ft-lbs (± 2 ft-lbs) (*Figure 44*).

STEP 6: Using a 1/2" socket, torque the (4) hex head cap screws (*Figure 1D, fastener D*) to 13 ft-lbs (± 2 ft-lbs) (*Figure 45*).

STEP 7: Using a 5/8" socket, torque the (2) hex head cap screws (*Figure 1D, fastener E*) to 55 ft-lbs (± 5 ft-lbs) (*Figure 46*).

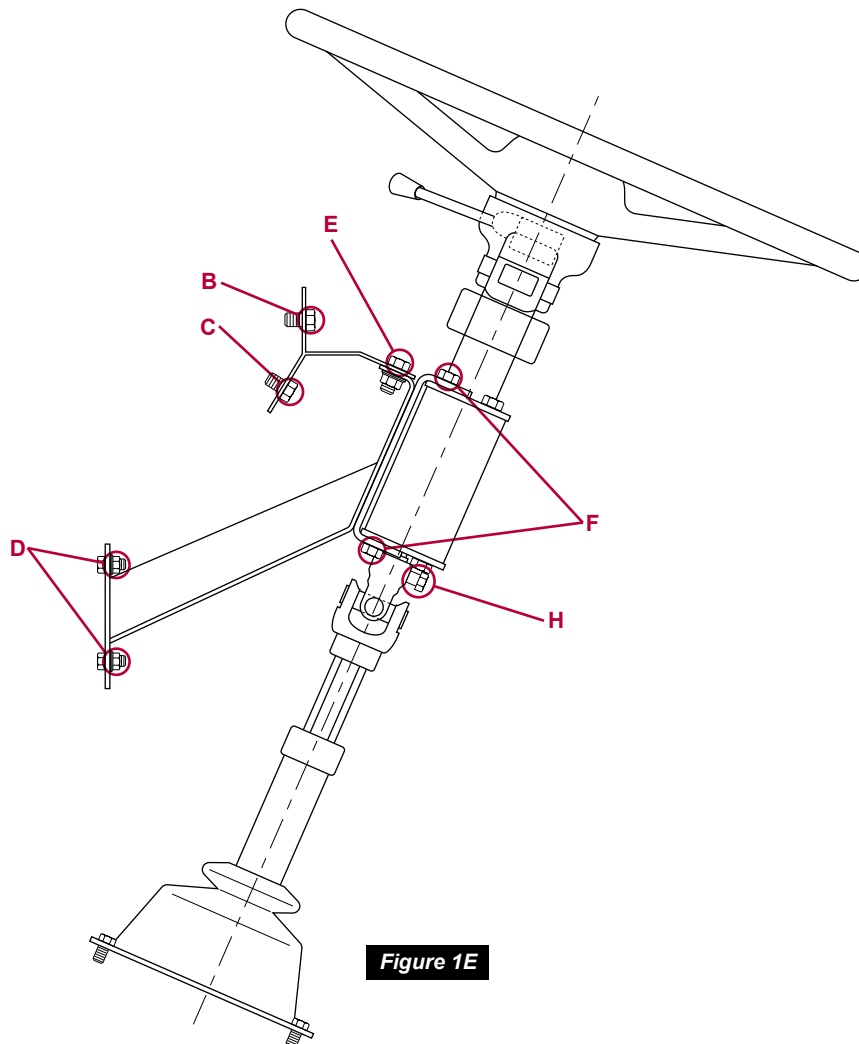
Figure 1E

Several steps in this repair procedure will reference the threaded fasteners securing the steering column to the mounting brackets, and securing the mounting brackets to the cab. The following fastener identification illustration (*Figure 1E*) has been provided to assist in locating each fastener as referenced by the repair procedure.

STEP 14: Using a 1/2" socket, torque the (2) hex head cap screws (*Figure 1E, fastener B*) to 13 ft-lbs (± 2 ft-lbs) (*Figure 57*).

STEP 17: Using a 5/8" socket, torque the (2) hex head cap screws (*Figure 1E, fastener E*) to 55 ft-lbs (± 5 ft-lbs) (*Figure 60*).

STEP 18: Using a 1/2" socket, torque the (4) hex head cap screws (*Figure 1E, fastener F*) to 35 ft-lbs (± 3 ft-lbs) (*Figures 61 and 62*).
