SUPPLEMENT TO RECALL A-0701

AUTOCAR SAFETY RECALL A-0701 NHTSA RECALL 07V-184

JUNE 2007

**SUBJECT: SUPPLEMENTAL FASTENER TORQUE SEQUENCE FOR
LOOSE STEERING COLUMN CLAMP FASTENERS**

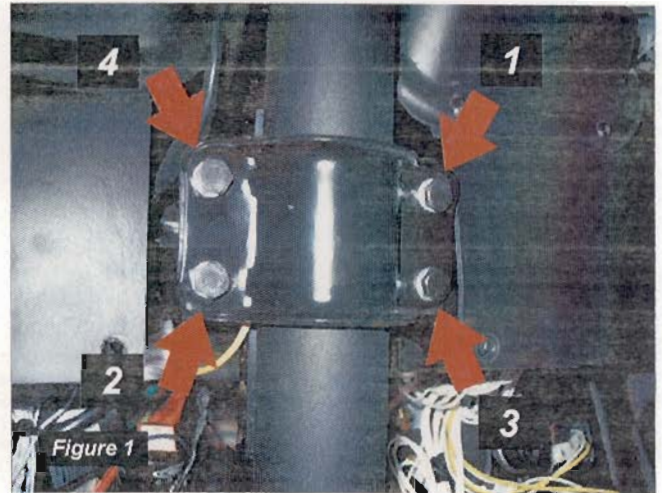
Autocar, LLC has determined that a supplemental work instruction is necessary to address the fastener torque sequence in certain WX, WXR, and WXLL vehicles, as affected by safety recall A-0701. The clamp which secures the steering column to the mounting bracket under the dashboard (*Figure 1*) requires a specific tightening sequence, which is outlined in the following **REPAIR PROCEDURE**.

STEP 1: Torque the fasteners securing the steering column clamp to the mounting bracket to 35 ft-lbs (± 3 ft-lbs), in the order shown in *Figure 1*.

STEP 2: Repeat the sequence as shown in *Figure 1*, torquing all fasteners again to a value of 35 ft-lbs (± 3 ft-lbs).
