MODEL  
XKR

NUMBER  
J003

**TECHNICAL BULLETIN**

**RECALL: Incorrect Brake Servo Vacuum Supply Hose Routing**

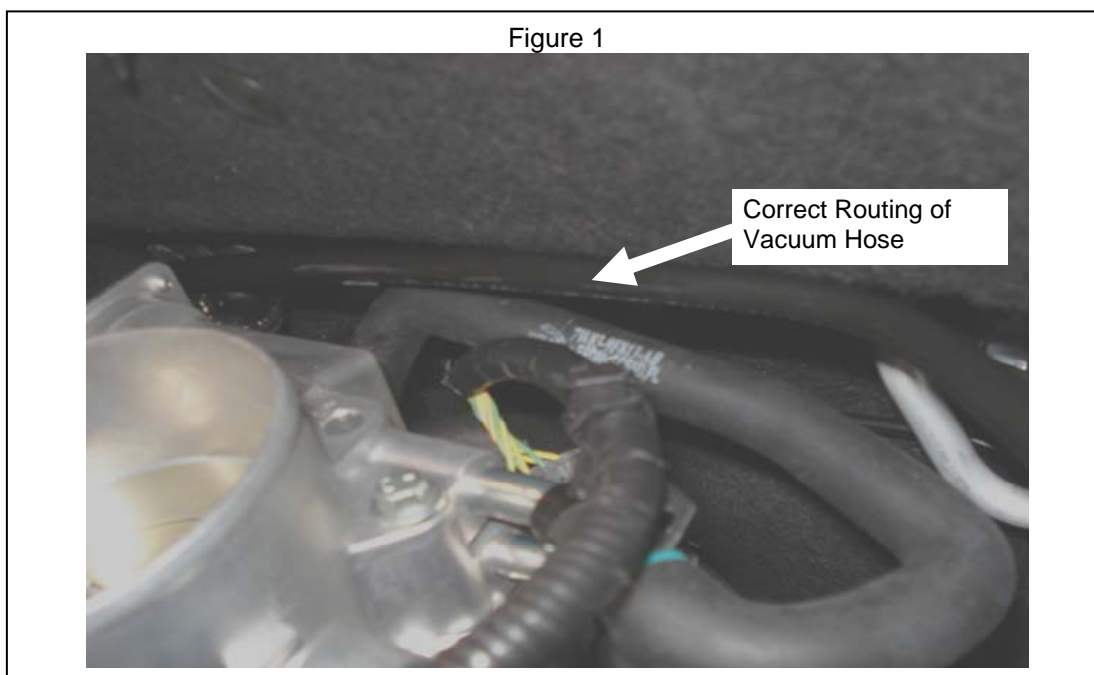
1. Refer to GTR Workshop Manual section 303-12A and remove the Intake Air Resonator.
2. Looking from above in the area of the 'Y' pipe, verify that the brake servo vacuum hose is routed correctly above both the rubber coolant hose and the steel low pressure Air Conditioning (AC) tubing as shown. (Figure 1)
3. If the hose is correctly aligned as shown in Figure 1, no further action is required. Re-install the Intake Air Resonator.

6. If the vacuum hose is determined to be undamaged, perform the following:
- Position the vacuum hose above the rubber coolant hose and steel AC tubing. (Figure 1)
  - Position the protective grommet.
  - Reconnect the quick connect fitting.
7. If **any damage** to the vacuum hose is determined, perform the following:
- Disconnect the installed vacuum hose at the throttle body. (Figure 4)
  - Remove the damaged vacuum hose from the vehicle.
  - Position the replacement vacuum hose above the rubber coolant hose and steel AC tubing.
  - Install the replacement vacuum hose to the throttle body.
  - Position the protective grommet.
  - Reconnect the replacement hose quick connect fitting above the brake servo.
8. Install air intake and engine compartment shielding components removed for access.

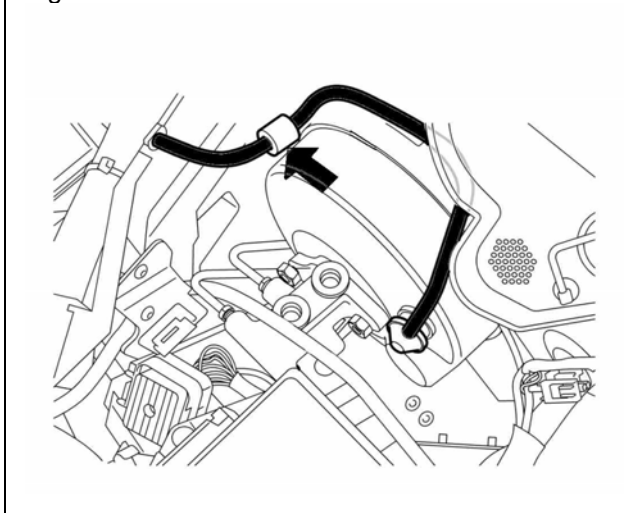
**NOTE: The brake master cylinder reservoir must not be removed from the vehicle. It is shown removed in Figure 3 for illustration clarity only.**

- Remove the four clips, and remove the brake master cylinder cover (Figure 2).
- Disconnect the vacuum line at the quick-connect fitting above the brake servo. (Arrowed in Figure 3)
- Disengage the protective grommet.
- Carefully pull the vacuum line back toward the passenger side of the vehicle to free it from under the hose and AC tubing.
