TRUCKS
Nissan Diesel America, Inc.

RECALL BULLETIN 07V-207

DATE: August 6, 2007
 MODEL YEAR: 2005 ~ 2007
 CHASSIS MODEL: UD1800HD, UD2000, UD2300, UD2600, UD3300
 BULLETIN NUMBER: 07V-207

VOLUNTARY SAFETY RECALL CAMPAIGN NUMBER 07V-207 DRIVE BELT TENSIONER REPLACEMENT

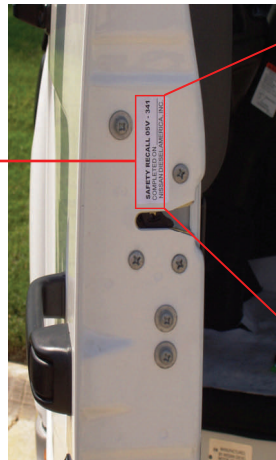
- If the involved vehicle has a label on the inside of the driver's door as shown in Figure A, the recall has already been performed and no further action is required.
- If the involved vehicle does not have the label on the inside of the driver's door, verify through the Vehicle Service Notification screen of the NDANET2 system that the recall is required. Complete the safety recall according to the following instructions.

Record the completion date on the Safety Recall 07V-207 sticker as shown in Figure H and apply it to the driver's side door as shown in Figure A on page 3.

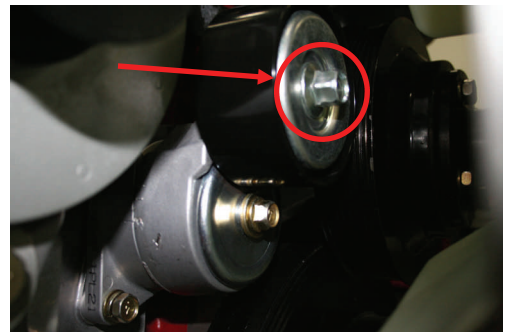
Fig. C

- ▣ The pulley bearing rolls smoothly.
- ▣ There is no damage to the belt mating surface of the pulley.
- ▣ The center bolt seating face, bolt head and threads are in good condition.

- Remove the idler pulley from tensioner by removing center bolt (**left hand threads**). Save idler pulley, large washer and bolt for reuse on new tensioner. See Figure C

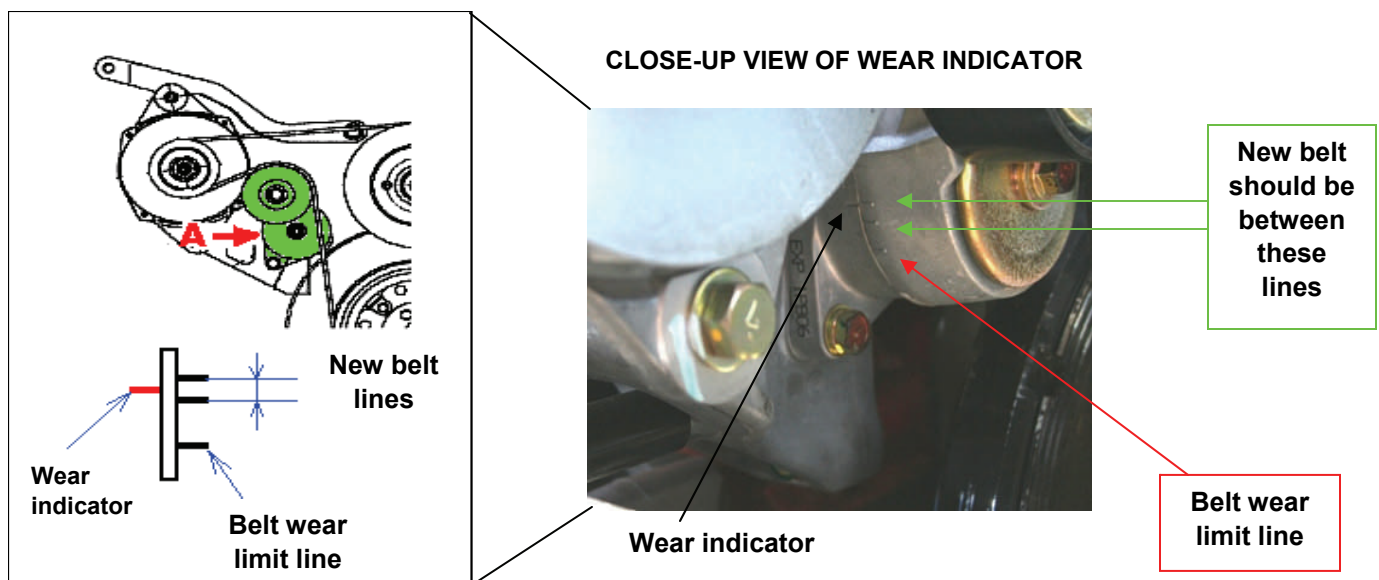
Fig. G

NOTE: When installing the new drive belt, inspect the wear indicator on the side of the drive belt tensioner as shown in Figure G, it should be positioned between the two marks as illustrated. If the wear indicator is not between these two lines, verify that the belt routing or correct drive belt part number was used
