Safety Recall

Subject: Fuel Pipe Bracket

Bulletin: R0020

Campaign #: A5371

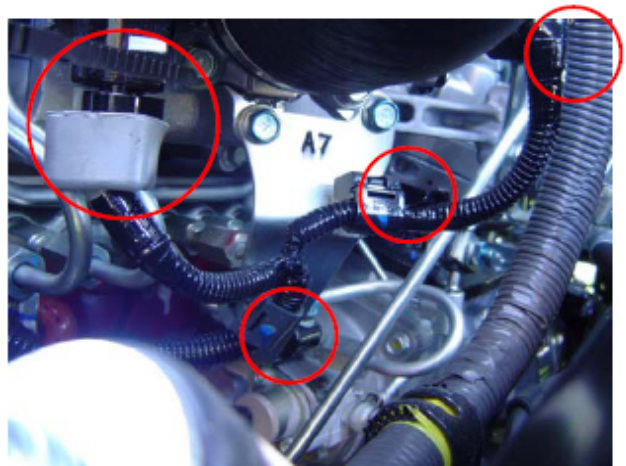
3. Disconnect the throttle position sensor connector, throttle motor connector, and unclip the two (2) P-clips from the bracket. Lay the harness to the side.

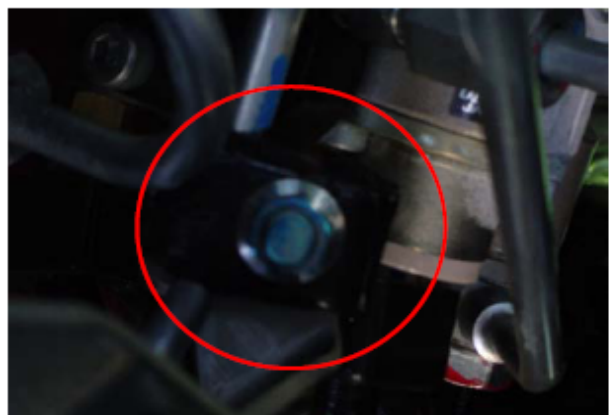
4. Remove nut from holding clip and remove the upper clip.

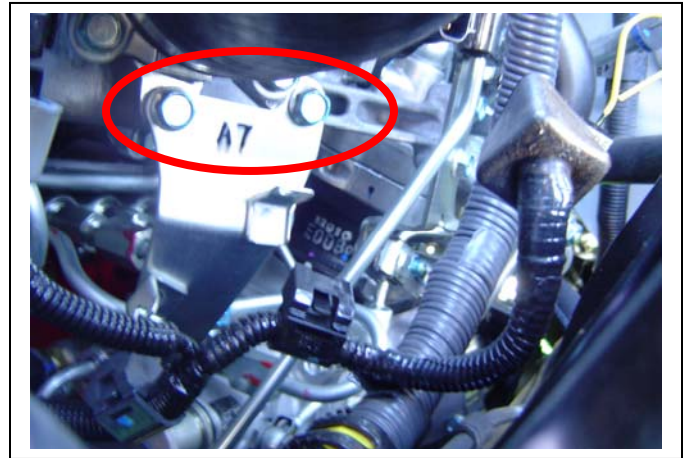
5. Remove the bracket mounting bolts and the bracket.

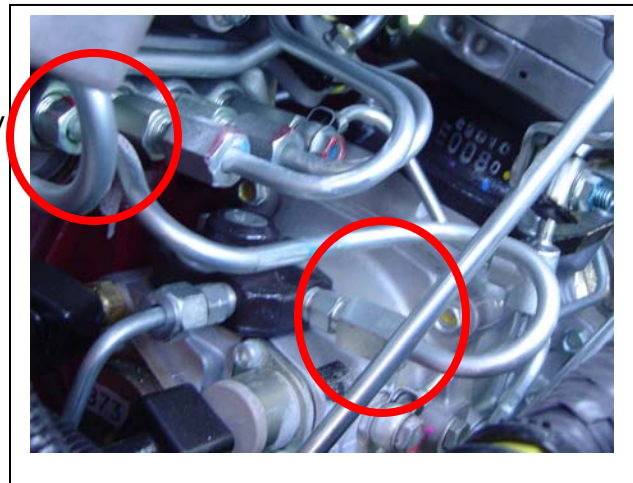
6. Remove pipe by loosening flare nuts at both ends of the pipe. Remaining fuel may run out of the pipe, clean with a rag and be careful that no dirt or debris is allowed to enter the common rail or pump fittings.

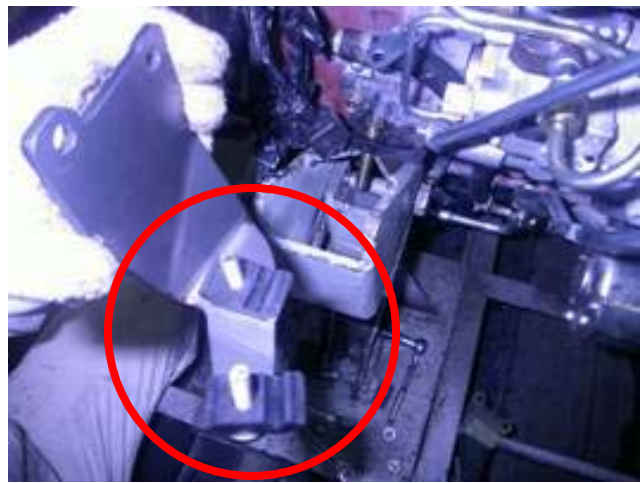
8. Install a clip on each stud of the bracket.

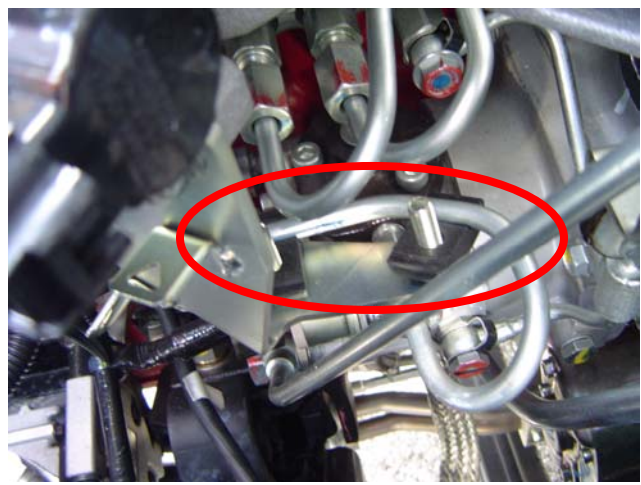
9. Install bracket so the fuel pipe will rest in the grooves of the clips.

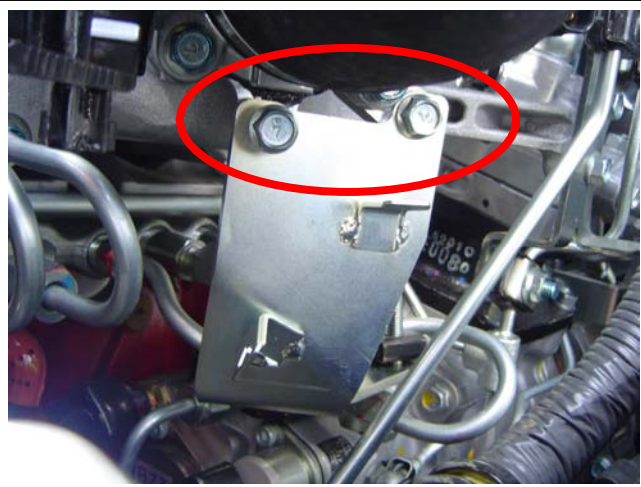
10. Install two (2) bracket mounting bolts.

Note: Make sure bolts do not cross thread, intake damage may result.

Torque to 21 lbf/ft (28.5 Nm)

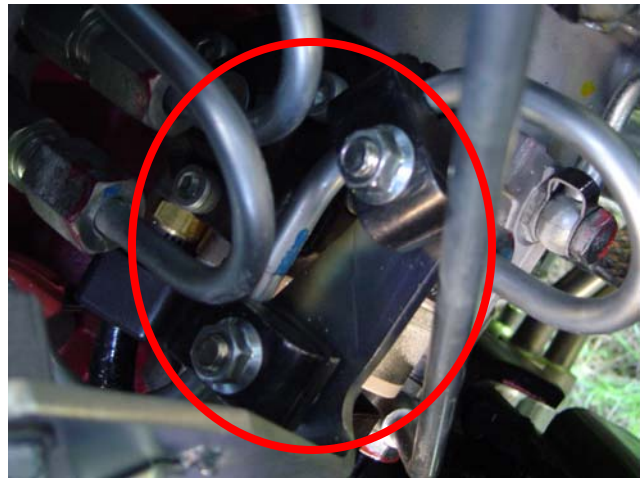
11. Install two (2) upper clips and nuts.

Torque to 30 lbf/in (3.4 Nm)

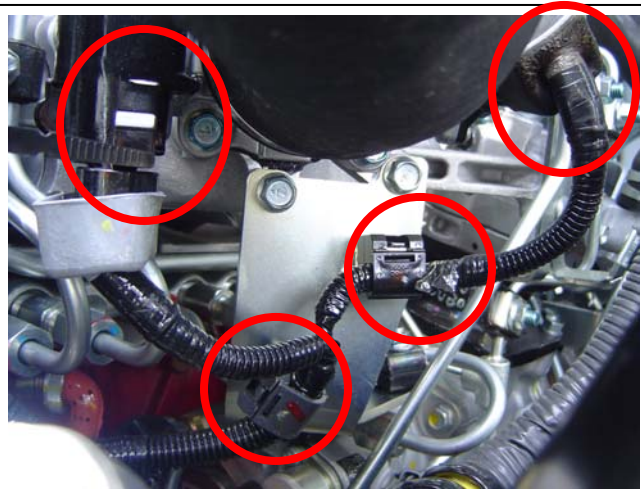
12. Reinstall throttle position sensor connector, throttle motor connector, and two (2) harness P-clips to the bracket.
