**FEDERAL RECALL CAMPAIGN 07KW9  
C500'S MANUFACTURED APRIL 4, 2006 THROUGH MARCH 29, 2007 WITH SHEET METAL HOODS AND  
STANDARD AXLE SETTING**

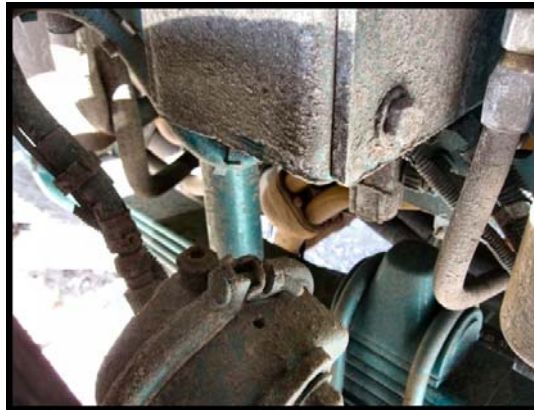
The front axle brake chamber can contact the rear hood mounting brackets in full axle (bump) articulation. This contact, which may go undetected, can cause damage to the front brake chamber resulting in application of the front brakes, or may cause air loss. Either condition could compromise vehicle braking, which may lead to physical injury or vehicle damage. This condition was determined to be a safety-related defect.

Hood support can contact brake chamber (see Figure 1).

Figure 1; Hood support & brake chamber "before" repairs
