TO: ALL VOLVO RETAILERS
RE: RECALL 180

VOLVO				TITLE:		GROUP:	NO:	
				Recall 180: Adjust Driver's Door Bowden Cable		83	180	
Service Manager Bulletin				2007 C70		ISSUING DEPARTMENT:		
						Warranty		
				REFERENCE BULLETINS:		CARMARKET:		
				TNN# 83-180		United States, Canada		
Service Personnel: read and initial.	SERVICE MANAGER	SERVICE WRITER	WARRANTY ADMINISTRATOR	DATE:		YEAR	MONTH	DAY
				2007 06 14				
				Page 1 of 3

SUBJECT: Recall 180: C70 Bowden Cable Attachment
REFERENCE: VIDA, Service Manager Bulletin 83-180

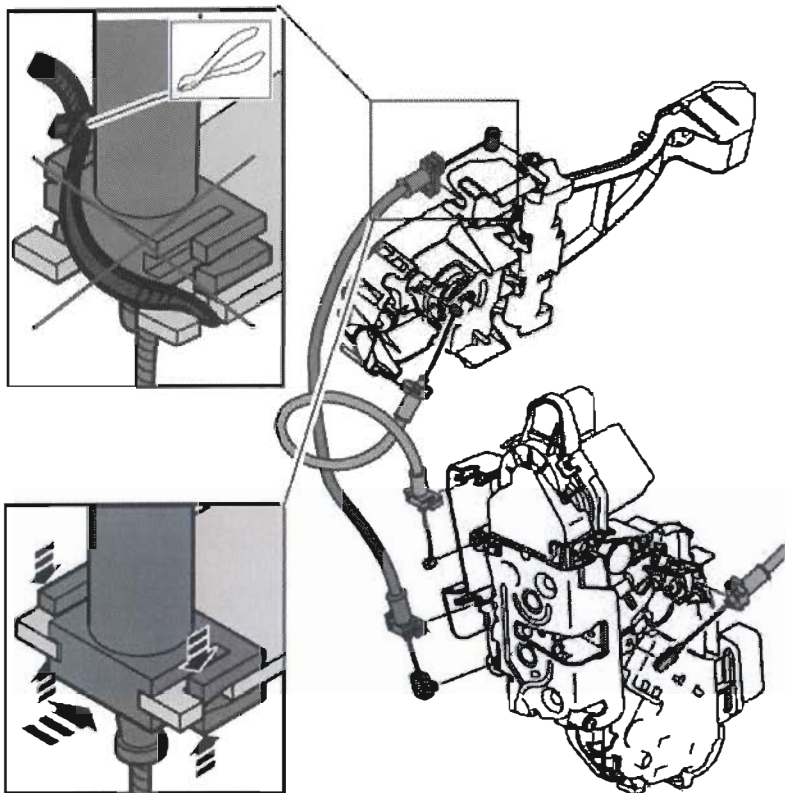
3.
**Bowden cable
attachment adjustment**

In certain vehicles, the Bowden cable, which connects the door handle to the door latch, may have been incorrectly adjusted after final assembly at the factory. This incorrect adjustment may increase the possibility of the driver door becoming unlatched in the event of certain side impact collisions. Volvo Car Corporation has decided to implement this Voluntary Safety recall on all effected vehicles as soon as possible

Cut off and remove the
cable tie, see illustration.

Install the Bowden cable
attachment in the
designated location, see
illustration.
