Dealer Service Instructions for:

Safety Recall G14

Seat Track Position Sensor

2007-2008 (JS) Chrysler Sebring and Dodge Avenger

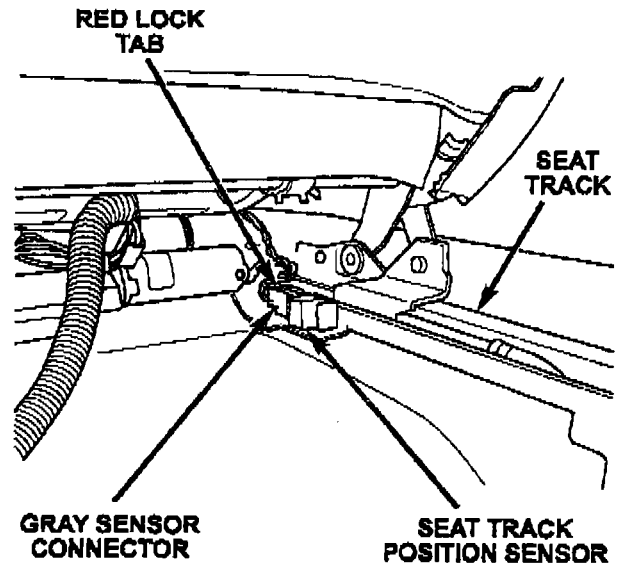
Figure 1 – Backside of Driver's Seat View

2. For four door models, place the driver's seat in the full forward and full up position.
3. For convertible models, place the driver's seat in the midpoint and full up position.
4. For four door models, locate the seat track position sensor on the seat track. Slide the red lock tab forward on the gray electrical connector (Figure 1).
5. For convertible models, locate the seat track position sensor on the seat track. Use a cotter pin removal tool (Snap-on CP3B or equivalent) to push the red lock tab forward on the gray electrical connector (Figure 2).
6. Disconnect the gray sensor electrical connector by pressing down on the red connector lock tab while pulling the connector forward..
