DaimlerChrysler Corporation

Reference: NHTSA Identification Number 07V-246

Safety Recall G20

Side Window Airbags

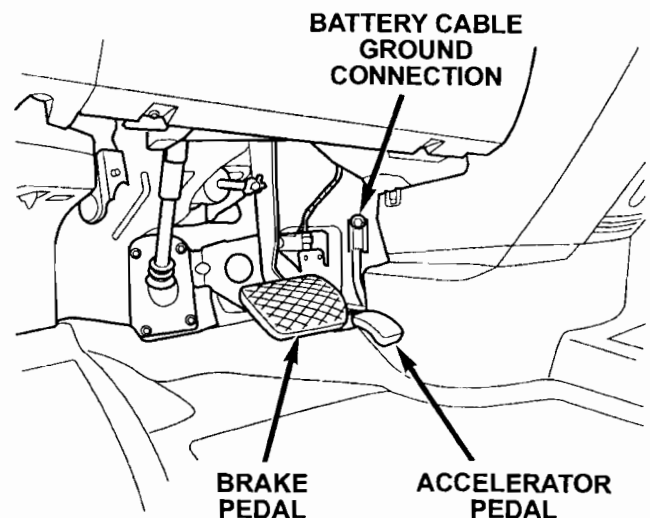
Figure 1

2. Place the ignition key in the “OFF” position.
3. Disconnect and isolate the negative battery cable ground connection located under the instrument panel, next to the accelerator pedal. **This will disconnect the main battery located under the floor pan** (Figure 1).

19. Tighten all of the side window airbag fasteners to 35 in. lbs. (4 N·m).
20. Remove the orange protective cap from the new airbag electrical connector and connect the body wiring connector to the window airbag squib connection (Figure 2).
21. Install the “A” pillar trim panel.
22. Place the “B” pillar trim panel into position.
23. Install the grab handle (if equipped).
24. Install the coat hook onto the “B” pillar.
25. Install the tie-down ring near the bottom of the “B” pillar.
26. Install the door opening weather strip.
27. Repeat Steps 4 through 26 if the opposite side window airbag requires replacement.
28. Connect the negative battery cable connector located under the instrument panel (Figure 1).

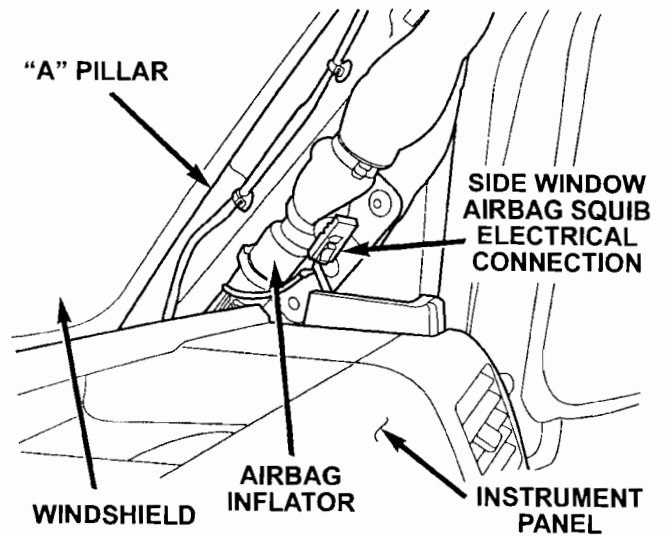
**Figure 2 – Right Side Shown**

9. Disconnect the electrical connector from the side window airbag squib wiring by pulling down the gray connector latch and pulling out the orange lock tab (Figure 2)
10. Remove and save the side window airbag inflator mounting bolts (Figure 3).
11. Remove and save the side window airbag “A” pillar fastener (Figure 3).
12. Remove and save the side window airbag “B” pillar fastener (Figure 3).
