INSTRUCTION TO SERVICE ITS: 3306

SECTION: 209 Steering	MODEL: <input type="checkbox"/> 30FT <input checked="" type="checkbox"/> 35FT <input type="checkbox"/> 40FT <input checked="" type="checkbox"/> 60FT	TYPE: <input checked="" type="checkbox"/> HIGH FLOOR	WRITTEN BY: Grant Li
	<input checked="" type="checkbox"/> DSL <input checked="" type="checkbox"/> CNG <input checked="" type="checkbox"/> LNG <input checked="" type="checkbox"/> ELEC	<input checked="" type="checkbox"/> LOW FLOOR	DRAFT

OBJECTIVE/SUBJECT:
Inspect and replace U-Joint Assembly.

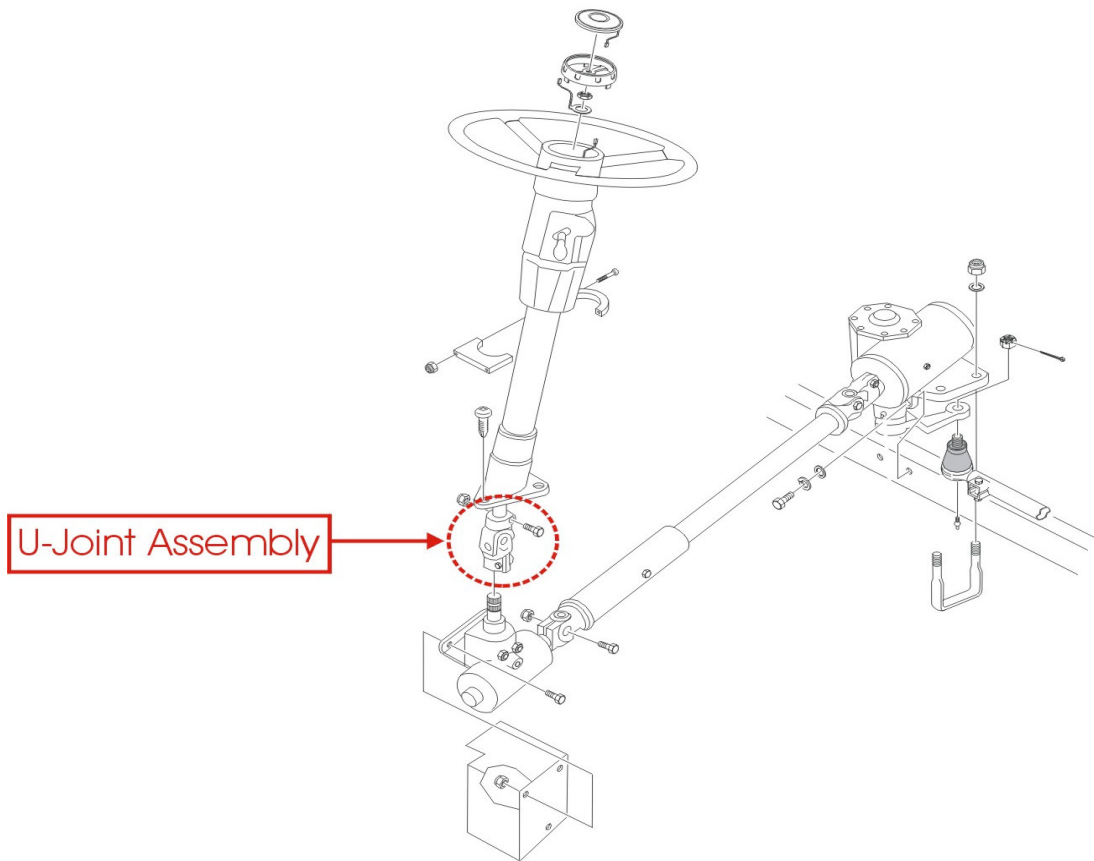
Figure 1:

2. Locate U-Joint Assembly as shown in Figure 1.

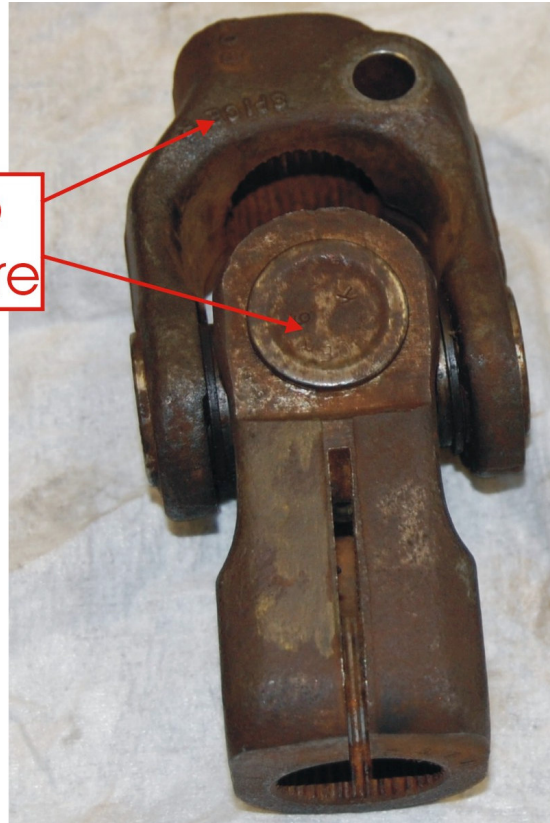
Figure 2:

3. Inspect U-Joint Assembly. If either or both of the following are present, U-Joint Assembly must be replaced, otherwise skip to step 10:
 - a. “Spicer” logo stamped on the U-Joint. See Figure 2.
 - b. One splined shaft protruding $\frac{1}{4}$ ” or more beyond yoke housing at end where offset bolt is located. See Figure 3.

"Spicer" logo stamped here

4. Install new U-Joint Assembly (PN 8112157) as required. Torque bolts between 30 to 35 ft-lbs.
5. Check for worn splines on the steering column and transfer gearbox by grasping the U-Joint Assembly by hand and twisting it back and forth.
6. If splined connection is too loose between steering column or transfer gearbox, replace components as required.

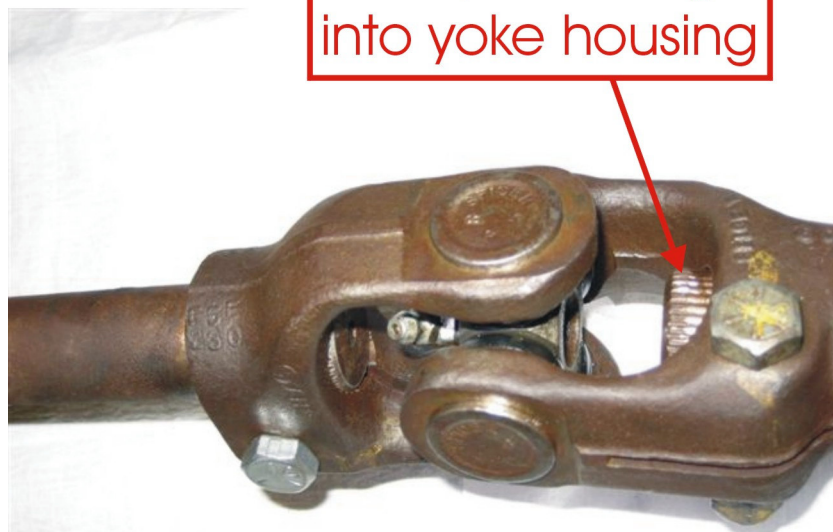
Figure 3:

Shaft protruding into yoke housing
