Frank M. Ligon
Director
Service Engineering Operations
Ford Customer Service Division

July 19, 2007

SUBJECT: DEMONSTRATION / DELIVERY HOLD: Safety Recall 07S54 - Supplement #3:
Certain 2007 Town Car and 2008 Crown Victoria and Grand Marquis Vehicles
Front Wheel Bearing and Hub Assembly Inspection

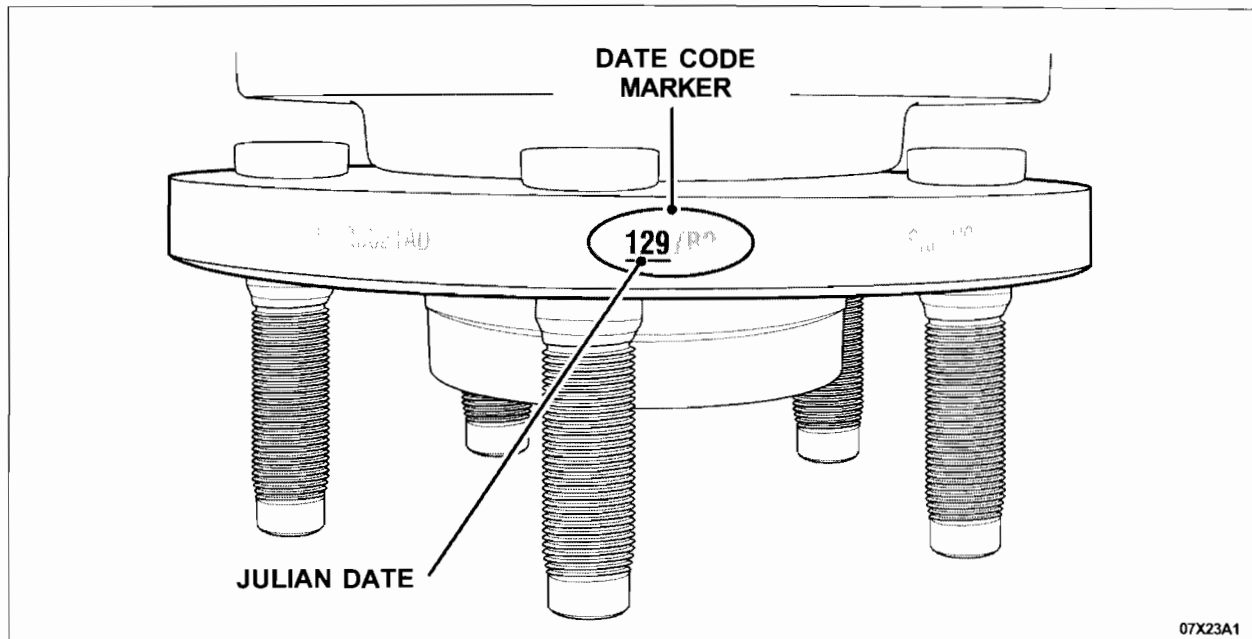
FIGURE 1

7. Inspect the wheel bearing hub assembly build date codes on the wheel bearing and hub assembly flange edge. See Figure 1.
 - **If the build date code is Julian date 128 or lower, the wheel bearing and hub assembly(s) do not need to be replaced. Proceed to the next step.**
 - **If the build date code is not present or has a Julian date of 129 through 181, proceed to the Front Hub Service Procedure in this Attachment III to install new wheel bearing and hub assembly(s).**

NOTE: Inspect the Julian date on the **new** wheel bearing and hub assembly prior to installation. It must have a Julian built date of 128 and lower or 182 and higher.

NOTE: Julian date is the day of the year. **EXAMPLE: 129 = May 9**
