## RECALL NOTICE

RECALL CAMPAIGN No. 07V-282

# THOR CALIFORNIA RECALL SERVICE BULLETIN

**Ramp Door Secondary Latch Installation**

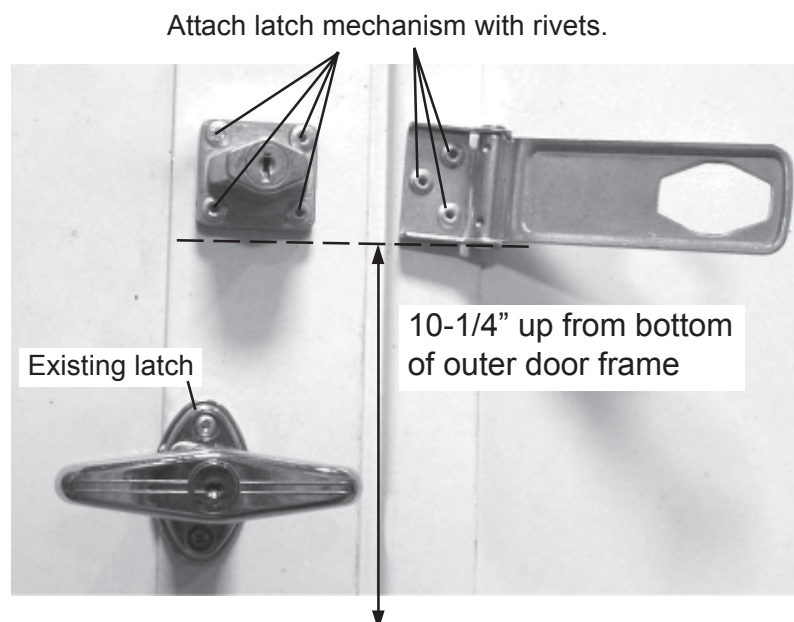
This bulletin describes the procedure to install a secondary latch mechanism and modify the original latch to prevent sudden opening of the ramp door if the primary latch fails or is not locked properly.

1. Measure up 10-1/4" from the bottom of the outer ramp door frame. Mark this position, and mark the attaching holes for latch hasp.
2. Drill holes through outer frame and into the sidewall deep enough to allow clearance for the rivets. Attach hasp with rivets. Do not use the screws included with the latch set.
3. Set the lock in position to align with the hasp. Mark and drill attaching holes.
4. Attach lock with rivets. Do not use the screws included with the latch set.
5. Test latch for proper operation. Give keys to customer.
