# VOLKSWAGEN of America, Inc.

**Subject: Update to Recall Campaign N8 (07V-284)**

# Safety Recall Circular

**Subject: 2006 Jetta with 2.5L Gasoline Engine  
Remove Plastic Tab from Windshield Washer Fluid  
Reservoir, Inspect and, if Necessary, Replace  
Underhood Fuel Supply Line**

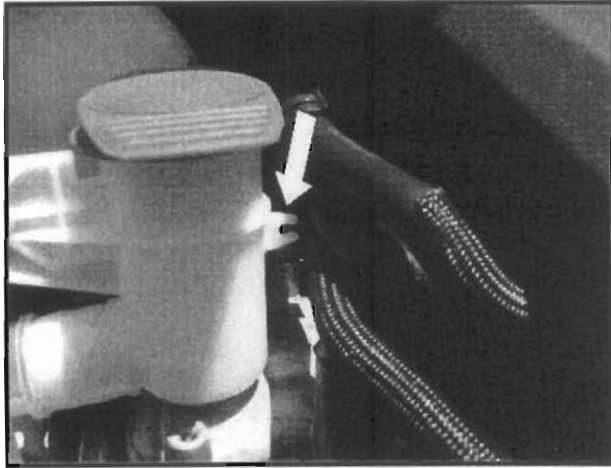
### Section A - Washer Bottle Inspection

- ⇐ Inspect washer bottle for tab -arrow-
- If tab is present, **continue to Section B**
- If tab is **not** present, **WORK IS COMPLETE**

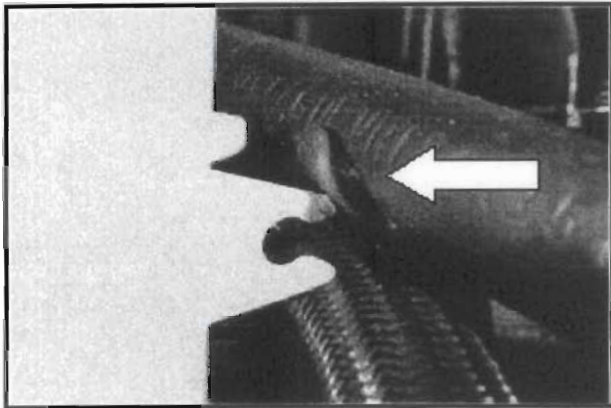
### Section B – Inspect Fuel Line

- ⇐ Inspect fuel line for any damage -arrow-
- If fuel line shows any signs of wear, **continue to Section C**
