**Subject: Update to Recall Campaign N4 (07V-063) and
Recall Campaign N8 (07V-284)**

Safety Recall Circular

Code: **N8**

**Subject: 2006 Jetta with 2.5L Gasoline Engine
Remove Plastic Tab from Windshield Washer Fluid
Reservoir, Inspect and, if Necessary, Replace
Underhood Fuel Supply Line**

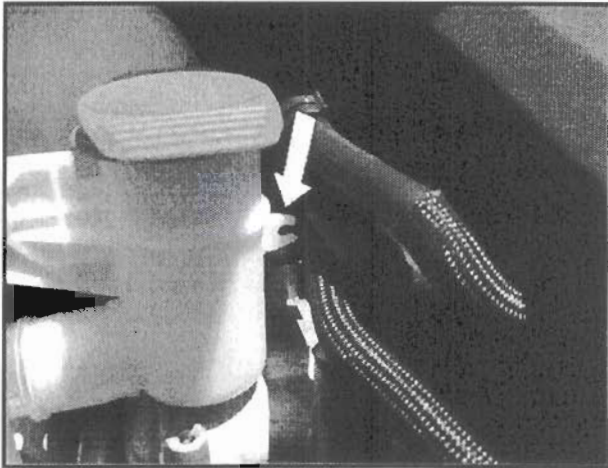
Section A - Washer Bottle Inspection

- ⇐ Inspect washer bottle for tab -arrow-
- If tab is present, continue to Section B
- If tab is not present, WORK IS COMPLETE

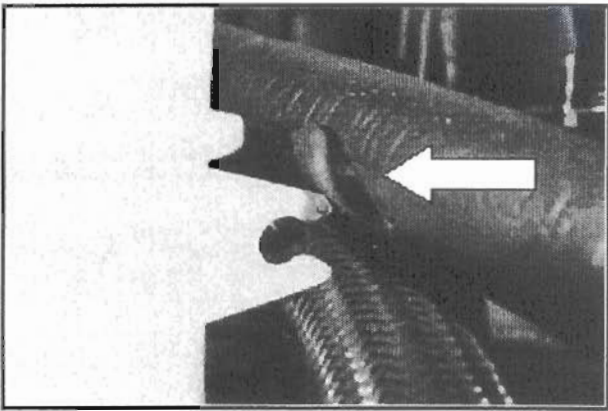
Section B - Inspect Fuel Line

- ⇐ Inspect fuel line for any damage -arrow-
- If fuel line shows any signs of wear, continue to Section C
