Electronic Field Communication

eFC Number: 07-00272

Subject: Upcoming Voluntary Safety Recall 4607F - 2007 MAZDASPEED3 Engine Mount

SUBJECT: 2007 MAZDASPEED3 Engine Mount Safety Recall 4607F

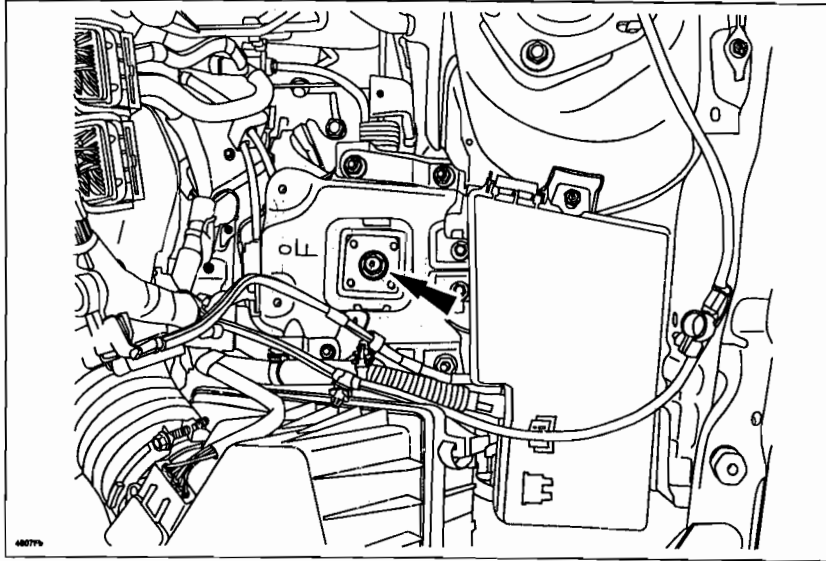
10. Check the torque of the No. 4 engine mount securing bolt (M14/8T, one piece). The specified tightening torque should meet or exceed 30 N-m (3.1 kgf-m, 22.1 ft-lbf).

NOTE: To check the torque, turn the torque wrench clockwise.

Procedure 1	VINs after JM1BK34**71708397 and bolt torqued to specified torque
Procedure 2	VINs before JM1BK34**71708396 and bolt torqued to specified torque
Procedure 3	Bolt not torqued to specified torque
