Reference: NHTSA Identification Number 07V-299

Safety Recall G27 Dome Lamps

2002-2006 (VA) Dodge Sprinter

2002-2006 (VA) Freightliner Sprinter

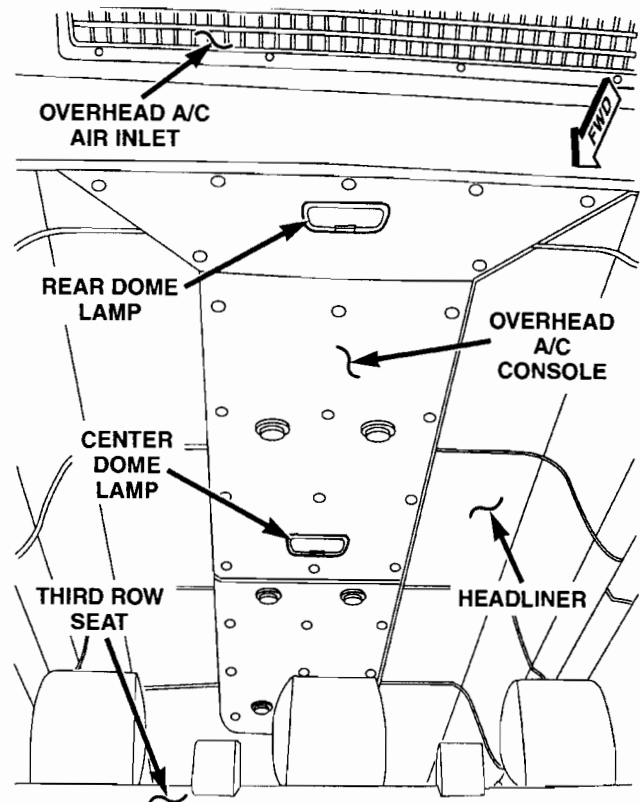
Figure 1 – View from Rear of Vehicle

2. Locate the center and rear dome lamps on the rear A/C overhead console (Figure 1).
