Technical Bulletin

Section Title: Restraint
 TSB No. TS 04 07277

SUBJECT: SAFETY RECALL CAMPAIGN “KY” FRONT SEAT BELT BUCKLE ASSEMBLY REPLACEMENT

MODEL(S): FORENZA, FORENZA WAGON, RENO (RQ420)

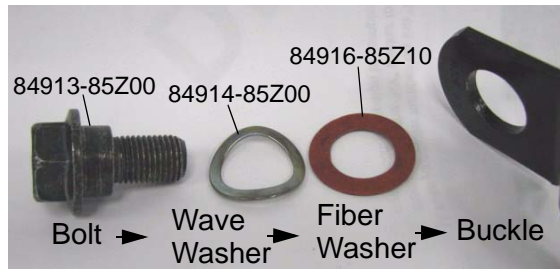
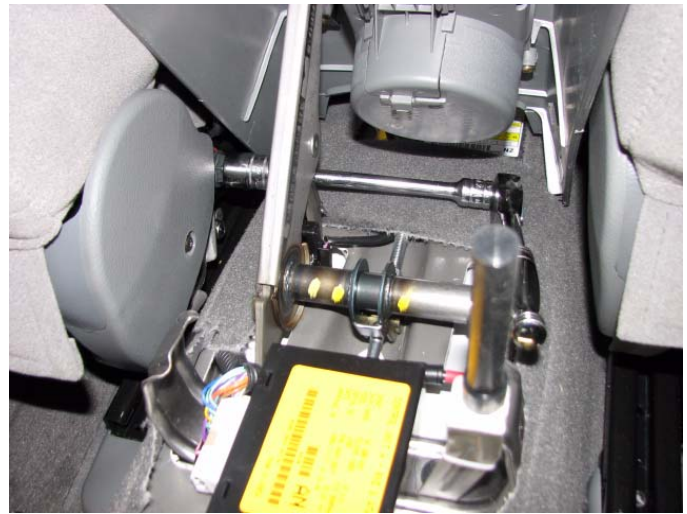
CONDITION: The buckle tongue will not latch in the buckle, or latches and can easily be pulled out.

CAUSE: Affected vehicles were produced with improperly manufactured driver and front passenger seat belt buckles. It is possible that plastic pieces inside the seat belt buckle can break off and remain inside the buckle. The buckle could fail to latch, or could seem to have latched without latching completely. If the buckle does not latch completely, the buckle could release without pressing the release button. These buckle malfunctions, which could prevent a person from using the seat belt or could cause the seat belt to fail to function as designed, can increase the risk of injury in a crash.

CORRECTION: Please replace the front left and right side seat belt buckle assemblies on all vehicles in the affected VIN range. Use the attached instructions for replacement.

6. Use a 17 mm socket with the appropriate length extension to remove the bolt. The bolt and washer(s) will be re-used.
7. Remove the buckle and re-install the new buckle with the same bolt and washer(s). See sequence below. Torque the bolt to 42 Nm (31 lb-ft).
