Re: Defect Information Report – Supplemental Report No. 2 07V-316, FL-502, TufTrac Center Suspension Casting

Subject: TufTrac Center Suspension Castings

January 2008
 FL502A-F
 NHTSA #07V-316
 REVISED NOTICE

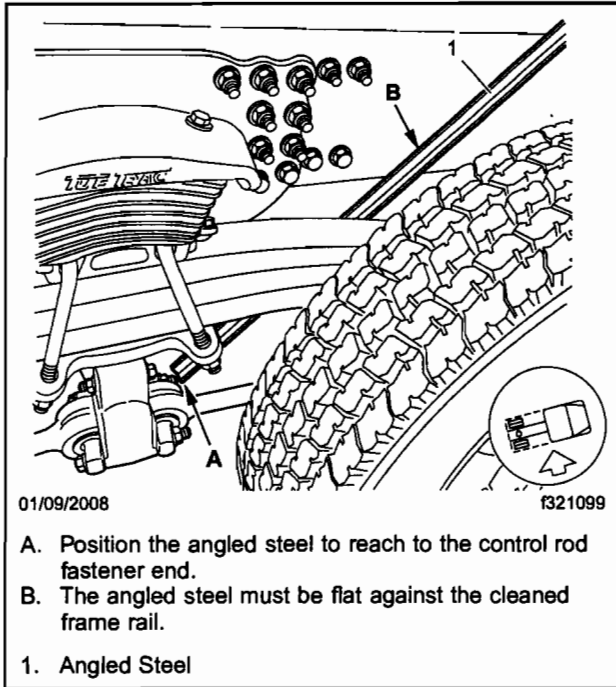
Fig. 1, Angled Steel Positioned for Frame Bracket Inspection

- 3.1 Find a place on the frame rail where the angled steel can be used to check the position of the control rod fastener relative to the frame rail. Clean both that area of the frame rail, and the threads of the fastener, so the angled steel can press flat against the rail during the inspection. See **Fig. 1** and **Fig. 2**.
- 3.2 Hold a piece of angled steel flat against the cleaned frame rail, and check the position of the fastener's threaded end relative to the frame rail.

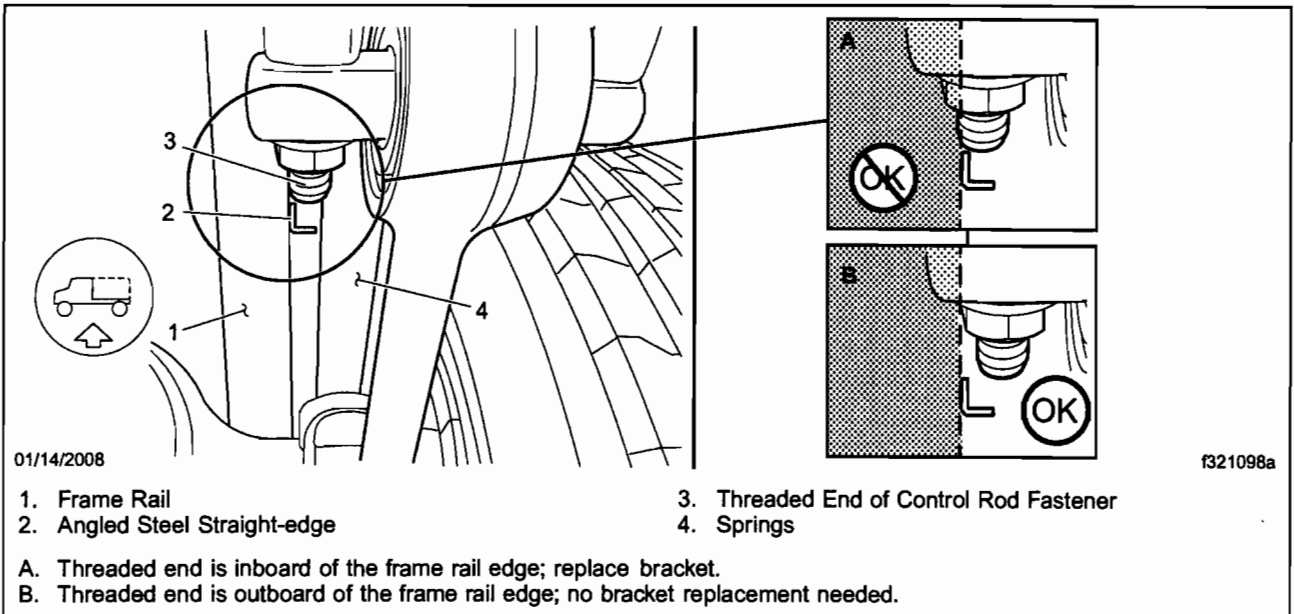
Fig. 3, Frame Bracket Inspection Viewed from Below

If the frame rail side of the angled steel does **not** intersect the threads of the fastener, and the fastener is outboard of the frame rail, no further work is needed. See inset B, **Fig. 3**. Clean a spot on the base label (Form WAR259). Write the recall number, FL502, on a blank, red completion sticker (Form WAR260) and attach it to the base label.

If the fastener end intersects or lies inboard of the angled steel edge, the fastener is too far inboard of the frame rail. See inset A, **Fig. 3**. Replace the center suspension bracket. Go to the "TufTrac Center Suspension Bracket Replacement" below after completing the inspection on the other side. **Replacement center suspension brackets must be ordered by vehicle serial number. You may order using "Next Day" (not "Next Morning") freight if necessary. Critical charges will not be covered by the Recall.**

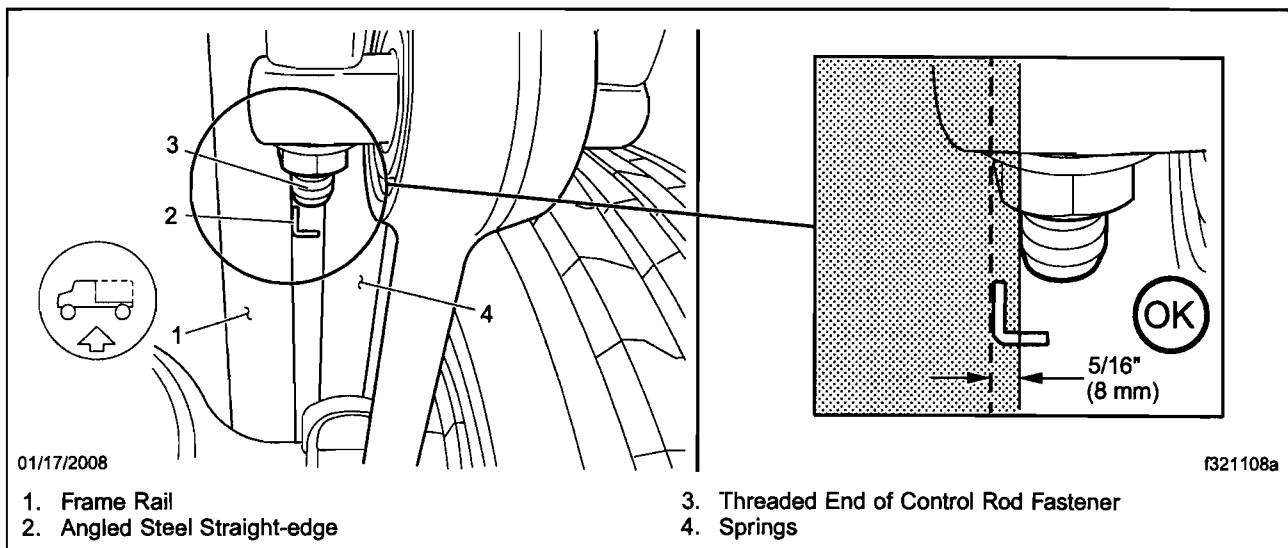
Fig. 8, Frame Bracket Inspection Viewed from Below, FL502C Vehicles Only

If the threaded fastener end is within 5/16 inch (8mm) of the angled steel edge, or inboard, the fastener is too far inboard of the frame rail. See Fig. 8. Replace the center suspension bracket. Go to the "TufTrac Center Suspension Bracket Replacement" after completing the inspection on the other side. **Replacement center suspension brackets must be ordered by vehicle serial number. You may order using "Next Day" (not "Next Morning") freight if necessary. Critical charges will not be covered by the Recall.**
