## Federal Recall Information

**707-H**

Peterbilt Motors

Peterbilt Motors is issuing a recall for certain tie rod and brackets installed in Medium Duty vehicles.

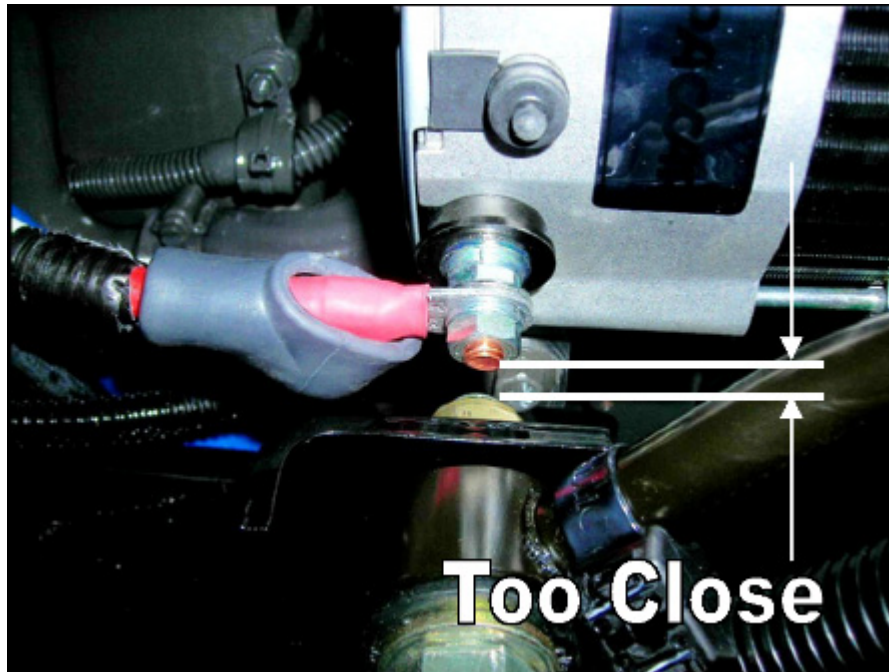
The suspect vehicles have insufficient clearance between the positive post on the alternator and the radiator tie rod and tie rod bracket.

The close proximity could enable an electrical arc which could ignite a fire in the engine compartment and may result in property damage or personal injury.

The picture below shows the tie rod and positive post of the alternator.

Peterbilt Motors is issuing this recall to replace the tie rod and tie rod bracket.

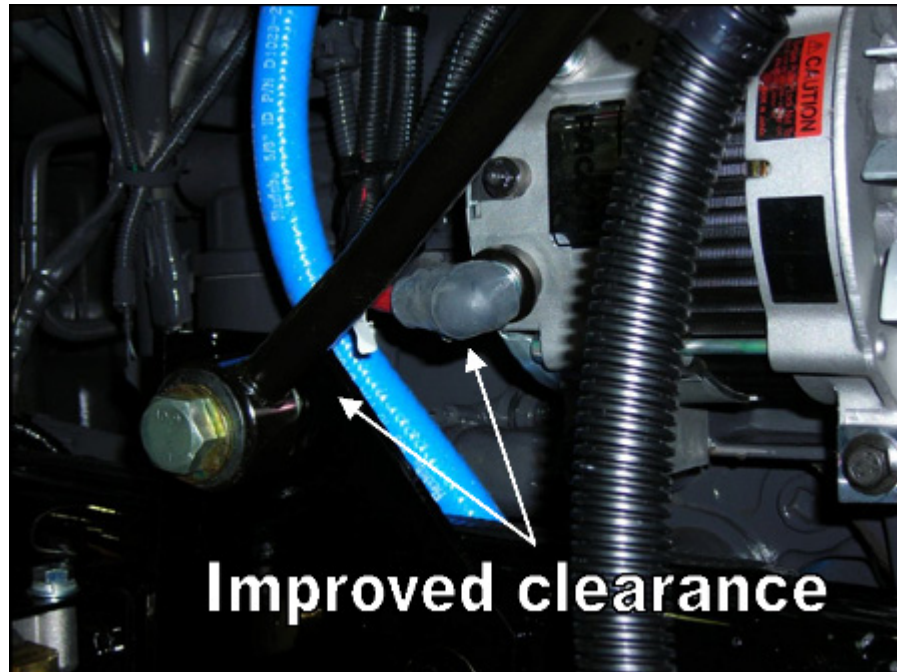
The image below shows the relative position of the new components to the alternator positive post.
