SUBJECT: Vehicle Safety Recall - SC0326
Steering Shaft Locknut

SAFETY RECALL

SC326

Subject: Steering Shaft Pinch Bolt and Locknut Replacement — GU7 and CHU Models

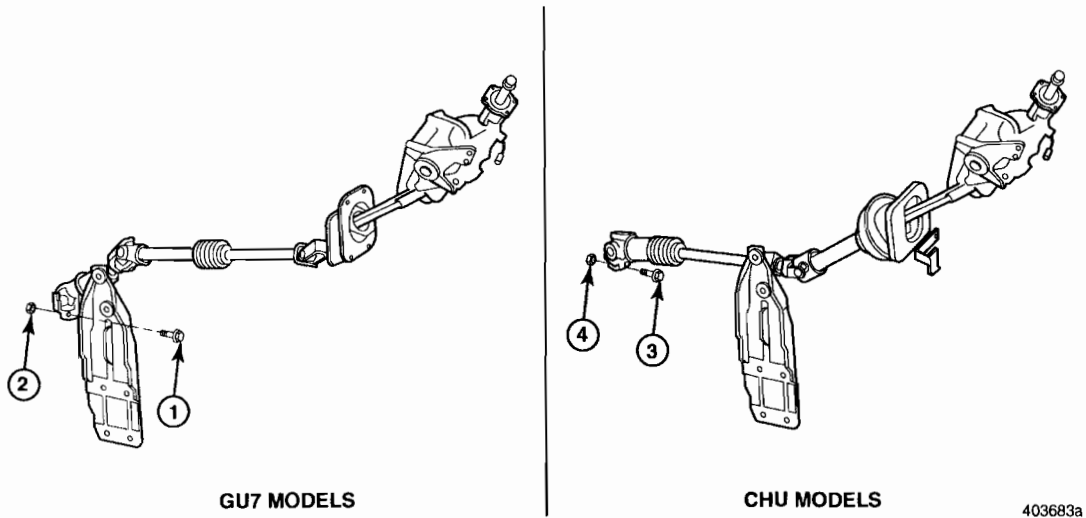
Figure 1 — Steering Shaft Pinch Bolt and Locknut

On certain GU7 and CHU model chassis manufactured between November 14, 2006 and May 22, 2007, it has been determined that the locking feature was omitted during the manufacturing process of the locknut used with the pinch bolt which retains the steering shaft to the steering gear input shaft. Should this nut come loose, the possibility exists for the steering shaft to separate. Approximately 1,072 GU7 and CHU models are affected by this campaign. A list of affected vehicles has been sent to all applicable dealers.

1. Secure the chassis for service, apply the parking brakes and block the wheels to prevent the vehicle from moving.
2. Open the hood.
3. Remove the existing pinch bolt and locknut from the universal joint at the steering shaft-to-steering gear connection (refer to figure 1).

4. Install a new pinch bolt and locknut. Refer to the chart below for the pinch bolt and locknut part numbers.

Key	Qty.	Part No.	Description
1	1	3AX1876	Bolt, 7/16-20 UNF - 2" long — GU7 models
2	1	21AX789	Locknut, 7/16-20 UNF — GU7 models
3	1	43RU42M	Bolt, M10 x 1.5 - 45 mm long — CHU models
4	1	171AM16	Locknut, M10 x 1.5 — CHU models

5. Tighten the pinch bolt locknut proper specifications as follows:
 - 7/16" pinch bolt — 95 N•m (70 lb-ft)
 - M10 pinch bolt — 60 N•m (44 lb-ft)
6. Mark the new nut with a yellow paint stick to signify that the pinch bolt and locknut have been replaced.
7. Return the vehicle to service.
