**Re: Defect Information Report (FL-507), NHTSA 07V-333, Supplemental No.: 1**

# Recall Campaign

July 2007  
FL507A-C  
NHTSA #07V-333

## Subject: Axilok Rear Wheel Spindle Nuts

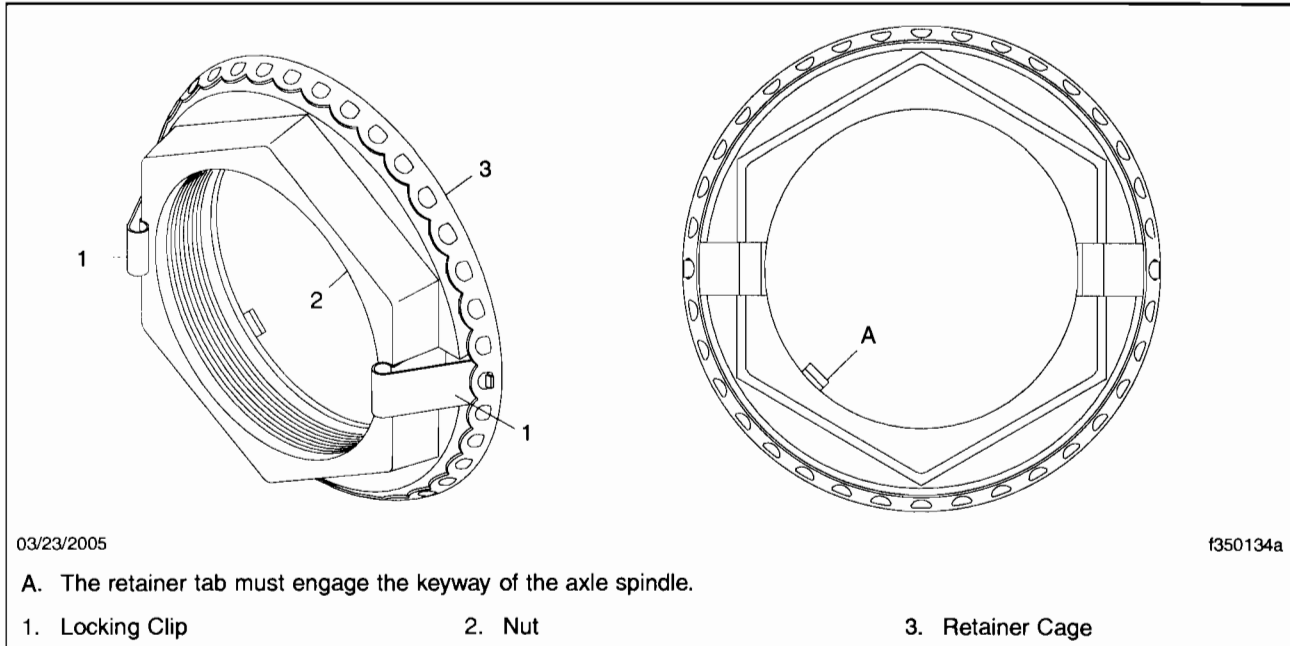
**Fig. 1, Axilok Nut**

5. Remove and discard the gasket.
6. Inspect the Axilok nut to verify whether either locking clip is bent, broken, or damaged. See **Fig. 1**. Repeat these steps for all affected axles.
7. If all locking clips are engaged and none of the locking clips are bent, broken, or damaged, go to the "Component Installation" procedure and install the removed components.

If a locking clip is not engaged and both clips on the nut are otherwise undamaged, reset it using the appropriate 6-point socket described in the "Axilok Nut Replacement" procedure. Install the Axilok nut by hand, rotating the

socket clockwise until the Axilok contacts the bearing. Then, using a properly calibrated torque wrench, tighten it 250 lbf-ft (339 N-m). The nut should lock in place when you remove the wrench. If it does not, advance the nut until it does. **Do not back it off.** Then go to the "Component Installation" procedure and install the removed components.

If any locking clip is bent, broken, or damaged, go to the "Axilok Nut Replacement" procedure and replace the damaged Axilok nut. Then go to the "Component Installation" procedure and install the removed components.

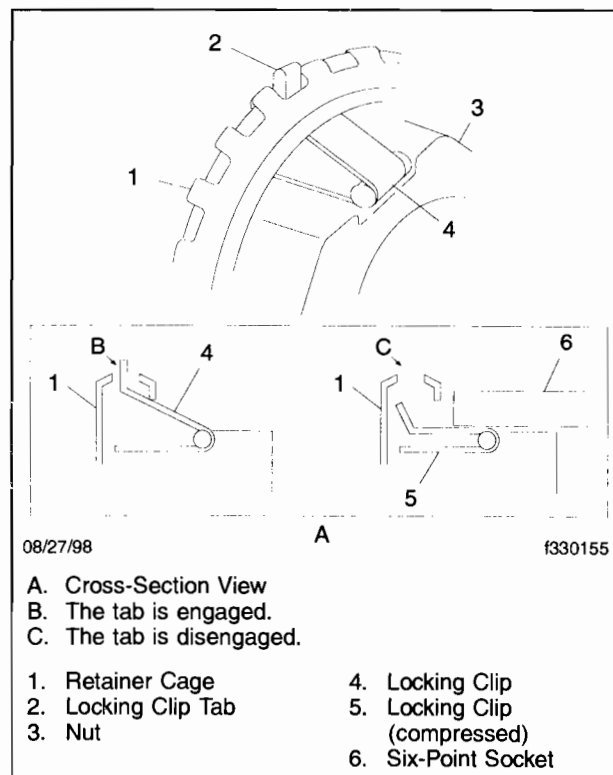
**Fig. 2, Axilok Nut, Checking the Position of the Locking Clip**

6. To ensure the Axilok nut and socket are compatible, turn an appropriately sized, 6-point socket upside down, and insert the nut completely into it. The locking clips should compress and allow the retainer cage to spin freely. See **Fig. 2**.

If the locking clip tabs interfere with rotation of the retainer cage, the socket is not fully compressing the locking clips. Replace the socket and check its compatibility with the Axilok nut.

8. Ensure that both locking clips are present and engaged in the retainer cage. See **Fig. 2**. If the locking clips are not engaged, the nut is not locked in position and can rotate freely.

- Always start an Axilok installation by hand.
7. Install the Axilok nut by hand, rotating the socket clockwise until the Axilok contacts the bearing. Then, using a properly calibrated torque wrench, tighten it 250 lbf-ft (339 N-m). The nut should lock in place when you remove the wrench. If it does not, advance the nut until it does. **Do not back it off.**
