**Subject: Revision to Safety Recall 55E5/JV
2006-2008 Model Year Audi A6 Avant
and Model Year 2007-2008 Audi Q7
Automatic Rear Lid Software**

Safety Recall Circular

Code: **55E5/JV**

**Subject: 2006-2008 MY Audi A6 Avant
2007-2008 MY Audi Q7**

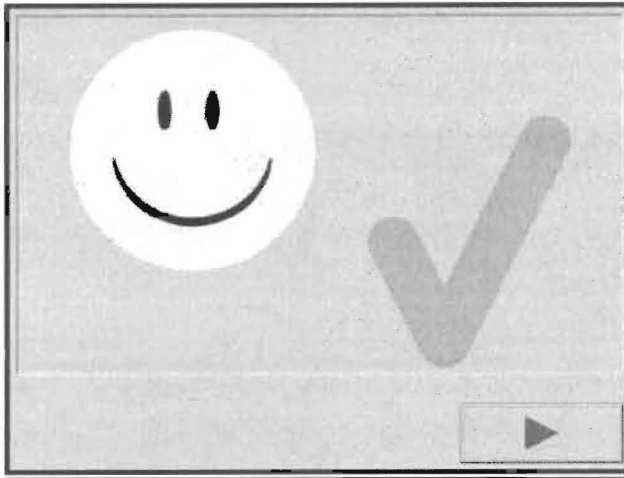
⇐ If this screen display appears, the software update was successful

- Press the 'Next' button (▶)

Proceed to section C - Complete final SVM update

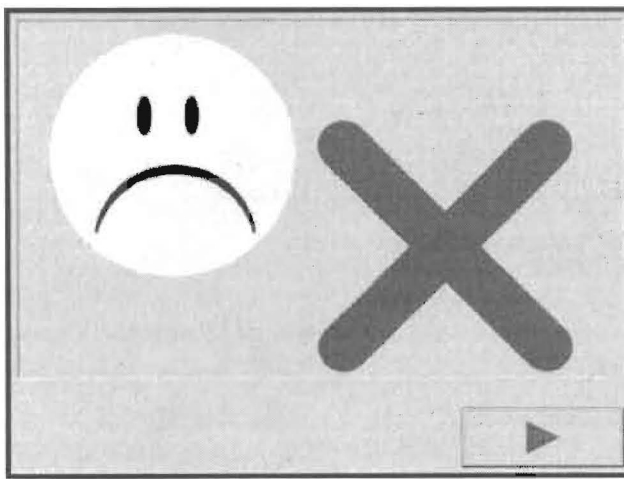
⇐ If this screen display appears, the software update was not successful

- Make a note of the error number displayed on the screen
- Press the 'Next' button (▶)
- If the update was unsuccessful – **do not continue to Section C**

- ◆ *Open a TAC ticket and contact the Audi Technical Assistance Center (TAC)*
- ◆ *Check CD installed in tester for proper installation and correct CD*
- ◆ *Lay tester flat and try update again*
