Ford Motor Company
 P. O. Box 1904
 Dearborn, Michigan 48121

August 3, 2007

SUBJECT: **Safety Recall 05S28 - Supplement #11:** 1992-2004 Multiple Vehicle Lines - Speed Control System Modification

1992-2004 MULTIPLE VEHICLE LINES — SPEED CONTROL SYSTEM MODIFICATION

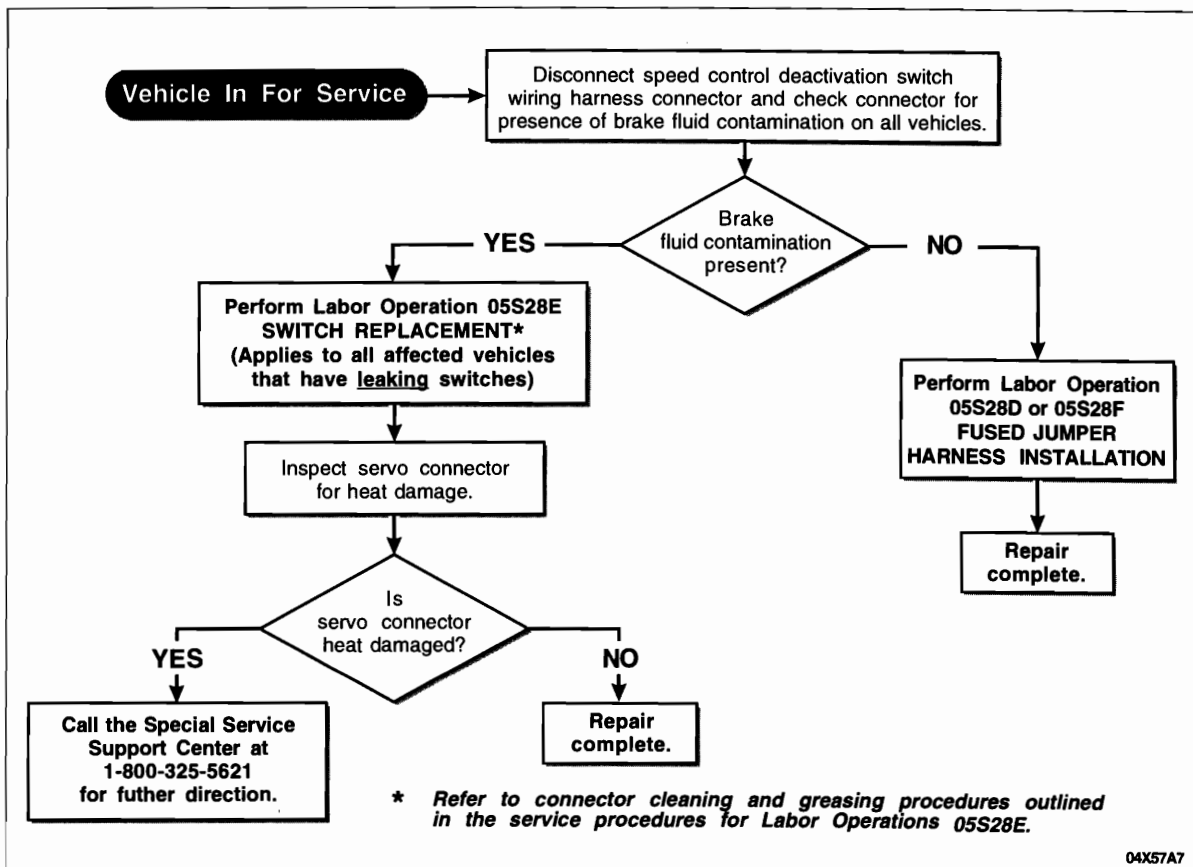
FIGURE 1

REPAIR FLOW CHART – PERMANENT REPAIR

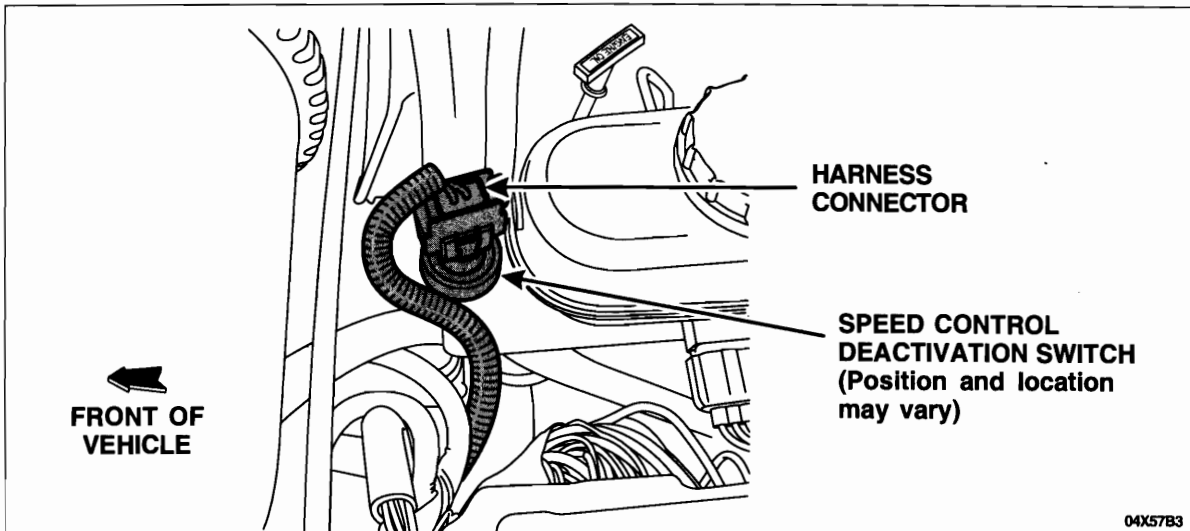
FIGURE 2

2. If necessary (E-150/250/350), lift the vehicle and disconnect the speed control deactivation switch and inspect the harness connector for the presence of brake fluid. See Figure 2.
 - If no brake fluid is present:
 - install the fused jumper harness (Labor Operation D or F).
 - If brake fluid is present, proceed to Labor Operation E.

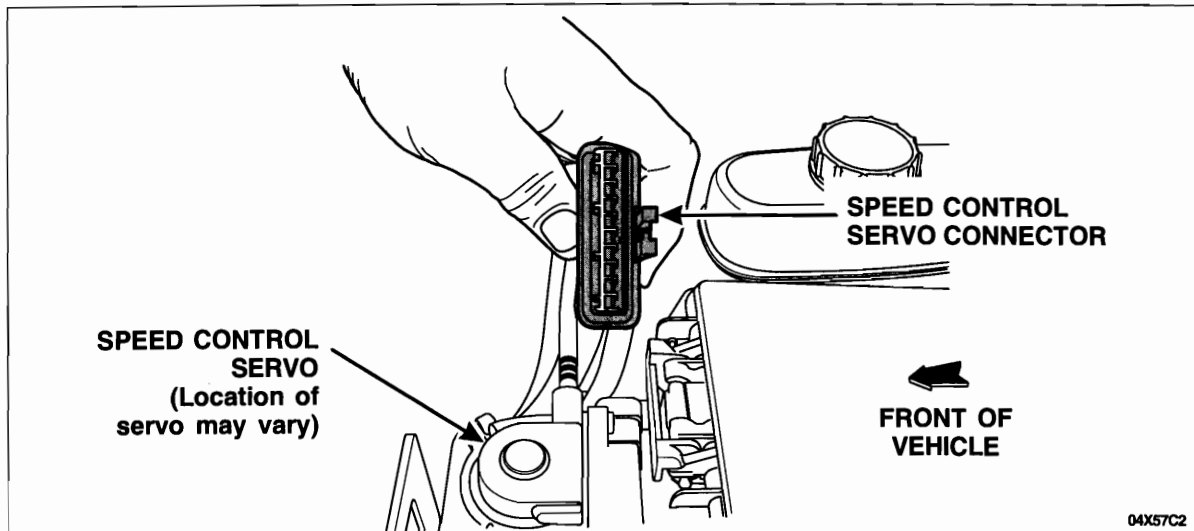
FIGURE 7

6. Disconnect the speed control servo and inspect the vehicle harness connector for heat damage.
See Figure 7.
 - If no heat damage is found at the speed control servo connector (even if there is presence of brake fluid in the connector), proceed to next step.
 - If the speed control servo connector is heat damaged, call the Special Service Support Center at 1-800-325-5621 for further instructions.
