**TO:** All Mazda Dealership General Managers, Service Managers, and Parts Managers

**DATE:** August 2008

**SUBJECT:** 1998-2002 B-Series Cruise Control Deactivation Switch Safety Recall 4707H  
**FINAL PHASE**

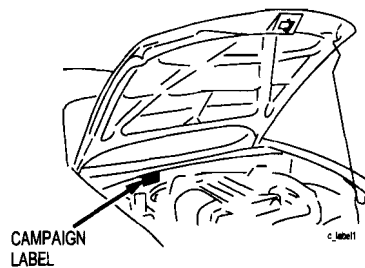
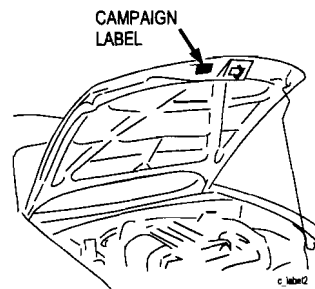
- If the vehicle is within the above range, proceed to step 2.
  - If the vehicle is not within the above range, return the vehicle to the customer or inventory.
2. Perform a Warranty Vehicle Inquiry using your eMDCS System and inspect vehicle for a Campaign Label **4707H** attached to the vehicle's hood or bulkhead. Refer to eMDCS System - Warranty Vehicle Inquiry Results table below.

Complete an "Campaign Label" with the Recall number written on the sticker and affix it to the vehicle's hood or bulkhead. Refer back to the illustration under "A. VEHICLE INSPECTION PROCEDURE".

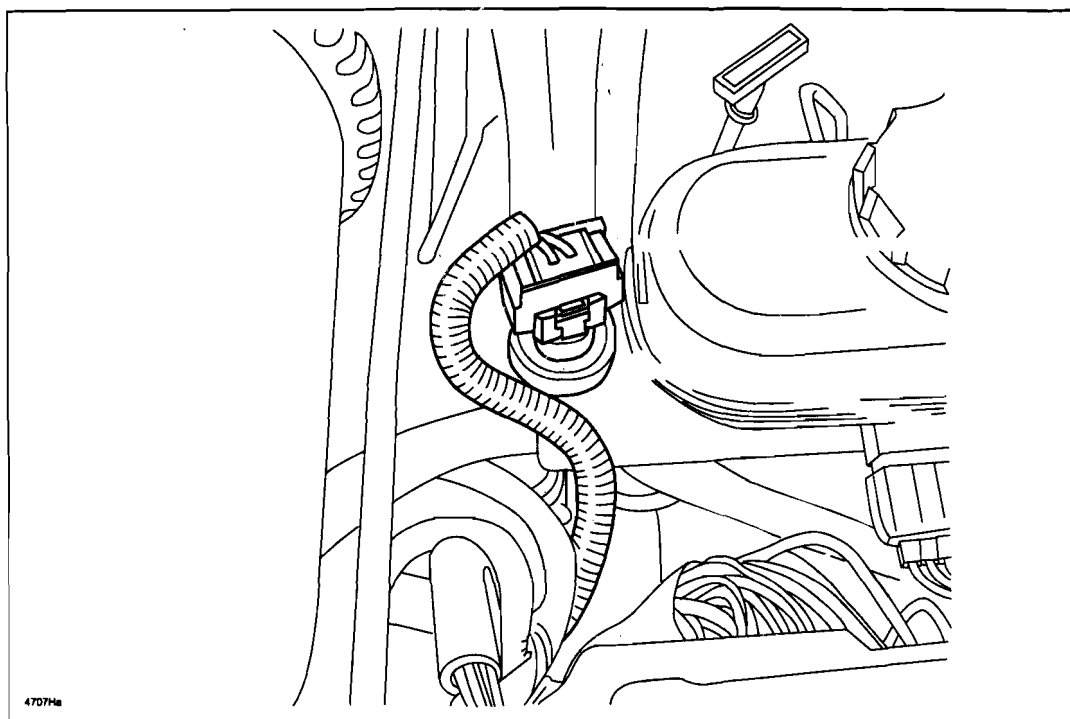
1. Disconnect the cruise control deactivation switch and inspect the harness connector for the presence of brake fluid.
  - If brake fluid IS NOT present, go to PROCEDURE 1.
  - If brake fluid IS present, go to PROCEDURE 2.

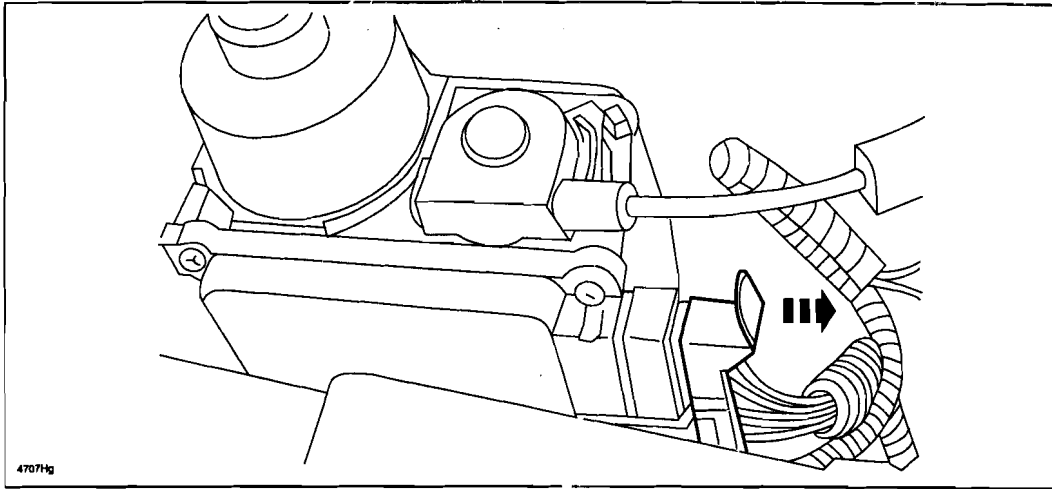
7. Disconnect the speed control servo and inspect the vehicle harness connector for heat damage.
  - If no heat damage is found at the speed control servo connector (even if there is presence of brake fluid in the connector), proceed to the next step.
  - If the speed control servo connector has heat damage, call the Mazda Technical Hotline for further instructions.
