**Re: Defect Information Report – Supplemental Report No. 2  
07V-357, FL-505, TRW P2 Steering Column Tilt Plate Bolts**

## Subject: TRW Steering Columns

**Models Affected: Specific Freightliner Century Class S/T, Columbia, and Coronado vehicles with TRW global adjustable upper steering columns manufactured between February 20, 2006, and July 6, 2007.**

November 2007  
 FL505A  
 NHTSA #07V-357

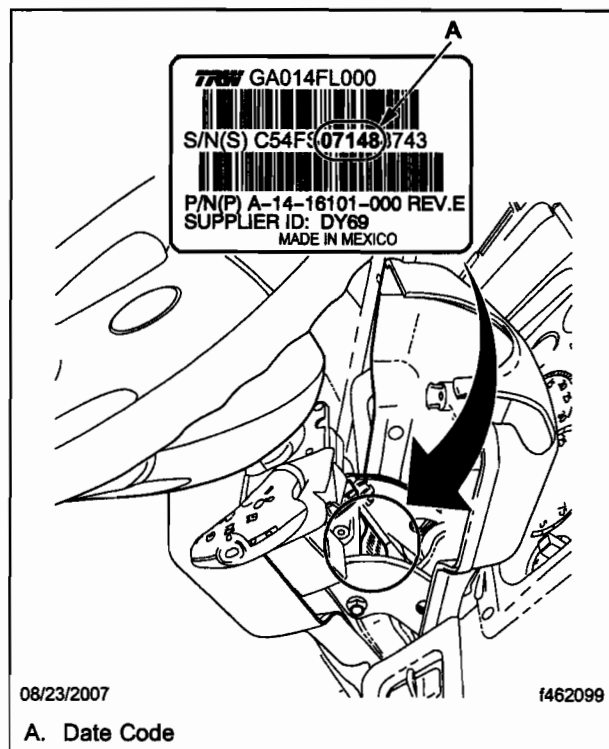
Fig. 1, Column Label and S/N Location

4. Identify the serial number (S/N) on the column label, which is located on the top, dash-facing surface of the column; see Fig. 1. The date of column manufacture follows the first five characters of the serial number; for example, if the serial number is C54FS071488743, the column was manufactured in the year 2007 (07), on the 148th day (148) of that year.

If the date code is 07148 or later, no further work is needed. Clean a spot on the base label (Form WAR259), write the recall number on a blank, red completion sticker (Form WAR260) and attach it to the base label.

If the date code is 07148 or earlier, the column must be repaired. Go to "Steering Column Repair."

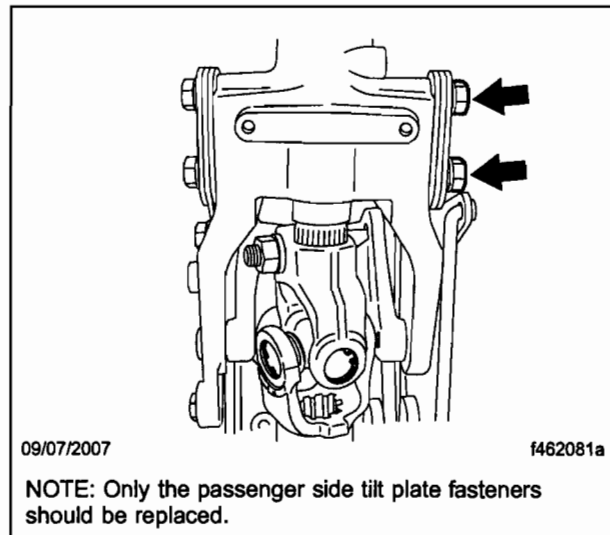
**Fig. 2, Location of Tilt Plate Bolts**

The upper tilt plate bolts on certain TRW Global steering columns may loosen with use and fall out. Steering columns with missing bolts may fracture at the steering column bracket and will not hold the steering wheel in position. Loss of steering wheel position may cause the steering to respond differently than expected and could result in a possible vehicle crash without prior warning.

1. Remove the nut and washer that holds the bottom of the dash knee bolster to the frontwall, then remove the bolster by pulling its upper corners away from the dash.
2. Remove the four column cover fasteners on the back of the column, then remove the covers.
3. Verify that passenger-side bolts are present. See **Fig. 2**. If any bolts are missing, install the new bolts and Nord-Lock washers from the kit.
