# Service Bulletin

## SAFETY RECALL

### 2002-2005 VFR800/A Wire Harness Replacement

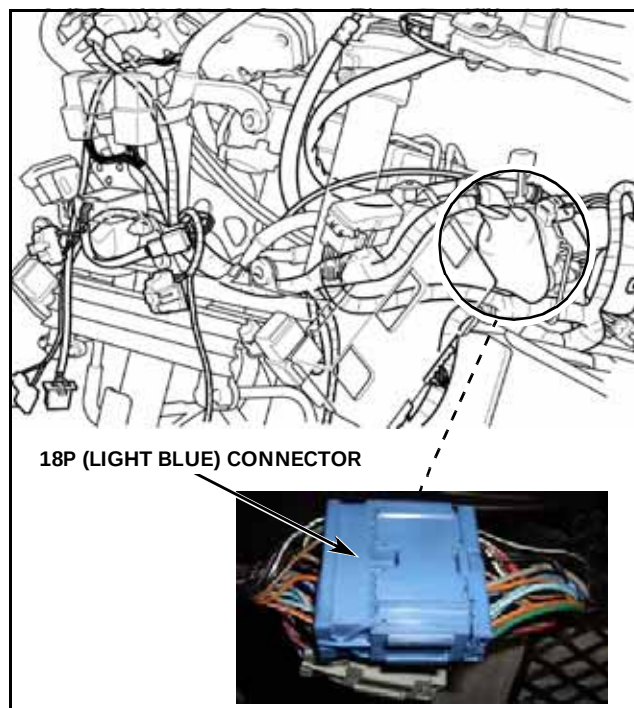
Inspect the 18P connector (light blue) inside the protective sleeve for any burnt, melted, or discolored condition.

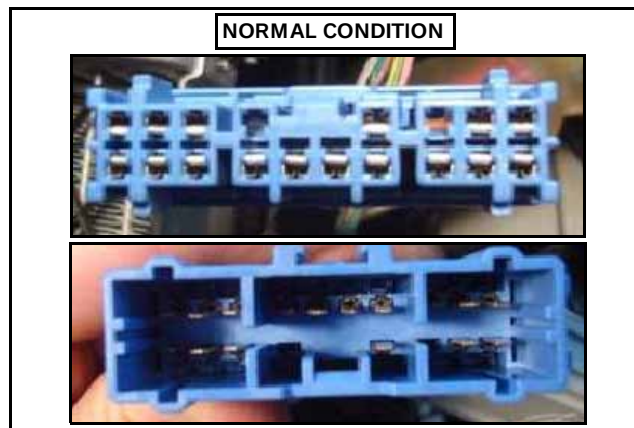
If the condition of the 18P (light blue) connector is normal, proceed with the FRONT SUB-HARNESS REPLACEMENT.

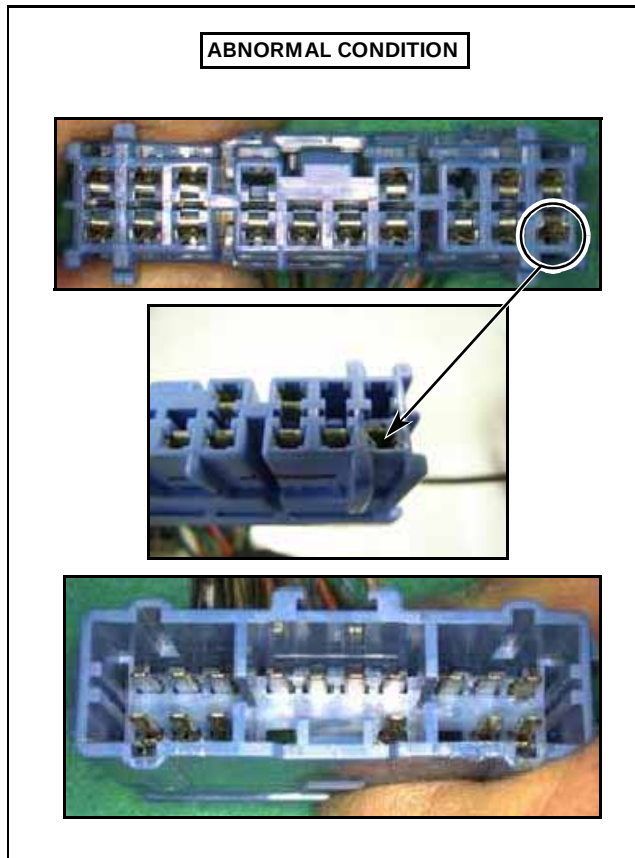
Under certain conditions, the ground wire terminals inside the connector between the main wiring harness and fairing sub-harness can overheat, resulting in melting of the connector and a loss of power to various circuits. As a result, a loss of critical lighting or engine power could occur without warning, which could result in a crash.

If the 18P (light blue) connector is in abnormal condition as shown below, contact TechLine at (800) 421-1900, option 9.

**NOTE: If the 18P connector (light blue) is melted, unable to disconnect, or modified, contact TechLine at (800) 421-1900, option 9, prior to starting the repair.**
