**GM SERVICE AND PARTS OPERATIONS
DCS1855
URGENT DISTRIBUTE IMMEDIATELY**

Date: September 21, 2007
Subject: 07221 Product Safety Recall
ABS Operation
Models: 2008 Hummer H2
To: All Hummer Dealers
Attention: Service Manager, Parts Manager and Warranty Administrator

PRODUCT SAFETY RECALL

SUBJECT: ABS Operation

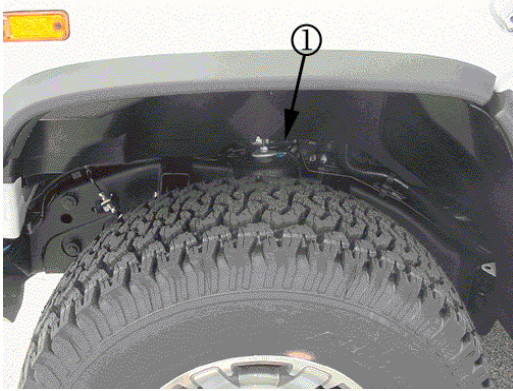
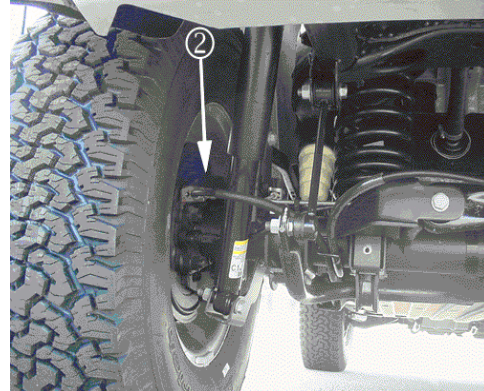
2006005

3. Disconnect the left front and left rear wheel speed sensor wires. The front wheel speed sensor wire can be disconnected at the connection near the upper control arm pivot point on the frame (1). The left rear wheel speed sensor wire can be disconnected at the wheel speed sensor on the end of the axle housing near the wheel (2).
4. Using the Tech 2, determine if the DTC set corresponds to the wheel speed sensor that was disconnected.
 - If the DTC set corresponds to the sensor disconnected, proceed to Step 11.
 - If the DTC set does NOT correspond to the sensor disconnected, then the left and right wheel speed sensor wires are cross-wired. Lower the vehicle. Refer to the *EBCM Wiring Schematic* and Step 5.

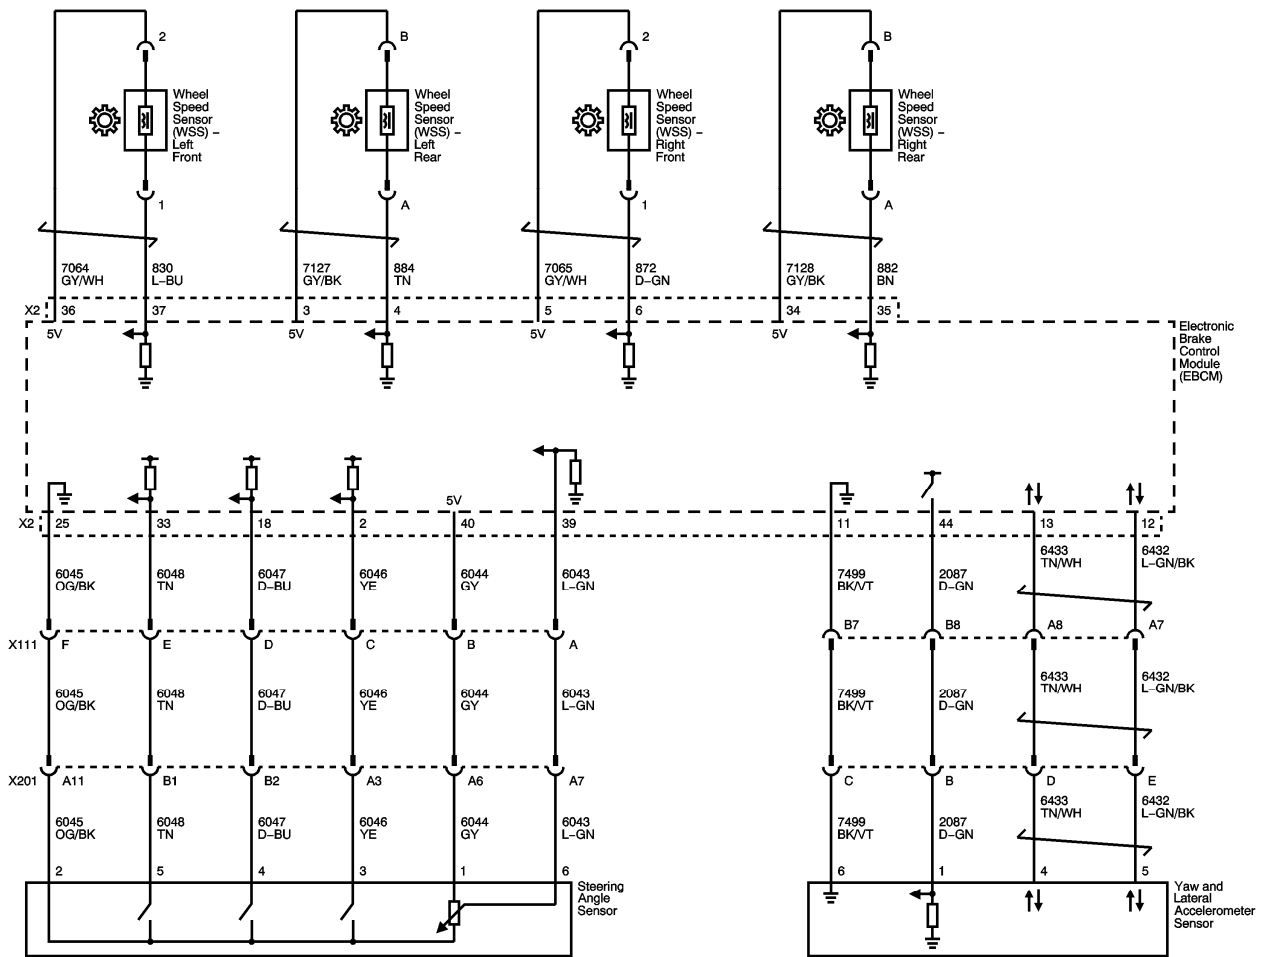
EBCM Wiring Schematic

8. Remove the white dress cover from the connector.
9. Refer to the *EBCM Wiring Schematic* to locate the correct connector cavities and terminal wire colors for the cross-wired wheel speed sensors. Note: Wires into cavities 6 and 37 may be switched (front wheels) or wires into cavities 4 and 35 may be switched (rear wheels).

10. Remove one of the cross-wired terminal wires from its connector cavity and install this terminal wire in the correct location of the connector. Do likewise with the other cross-wired terminal wire. The two wires should now be located in each other's original pin locations in the connector.
11. Connect the wheel speed sensors and clear the DTCs. Ensure that there are no DTCs set.
12. Lower the vehicle.
