**Re: Defect Information Report – Supplemental Report No. 3  
07V-400, FL-512, Steering Arm Installation**

## Subject: Tie-Rod Arm Installation

**Models Affected: Specific Freightliner Century Class S/T and Columbia vehicles manufactured between November 12, 2004, and November 23, 2006, with rack-and-pinion steering.**

April 2008  
FL512A-D  
NHTSA #07V-400

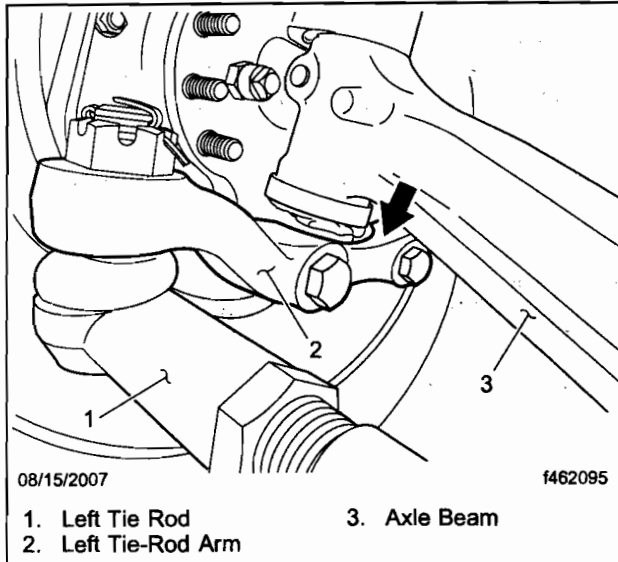
Fig. 1, Part Number Location, Left Tie-Rod Arm

4. Check the part numbers of the tie-rod arms as follows.
  - 4.1 Turn the steering wheel one turn to the right. This will expose the top surface of the left tie-rod arm, where the raised part number is. See Fig. 1.
  - 4.2 Looking down from the left side of the vehicle, check and record the raised part number of the left tie-rod arm.
  - 4.3 From underneath the right side of the vehicle, check and record the raised part number on the lower surface (facing the ground) of the right tie-rod arm. See Fig. 2.
  - 4.4 If the part number of the left tie-rod arm ends in "L" (e.g., A680xxxxxxxL or AACxxxxL), and the part number of the right tie-rod arm ends in "R" (e.g., A680xxxxxxxR or AACxxxxR), the tie-rod arms are correctly installed. Go to the next step.

If the tie-rod arms are not installed correctly, go to "Tie-Rod Arm and Rack-and-Pinion Assembly Replacement" in these Work Instructions.
