SUBJECT: Vehicle Safety Recall - SC0324 – Third Release  
ASET™ AC Fuel Injection Lines

## SC324

**Subject:** High-Pressure Injection Line Replacement — ASET™ AC Engines

**SAFETY RECALL SC0324  
JANUARY 2008**

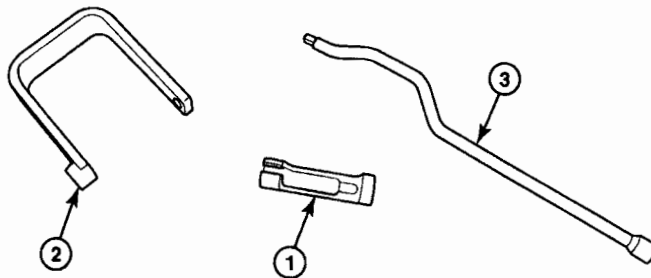
006917a

**Figure 1 — Injection Line End Nut Torque Adapter Tool Kit (Kit No. 57GC2254)**

| <p>1. Fuel Line Socket (part No. 525GC22), used to tighten the cylinder head end line nut for injection line Nos. 1, 2, 4, 5 and 6.</p> <p>2. Direct-Torque Special Wrench (part No. 525GC31), used to tighten the cylinder head end line nut for injection line No. 3 (ASET™ AC engines only).</p> | <p>3. Direct-Torque Extension (part No. 2QM3114), use with a suitable flare nut crowfoot adapter such as Snap-On tool Nos. FRHM17 for 17 mm line nuts or FRHM19 for 19 mm line nuts when tightening the unit pump ends of the injection lines.</p> |

The tools listed above are only to be used for tightening the injection lines. Use suitable open-end wrenches to loosen the line nuts when removing the lines.

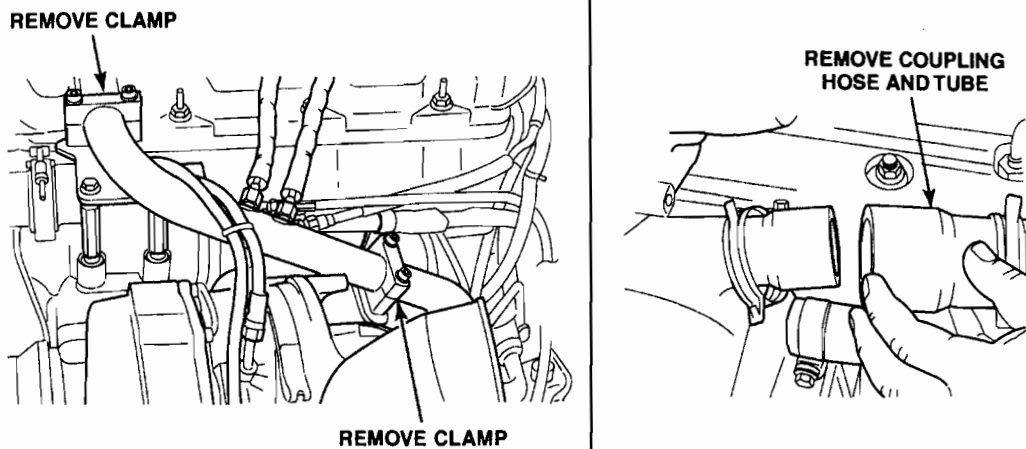
272110a

Figure 2 — Removing Mass Flow Tube

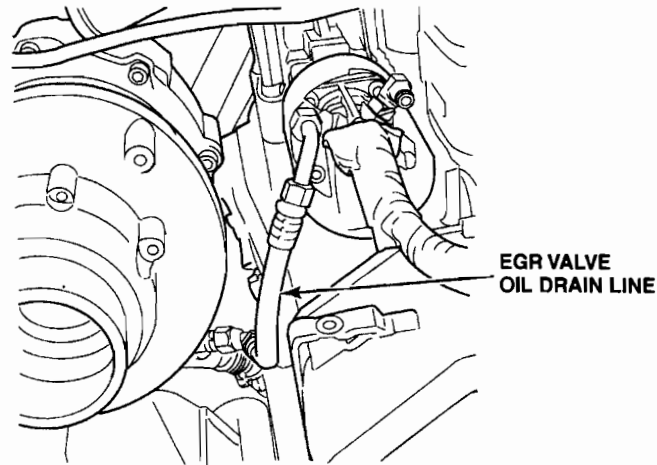
272109a

**Figure 3 — Removing EGR Oil Drain Line**

7. Disconnect both ends of the EGR valve oil line, and then remove the line from the engine.

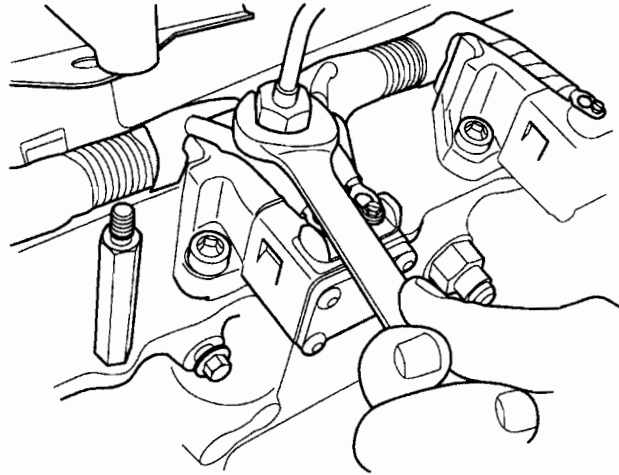
272102a

**Figure 4 — Using Standard Hand Tools to Loosen Injection Line Nuts (Unit Pump End Shown)**

1. Using suitable hand tools, completely loosen the end nuts at both the unit pump and cylinder head ends of the injection lines.

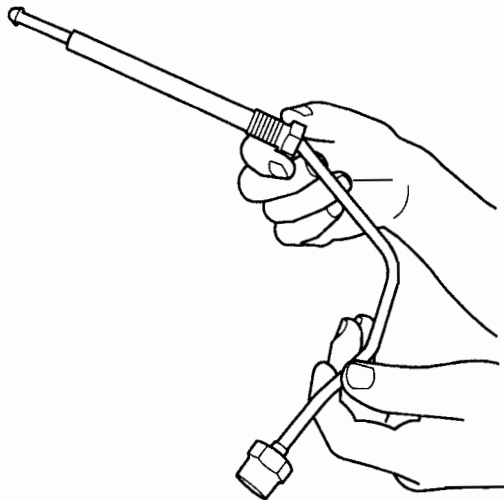
272108a

**Figure 5 — Slide Nut and Sleeve Against Bend in Line**

- a. Slide the end nut and sleeve against the bend in the line.

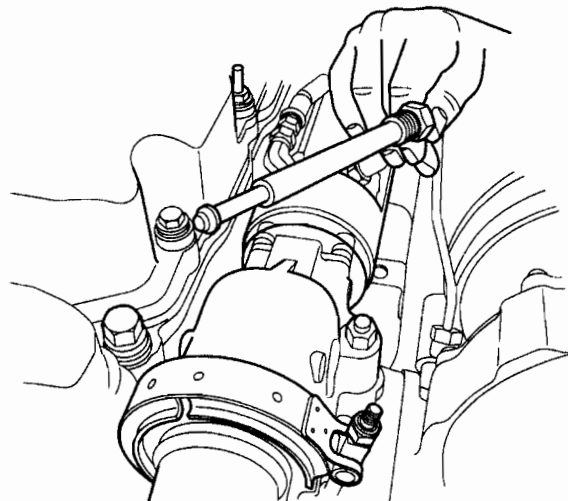
272107a

**Figure 6 — Guiding Line Between Turbocharger Housings**

- b. Holding the line with the ends facing the rear of the engine and the upper nut and sleeve against the bend in the line, guide the line between the turbocharger housings and down behind the EGR cooler.

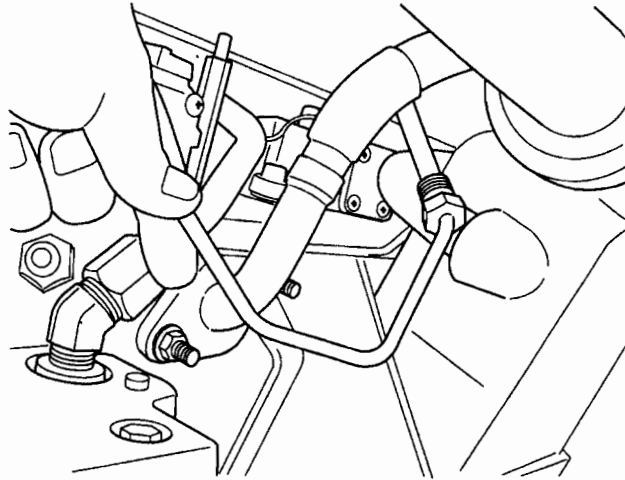
269956a

Figure 7 — Guiding End of Line Toward Cylinder Head Port

- c. When the line is down far enough so that the upper end is below the EGR valve, rotate the line slightly and begin moving the line upward while guiding the end of the line toward the cylinder head port. Keep the unit pump end of the line facing the rear of the engine.

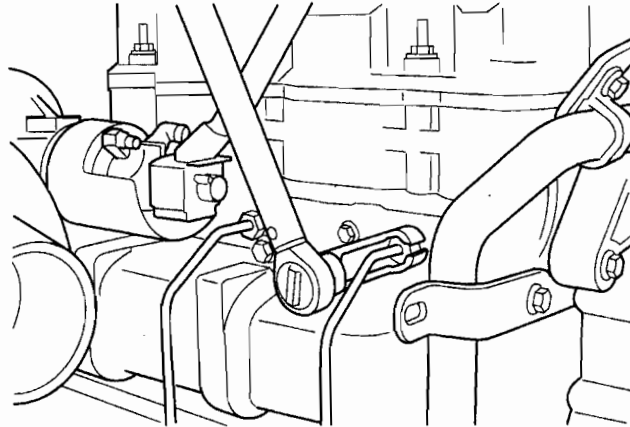
272106a

**Figure 8 — Using the Injection Line Socket (Tool No. 525GC22)**

- REV
1. Tighten the line nut at the cylinder head end first. For line Nos. 1, 2, 4, 5 and 6, use the special injection line socket (tool No. 525GC22) and an accurately calibrated 3/8" drive click-type torque wrench. Tighten the nut to 40 N•m (30 lb-ft), immediately back off the nut slightly (approximately one nut flat) and then retighten the nut to 40 N•m (30 lb-ft). This critical "joint conditioning" procedure is necessary to ensure a proper leak-free connection.

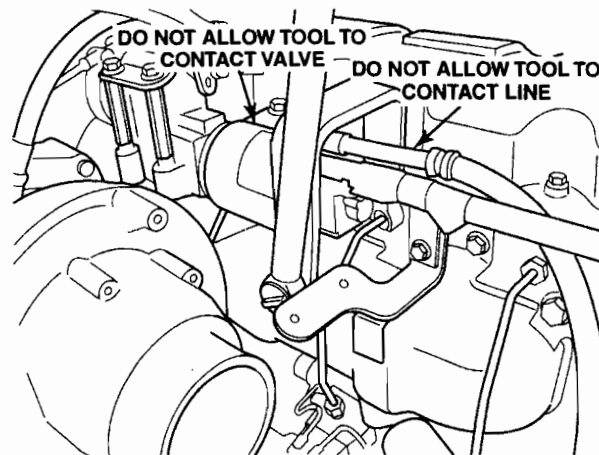
272105a

**Figure 9 — Using the Direct-Torque Adapter (Tool No. 525GC31)**

- REV
- To tighten the cylinder head end line nut for line No. 3, use the special direct-torque adapter tool (tool No. 525GC31) and an accurately calibrated 3/8" drive click-type torque wrench. Place the tool over the EGR valve and install the socket on the line nut. Install the torque wrench and then tighten the nut to 40 N•m (30 lb-ft), immediately back off the nut slightly (approximately one nut flat) and retighten to 40 N•m (30 lb-ft).

Use care when tightening the end nut with the direct-torque adapter so that the tool does not contact the EGR valve or any of the oil lines surrounding the valve. Doing so will result in a false torque reading and an under-torque condition.

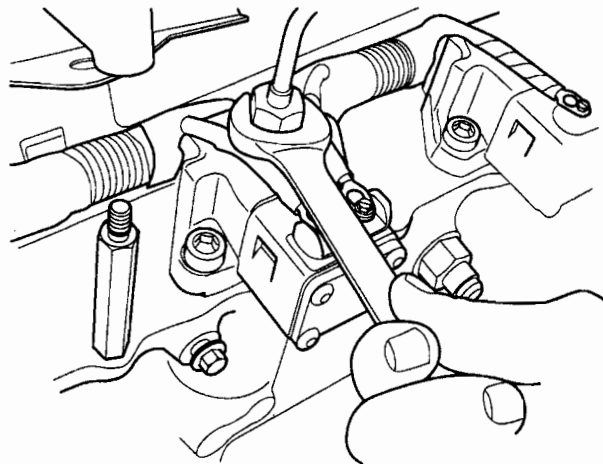
272102a

**Figure 10 — Loosening Unit Pump Line Nut with a Standard Open-End Wrench**

- a. Using a standard open-end wrench, snug the unit pump line nut, and then back the line nut off one turn.

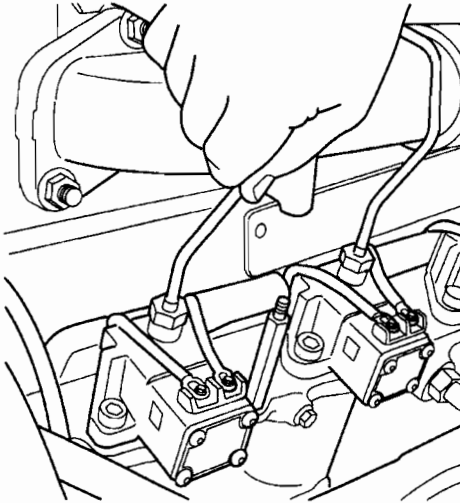
272104a

**Figure 11 — Unseating Injection Line at Unit Pump**

- b. Gently lift the injection line to unseat it from the unit pump.

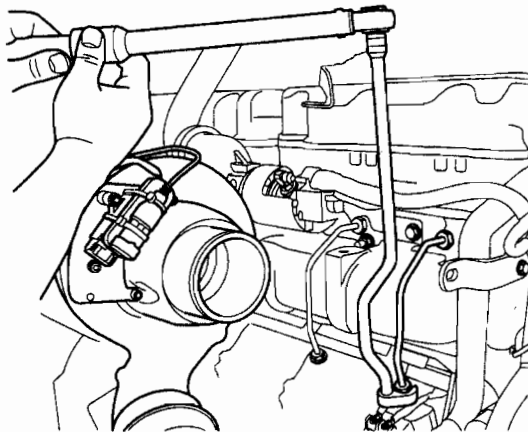
272100a

**Figure 12 — Using Direct-Torque Extension (Tool No. 2QM3114) and Flare Nut Crowfoot Adapter**

3. Once the air has been purged from the line and the line nut snugged with the open-end wrench, use the special direct-torque extension (tool No. 2QM3114), the appropriate flare nut crowfoot adapter (such as Snap-On tool Nos. FRHM17 for 17 mm end nuts or FRHM19 for 19 mm end nuts) and an accurately calibrated 3/8" drive click-type torque wrench to tighten the unit pump line nuts. Tighten the line nut to 33 N•m (25 lb-ft), immediately back off the nut slightly (approximately one nut flat) and then retighten to 33 N•m (25 lb-ft).

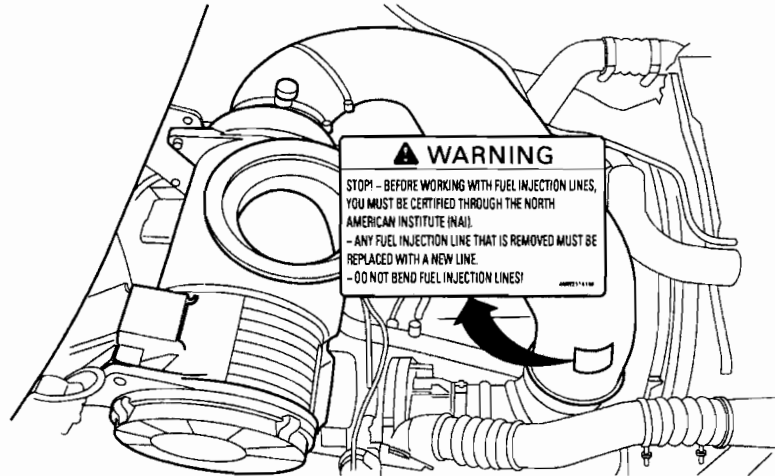
272101a

**Figure 13 — Fuel Line Warning Label (Part No. 4MR21141M)**

There should be a fuel injection warning label (part No. 4MR21141M) affixed to the inlet air duct, just above the turbocharger inlet. If a label is not present, the label supplied in the kit must be applied. Be sure to clean the area of the duct where the label is to be applied with a suitable cleaning fluid (such as alcohol or some other type of solvent) that will dry or evaporate quickly, and not leave a residue or damage the air duct. The label adhesive allows it to be quickly lifted off the duct immediately after application, and then reapplied, should alignment of the label not be correct at the first application.

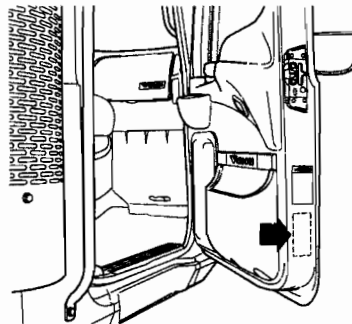
703153a

**Figure 14 — Campaign Label Location**  
SC324 — Page 12 of 13

To signify that the campaign has been completed, use a permanent-type marker (such as a Sharpie®) to write the campaign number (SC324) and completion date in the spaces provided on the Campaign Completion label located on the lower edge (below the door latch) of the passenger-side door. If a label is not already affixed to the door, apply a label (part No. TS897) and supply the information as required. Campaign Completion labels are available in packs of 50 and can be ordered by faxing a completed BR313 to Pacesetters Business Services at 610-264-9465.

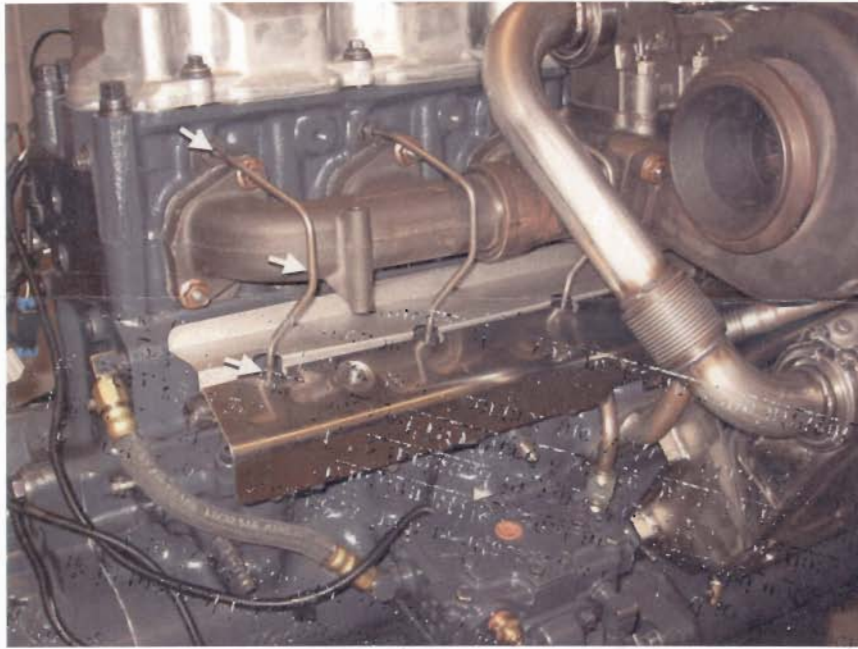
1. Before starting the engine, open the hood and inspect the six high-pressure fuel lines for signs of fuel leakage. This inspection must include the injection line itself, as well as both ends of the line at the cylinder head connection and the Electronic Unit Pump (EUP) connection. Refer to the following illustration.

Figure 1 — ASET™ AC High-Pressure Fuel Injection Lines

2. If no leaks are found, keep the hood open and start the engine. If leaks are seen, DO NOT proceed, and DO NOT operate the vehicle. Call your local MACK dealer or the MACK OneCall™ CompleteCare center for further instructions.
3. Allow the engine to idle approximately 5 minutes, and then shut the engine off.

If leakage is seen or suspected, DO NOT OPERATE the vehicle. Contact your local MACK dealer or the MACK OneCall™ CompleteCare center for further instructions.
