SUBJECT: Vehicle Safety Recall - SC0324 – Fifth & Final Release  
ASET™ AC Fuel Injection Lines

# SAFETY RECALL

## SC324

**Subject:** High-Pressure Injection Line Replacement — ASET™ AC Engines

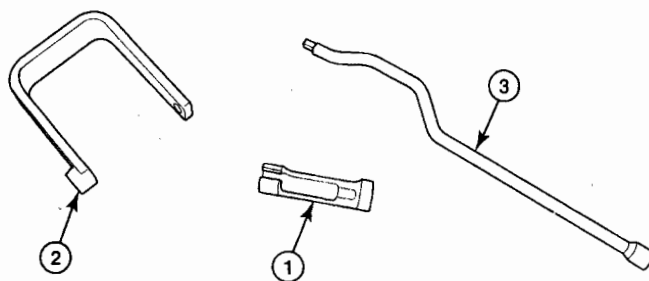
006917a

Figure 1 — Injection Line End Nut Torque Adapter Tool Kit (Kit No. 57GC2254)

1. Fuel Line Socket (part No. 525GC22), used to tighten the cylinder head end line nut for injection line Nos. 1, 2, 4, 5 and 6.
2. Direct-Torque Special Wrench (part No. 525GC31), used to tighten the cylinder head end line nut for injection line No. 3 (ASET™ AC engines only).

3. Direct-Torque Extension (part No. 2QM3114), use with a suitable flare nut crowfoot adapter such as Snap-On tool Nos. FRHM17 for 17 mm line nuts or FRHM19 for 19 mm line nuts when tightening the unit pump ends of the injection lines.

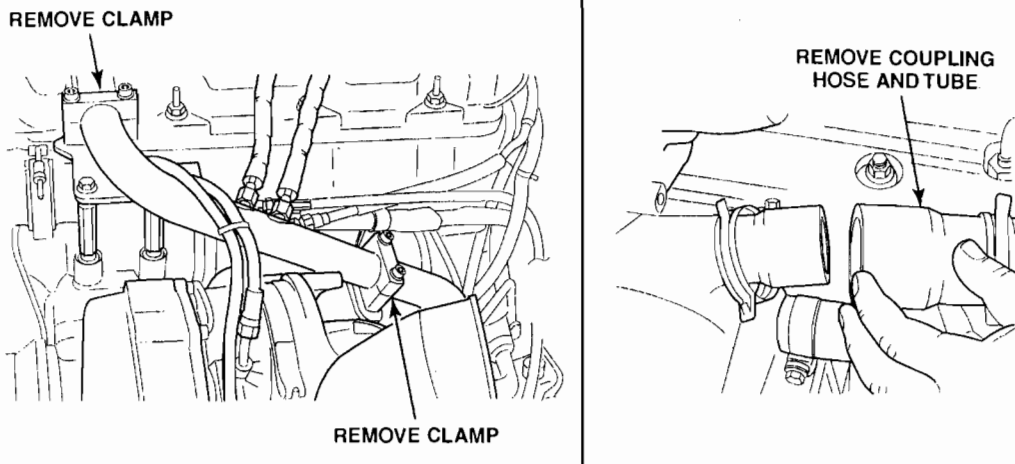
272110a

Figure 2 — Removing Mass Flow Tube

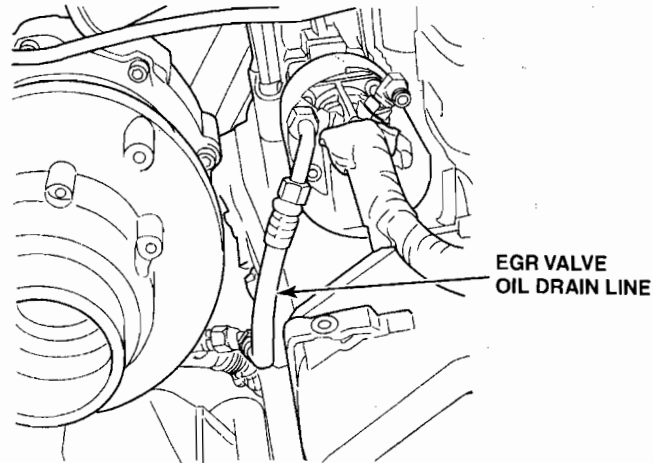
272109a

7. Disconnect both ends of the EGR valve oil line, and then remove the line from the engine.

**Figure 3 — Removing EGR Oil Drain Line**

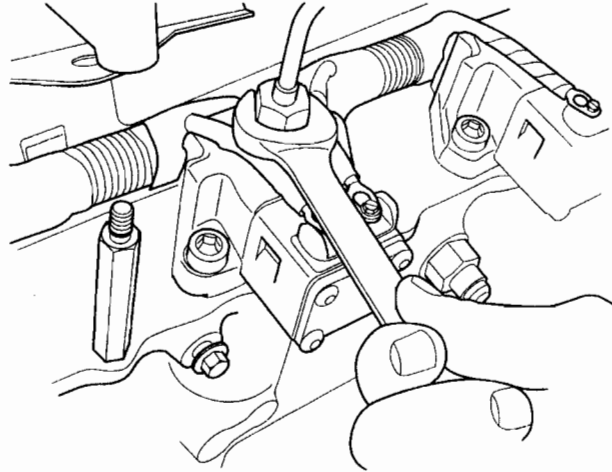
272102a

1. Using suitable hand tools, completely loosen the end nuts at both the unit pump and cylinder head ends of the injection lines.

**Figure 4 — Using Standard Hand Tools to Loosen Injection Line Nuts (Unit Pump End Shown)**

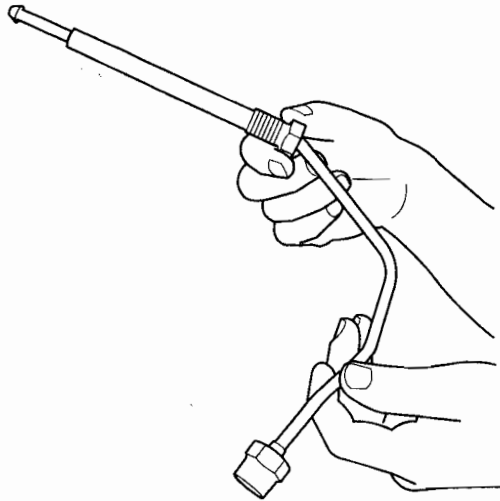
272108a

- a. Slide the end nut and sleeve against the bend in the line.

**Figure 5 — Slide Nut and Sleeve Against Bend in Line**

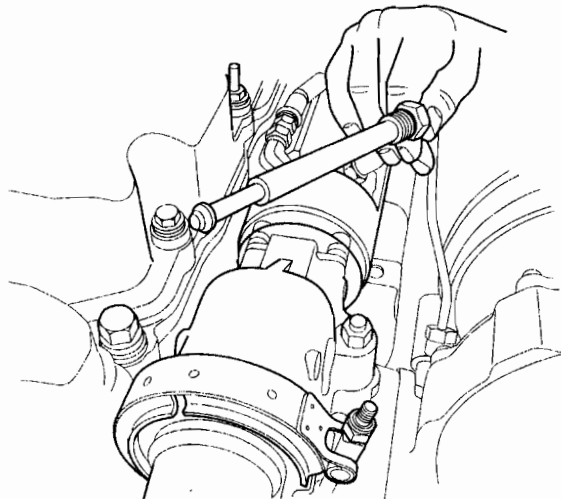
272107a

- b. Holding the line with the ends facing the rear of the engine and the upper nut and sleeve against the bend in the line, guide the line between the turbocharger housings and down behind the EGR cooler.

**Figure 6 — Guiding Line Between Turbocharger Housings**

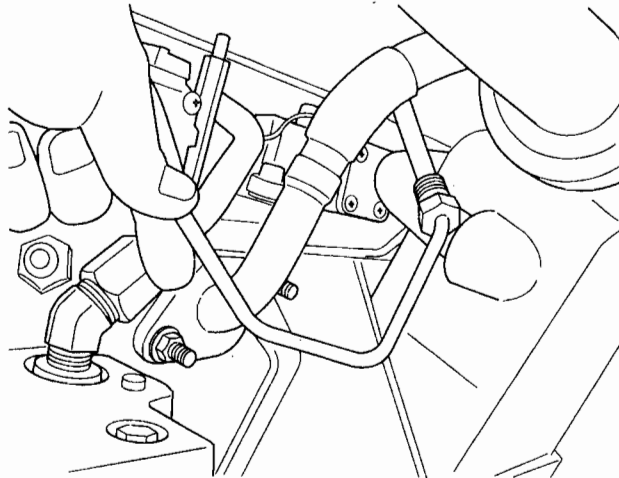
269956a

- c. When the line is down far enough so that the upper end is below the EGR valve, rotate the line slightly and begin moving the line upward while guiding the end of the line toward the cylinder head port. Keep the unit pump end of the line facing the rear of the engine.

**Figure 7 — Guiding End of Line Toward Cylinder Head Port**

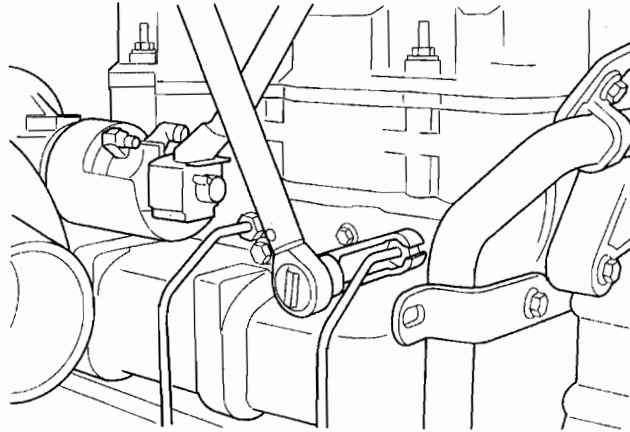
272106a

- REV
1. Tighten the line nut at the cylinder head end first. For line Nos. 1, 2, 4, 5 and 6, use the special injection line socket (tool No. 525GC22) and an accurately calibrated 3/8" drive click-type torque wrench. Tighten the nut to 40 N•m (30 lb-ft), immediately back off the nut slightly (approximately one nut flat) and then retighten the nut to 40 N•m (30 lb-ft). This critical "joint conditioning" procedure is necessary to ensure a proper leak-free connection.

**Figure 8 — Using the Injection Line Socket (Tool No. 525GC22)**

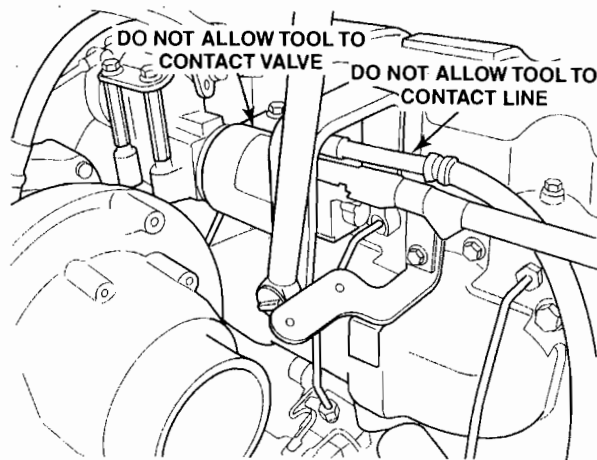
272105a

- REV
- To tighten the cylinder head end line nut for line No. 3, use the special direct-torque adapter tool (tool No. 525GC31) and an accurately calibrated 3/8" drive click-type torque wrench. Place the tool over the EGR valve and install the socket on the line nut. Install the torque wrench and then tighten the nut to 40 N•m (30 lb-ft), immediately back off the nut slightly (approximately one nut flat) and retighten to 40 N•m (30 lb-ft).

**Figure 9 — Using the Direct-Torque Adapter (Tool No. 525GC31)**

Use care when tightening the end nut with the direct-torque adapter so that the tool does not contact the EGR valve or any of the oil lines surrounding the valve. Doing so will result in a false torque reading and an under-torque condition.

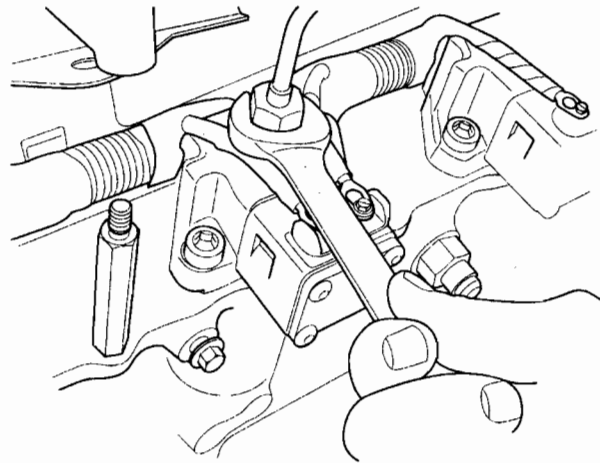
272102a

- a. Using a standard open-end wrench, snug the unit pump line nut, and then back the line nut off one turn.

**Figure 10 — Loosening Unit Pump Line Nut with a Standard Open-End Wrench**

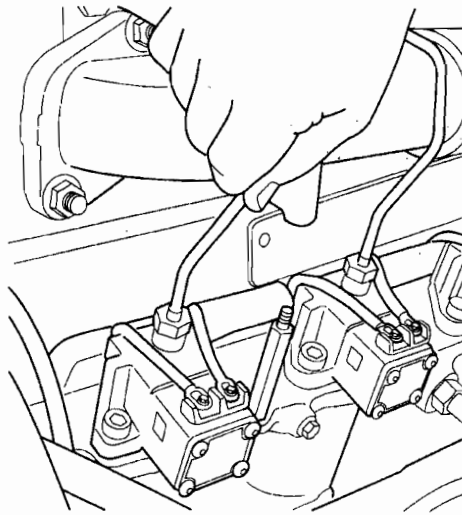
272104a

- b. Gently lift the injection line to unseat it from the unit pump.

**Figure 11 — Unseating Injection Line at Unit Pump**

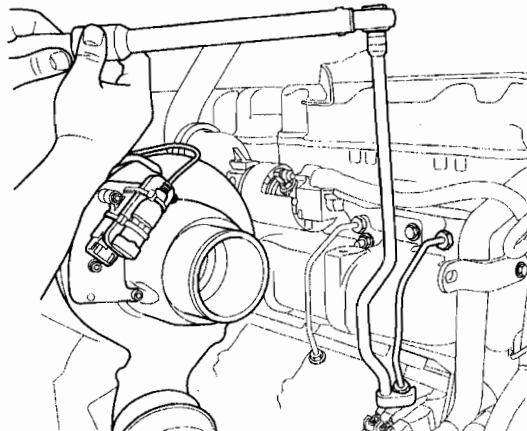
272100a

3. Once the air has been purged from the line and the line nut snugged with the open-end wrench, use the special direct-torque extension (tool No. 2QM3114), the appropriate flare nut crowfoot adapter (such as Snap-On tool Nos. FRHM17 for 17 mm end nuts or FRHM19 for 19 mm end nuts) and an accurately calibrated 3/8" drive click-type torque wrench to tighten the unit pump line nuts. Tighten the line nut to 33 N•m (25 lb-ft), immediately back off the nut slightly (approximately one nut flat) and then retighten to 33 N•m (25 lb-ft).

**Figure 12 — Using Direct-Torque Extension (Tool No. 2QM3114) and Flare Nut Crowfoot Adapter**

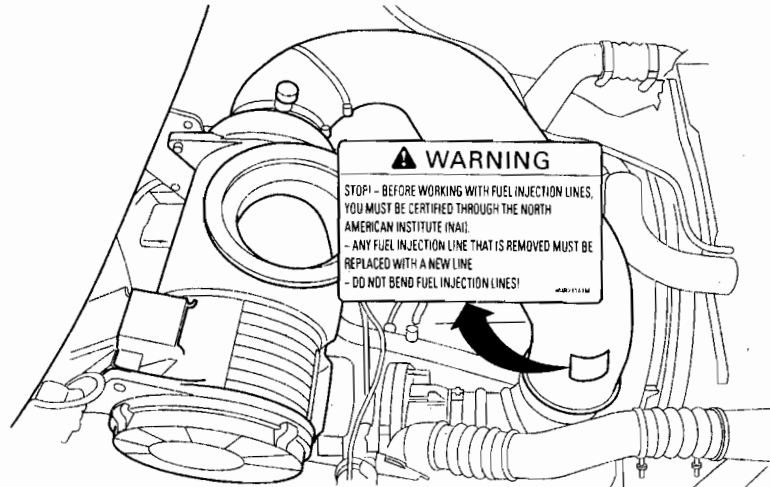
272101a

There should be a fuel injection warning label (part No. 4MR21141M) affixed to the inlet air duct, just above the turbocharger inlet. If a label is not present, the label supplied in the kit must be applied. Be sure to clean the area of the duct where the label is to be applied with a suitable cleaning fluid (such as alcohol or some other type of solvent) that will dry or evaporate quickly, and not leave a residue or damage the air duct. The label adhesive allows it to be quickly lifted off the duct immediately after application, and then reapplied, should alignment of the label not be correct at the first application.

Figure 13 — Fuel Line Warning Label (Part No. 4MR21141M)

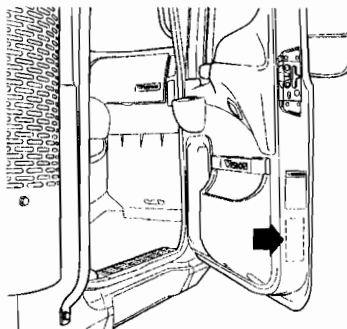
703153a

To signify that the campaign has been completed, use a permanent-type marker (such as a Sharpie®) to write the campaign number (SC324) and completion date in the spaces provided on the Campaign Completion label located on the lower edge (below the door latch) of the passenger-side door. If a label is not already affixed to the door, apply a label (part No. TS897) and supply the information as required. Campaign Completion labels are available in packs of 50 and can be ordered by faxing a completed BR313 to Pacesetters Business Services at 610-264-9465.

Figure 14 — Campaign Label Location

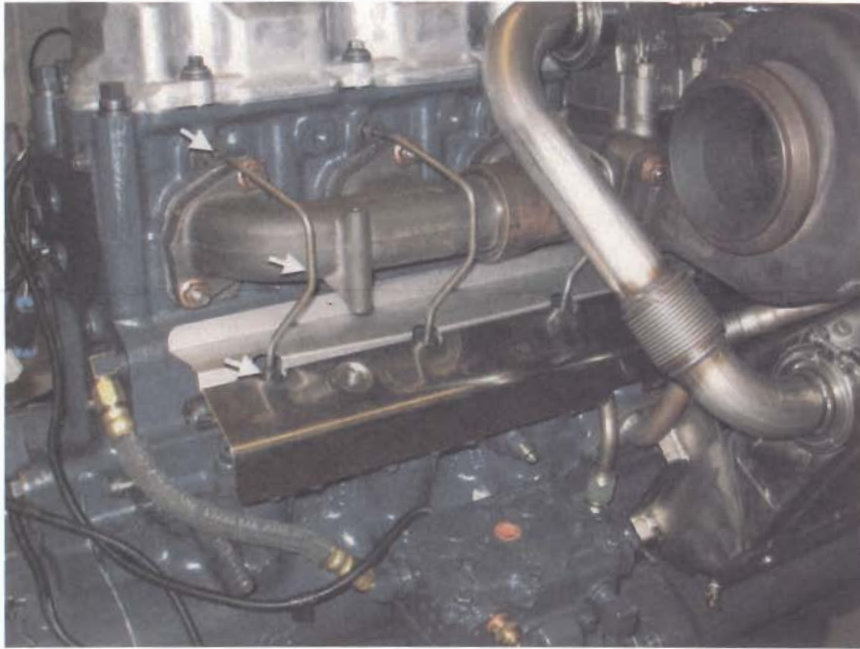
1. Before starting the engine, open the hood and inspect the six high-pressure fuel lines for signs of fuel leakage. This inspection must include the injection line itself, as well as both ends of the line at the cylinder head connection and the Electronic Unit Pump (EUP) connection. Refer to the following illustration.

Figure 1 — ASET™ AC High-Pressure Fuel Injection Lines
