SUBJECT: Vehicle Safety Recall - SC0324  
ASET™ AC Fuel Injection Lines

**SC324**

**Subject:** High-Pressure Injection Line Replacement — ASET™ AC Engines

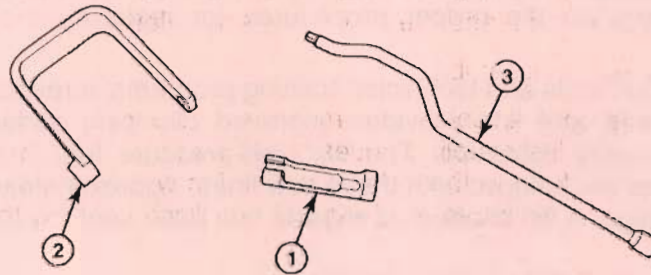
306917a

**Figure 1 — Injection Line End Nut Torque Adapter Tool Kit (Kit No. 57GC2254)**

1. Fuel Line Socket (part No. 525GC22), used to tighten the cylinder head end line nut for injection line Nos. 1, 2, 4, 5 and 6.
2. Direct-Torque Special Wrench (part No. 525GC31), used to tighten the cylinder head end line nut for injection line No. 3 (ASET™ AC engines only).

3. Direct-Torque Extension (part No. 2GM3114), use with a suitable flare nut crowfoot adapter such as Snap-On tool Nos. FRHM17 for 17 mm line nuts; or FRHM19 for 19 mm line nuts when tightening the unit pump ends of the injection lines.

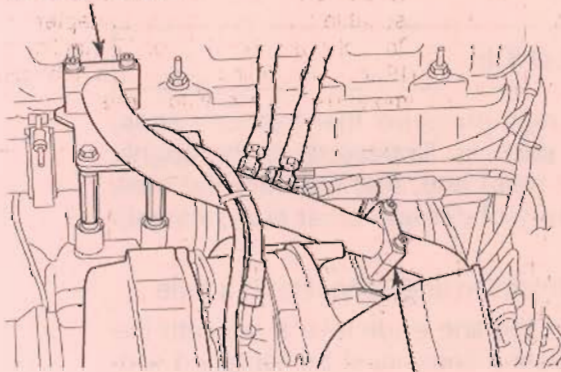
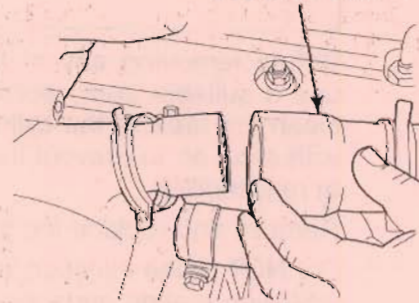
272110a

Figure 2 — Removing Mass Flow Tube

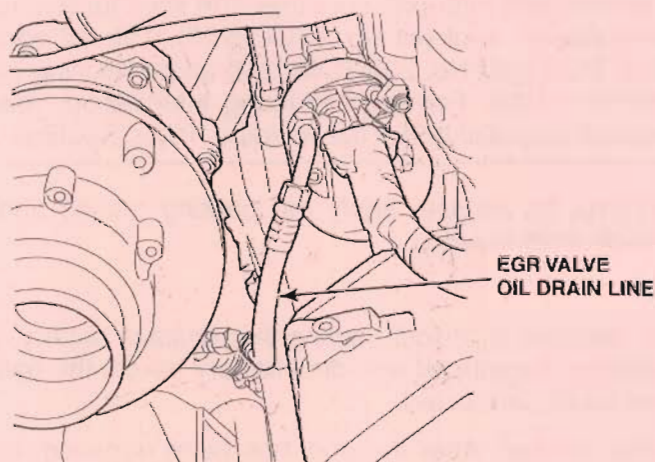
272109a

Figure 3 — Removing EGR Oil Drain Line

7. Disconnect both ends of the EGR valve oil line, and then remove the line from the engine.

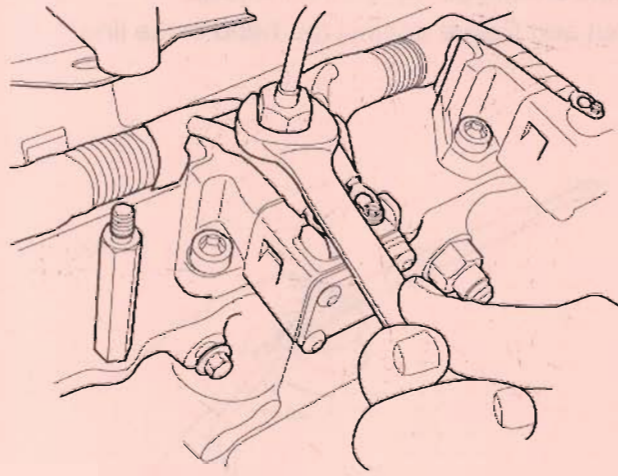
Figure 4 — Using Standard Hand Tools to Loosen Injection Line Nuts (Unit Pump End Shown)

1. Using suitable hand tools, completely loosen the end nuts at both the unit pump and cylinder head ends of the injection lines.

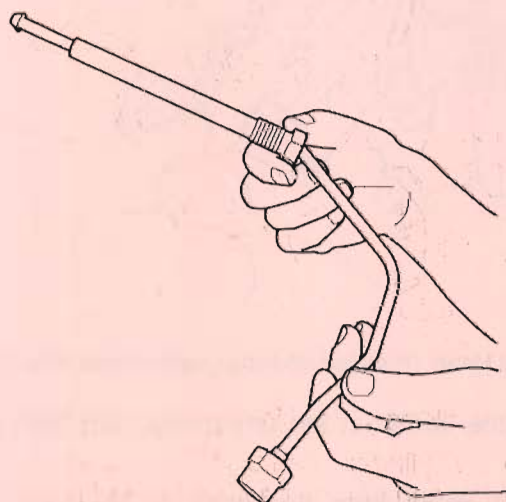
272108a

**Figure 5 — Slide Nut and Sleeve Against Bend in Line**

- a. Slide the end nut and sleeve against the bend in the line.

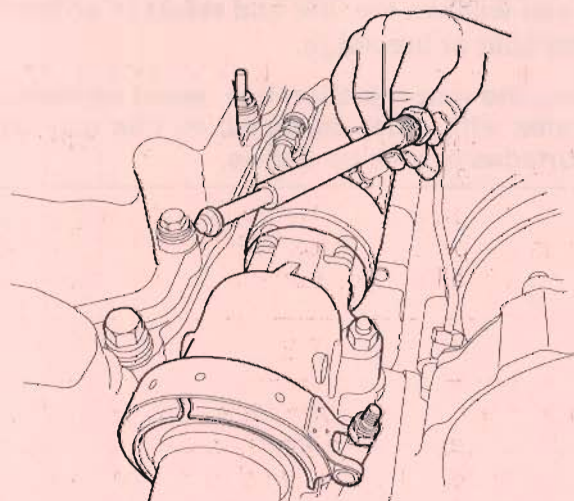
272107a

**Figure 6 — Guiding Line Between Turbocharger Housings**

- b. Holding the line with the ends facing the rear of the engine and the upper nut and sleeve against the bend in the line, guide the line between the turbocharger housings and down behind the EGR cooler.

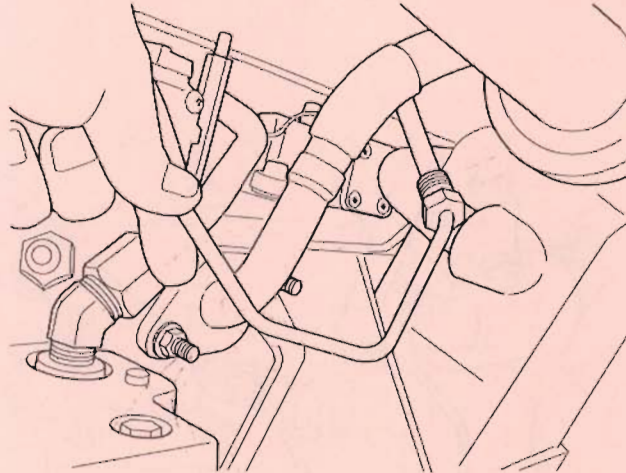
269956a

Figure 7 — Guiding End of Line Toward Cylinder Head Port

- c. When the line is down far enough so that the upper end is below the EGR valve, rotate the line slightly and begin moving the line upward while guiding the end of the line toward the cylinder head port. Keep the unit pump end of the line facing the rear of the engine.

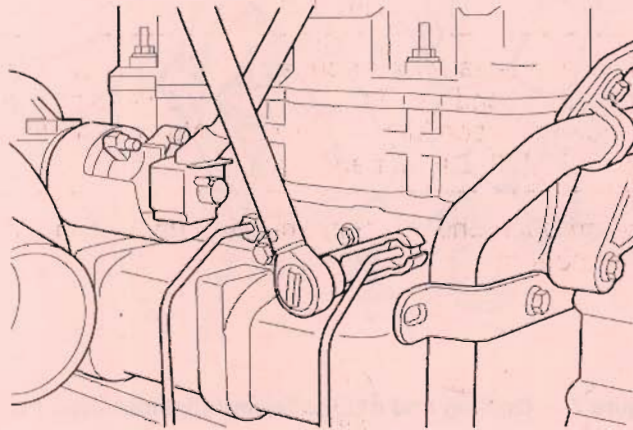
272106a

**Figure 8 — Using the Injection Line Socket (Tool No. 525GC22)**

1. Tighten the line nut at the cylinder head end first. For line Nos. 1, 2, 4, 5 and 6, use the special injection line socket (tool No. 525GC22) and an accurately calibrated 3/8" drive click-type torque wrench. Tighten the nut to 48 N•m (35 lb-ft), immediately back off the nut slightly (approximately one nut flat) and then retighten the nut to 48 N•m (35 lb-ft). This critical "joint conditioning" procedure is necessary to ensure a proper leak-free connection.

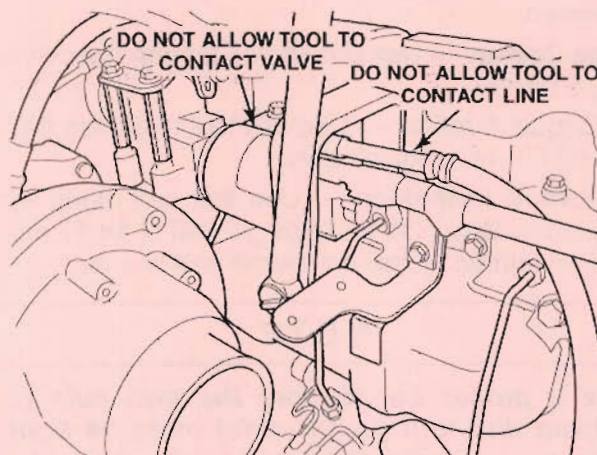
272105a

**Figure 9 — Using the Direct-Torque Adapter (Tool No. 525GC31)**

To tighten the cylinder head end line nut for line No. 3, use the special direct-torque adapter tool (tool No. 525GC31) and an accurately calibrated 3/8" drive click-type torque wrench. Place the tool over the EGR valve and install the socket on the line nut. Install the torque wrench and then tighten the nut to 48 N•m (35 lb-ft), immediately back off the nut slightly (approximately one nut flat) and retighten to 48 N•m (35 lb-ft).

Use care when tightening the end nut with the direct-torque adapter so that the tool does not contact the EGR valve or any of the oil lines surrounding the valve. Doing so will result in a false torque reading and an under-torque condition.

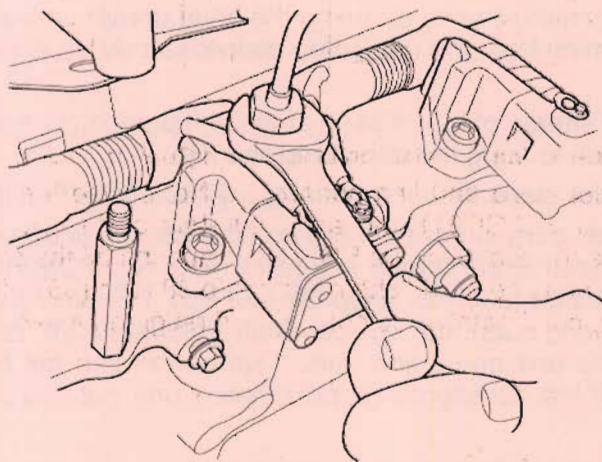
272102a

Figure 10 — Loosening Unit Pump Line Nut with a Standard Open-End Wrench

- a. Using a standard open-end wrench, snug the unit pump line nut, and then back the line nut off one turn.

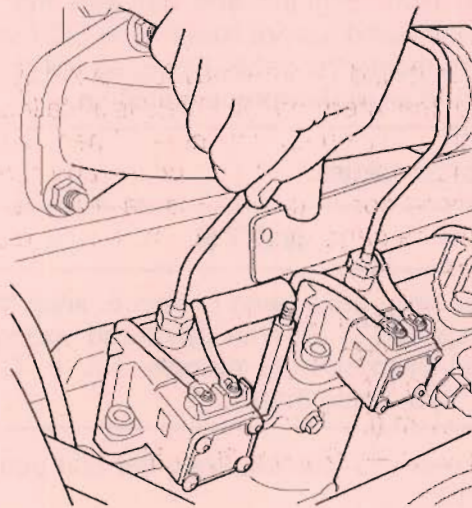
272104a

**Figure 11 — Unseating Injection Line at Unit Pump**

- b. Gently lift the injection line to unseat it from the unit pump.

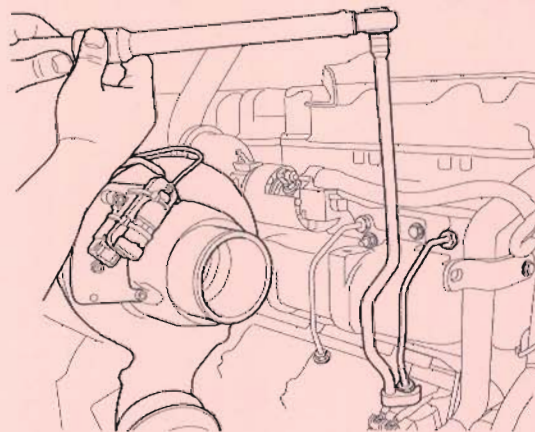
272100a

**Figure 12 — Using Direct-Torque Extension (Tool No. 2QM3114) and Flare Nut Crowfoot Adapter**

3. Once the air has been purged from the line and the line nut snugged with the open-end wrench, use the special direct-torque extension (tool No. 2QM3114), the appropriate flare nut crowfoot adapter (such as Snap-On tool Nos. FRHM17 for 17 mm end nuts or FRHM19 for 19 mm end nuts) and an accurately calibrated 3/8" drive click-type torque wrench to tighten the unit pump line nuts. Tighten the line nut to 41 N•m (30 lb-ft), immediately back off the nut slightly (approximately one nut flat) and then retighten to 41 N•m (30 lb-ft).

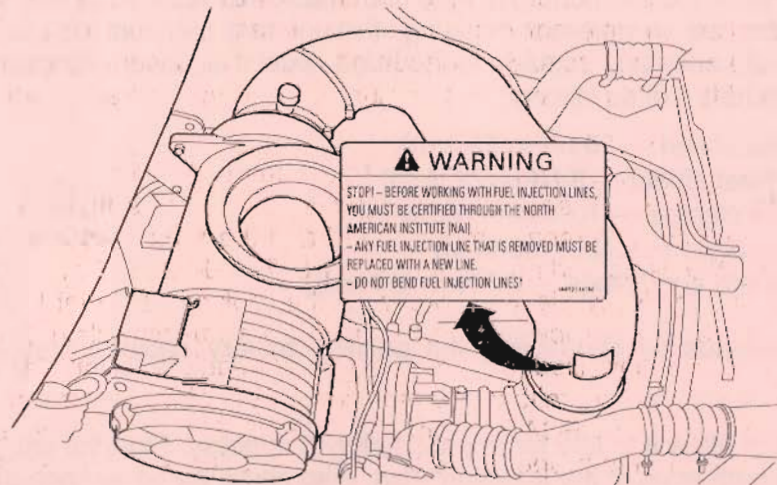
272101a

Figure 13 — Fuel Line Warning Label (Part No. 4MR21141M)

There should be a fuel injection warning label (part No. 4MR21141M) affixed to the inlet air duct, just above the turbocharger inlet. If a label is not present, the label supplied in the kit must be applied. Be sure to clean the area of the duct where the label is to be applied with a suitable cleaning fluid (such as alcohol or some other type of solvent) that will dry or evaporate quickly, and not leave a residue or damage the air duct. The label adhesive allows it to be quickly lifted off the duct immediately after application, and then reapplied, should alignment of the label not be correct at the first application.

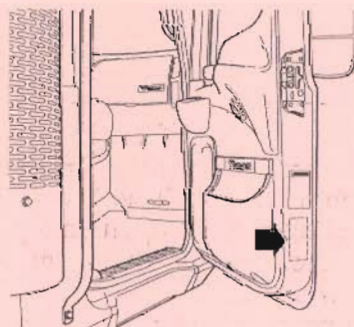
703153a

Figure 14 — Campaign Label Location  
SC324 — Page 12 of 13

To signify that the campaign has been completed, use a permanent-type marker (such as a Sharpie®) to write the campaign number (SC324) and completion date in the spaces provided on the Campaign Completion label located on the lower edge (below the door latch) of the passenger-side door. If a label is not already affixed to the door, apply a label (part No. TS897) and supply the information as required. Campaign Completion labels are available in packs of 50 and can be ordered by faxing a completed BR313 to Pacesetters Business Services at 610-264-9465.

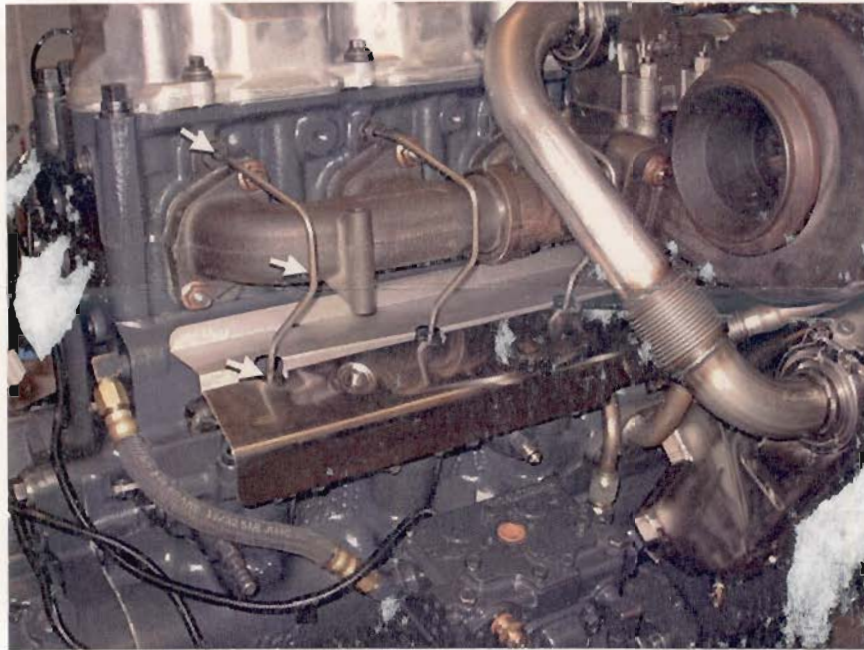
Figure 1 — ASET™ AC High-Pressure Fuel Injection Lines

1. Before starting the engine, open the hood and inspect the six high-pressure fuel lines for signs of fuel leakage. This inspection must include the injection line itself, as well as both ends of the line at the cylinder head connection and the Electronic Unit Pump (EUP) connection. Refer to the following illustration.
