GM SERVICE AND PARTS OPERATIONS
DCS1860
URGENT - DISTRIBUTE IMMEDIATELY

SUBJECT: 07263 – Noncompliance Recall
Seat Stud Strength – Inspect Seat Studs

MODELS: 2008 Pontiac Solstice
2008 Saturn Sky

SUBJECT: Seat Stud Strength – Inspect Seat Studs

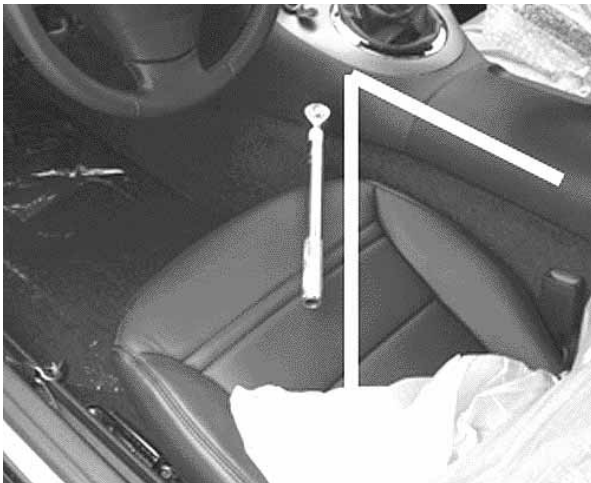
2013955

2. Pull the wrench until it clicks.
 - If the wrench clicks at or less than 45 degrees, the stud is good.
 - If the wrench pulls beyond 45 degrees and does not click, the stud is suspect and needs to be replaced.

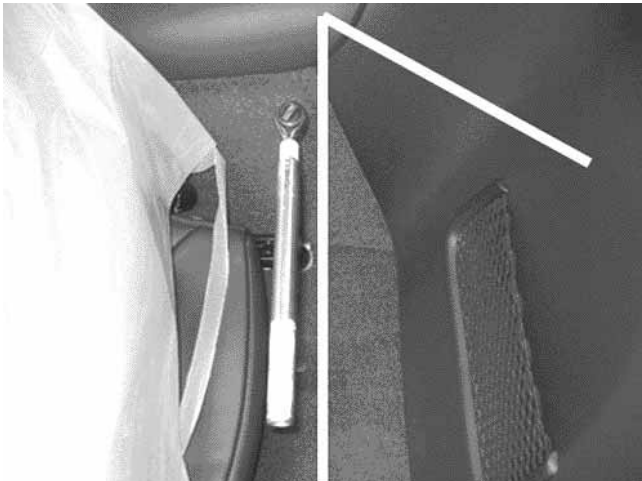
2013963

4. Pull the wrench until it clicks. Use the rear edge of seat as guide.
 - If the wrench clicks at or less than 45 degrees, the stud is good.
 - If the wrench pulls beyond 45 degrees and does not click, the stud is suspect and needs to be replaced.

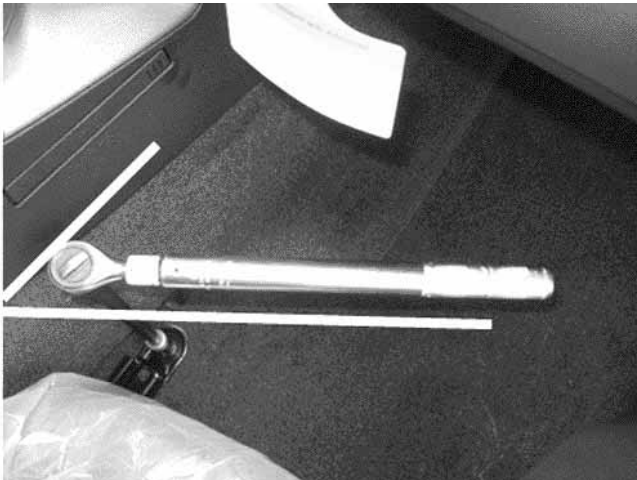
2013967

6. Pull the wrench until it clicks. Use the floor bump as a guide.
- If the wrench clicks at or less than 45 degrees, the stud is good.
 - If the wrench pulls beyond 45 degrees and does not click, the stud is suspect and needs to be replaced.

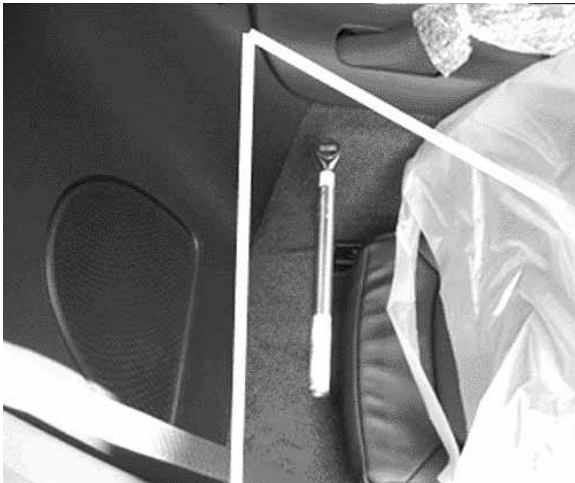
2013972

8. Pull the wrench until it clicks. Use the rear edge of the seat as a guide.
 - If the wrench clicks at or less than 45 degrees, the stud is good.
 - If the wrench pulls beyond 45 degrees and does not click, the stud is suspect and needs to be replaced.
