GM SERVICE AND PARTS OPERATIONS  
DCS2051  
URGENT - DISTRIBUTE IMMEDIATELY

Subject: 07149 - Noncompliance Recall  
Sunroof Power Remains On

Models: 2007 Buick Lucerne  
2007 Cadillac CTS, CTS-V  
Equipped with a Sunroof (RPO CF5)

**SUBJECT:** Sunroof Power Remains On

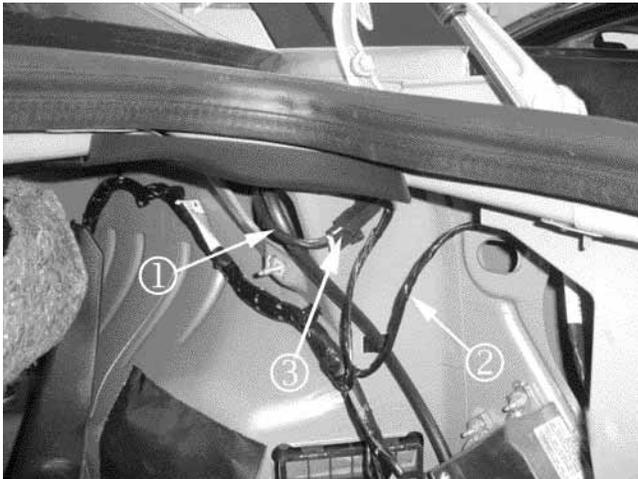
2014899

- (1) Sunroof Harness
- (2) Body Harness
- (3) Sunroof-to-Body Inline Connection

3. Gain access behind the passenger side trunk sidewall cover.
  - 3.1 Remove the last cargo net plastic anchor, which is located on the passenger side of the trunk trim panel.
  - 3.2 Lift the trim panel over the anchor and stud in the trunk floor.
  - 3.3 Carefully flex the trim panel away from the side of the vehicle.

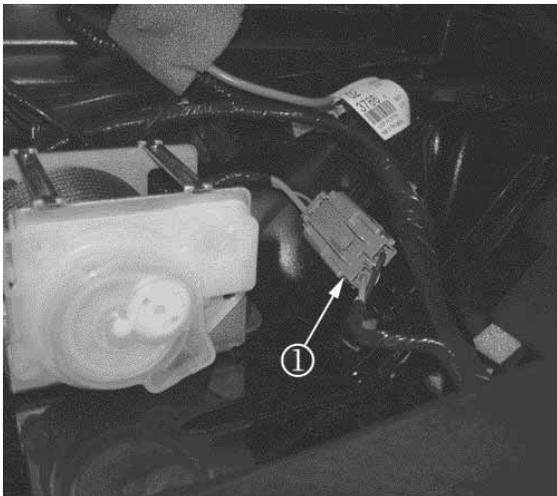
**Important:** The sunroof-to-body inline connection (1) is located behind the passenger's side rear quarter trim panel and underneath the rear window shelf trim panel. Refer to illustration.

3. Locate the sunroof-to-body inline connection (1).
4. Disconnect the sunroof-to-body inline connection (1).
