SAFETY RECALL BULLETIN

SUBJECT: Steering Gear Mounting Fastener Torque

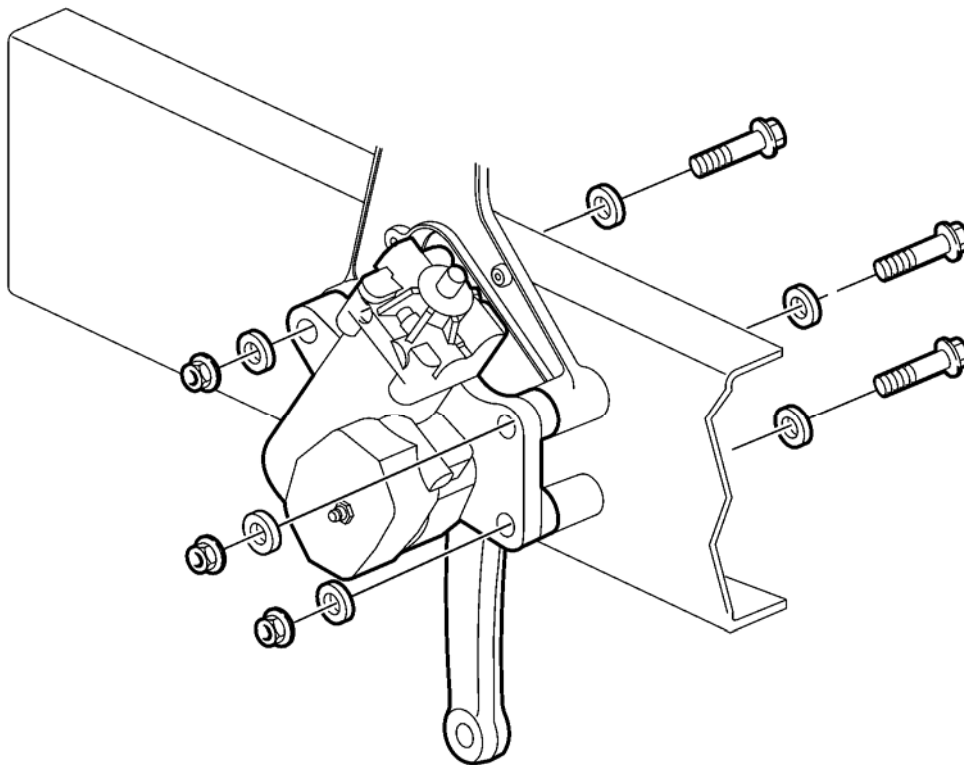
W6001615

The bolts that attach the steering gear to the frame may not have been tightened to the correct torque.

Using an accurately calibrated torque wrench on the mounting nuts (outer) and a wrench on the bolts (inner), tighten the fasteners to 398 ± 66 ft-lb (540 ± 90 Nm). **Note:** Some vehicle may have four bolts securing the steering gear.

3. Mark each nut with a yellow paint stick to signify that the fasteners have been torqued to specification.
