**Subject:** NHTSA Toyota Sienna Rampvan rear axle beam mounting (Recall Number 07V-546)

## Service Bulletin 34238

Instructions for Rear Axle Beam Assembly  
Evaluation and Securement  
Applicable for **2004-2007 Toyota Sienna  
Side Entry Rampvan® Conversions**

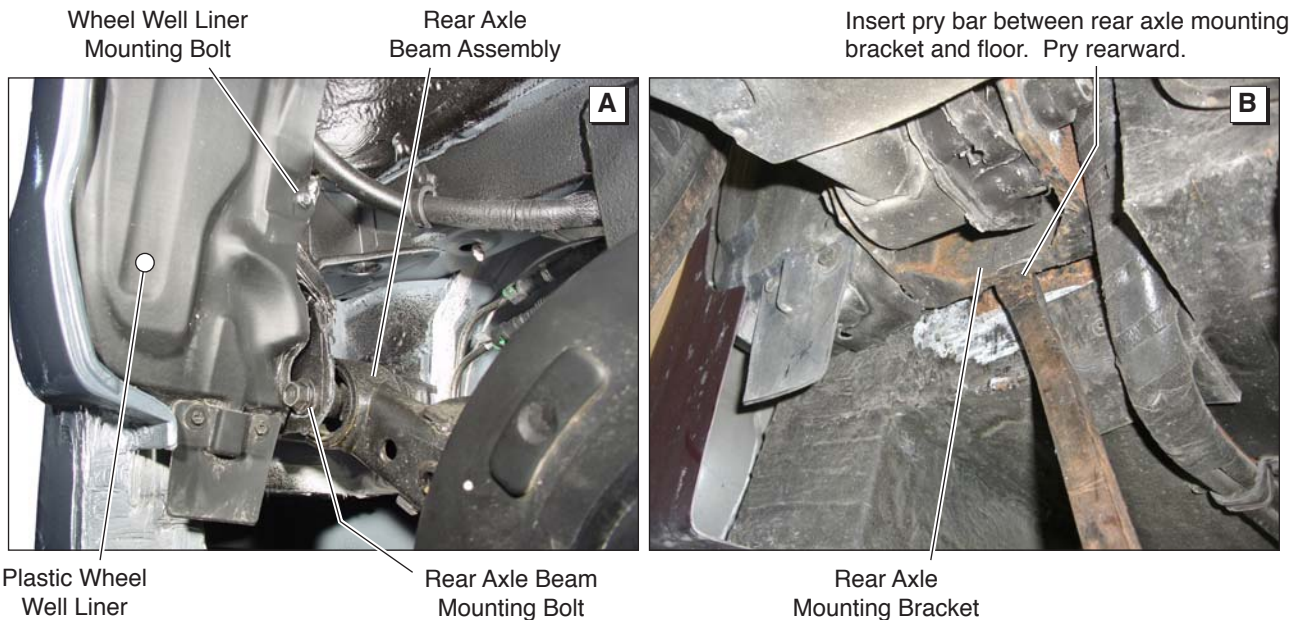
**Introduction:** In event of a rear suspension squeak in a Toyota Sienna Side Entry Rampvan® - refer to this bulletin. A suspension mounting bracket located just ahead of the driver side rear wheel could potentially loosen due to a stress fracture or broken weld. Movement of the bracket could result in squeaks or potentially a rough ride. Excessive tire wear may be visible.

2. Remove the driver side rear tire to expose the wheel well. See Photo A. Remove the plastic wheel well liner. See Photo A.

3. Insert a pry bar between rear axle beam mounting bracket and the lowered floor pan. See Photo B. Attempt to pry the axle beam bracket rearward. The course of action to be taken is based on this procedure (details on next page).

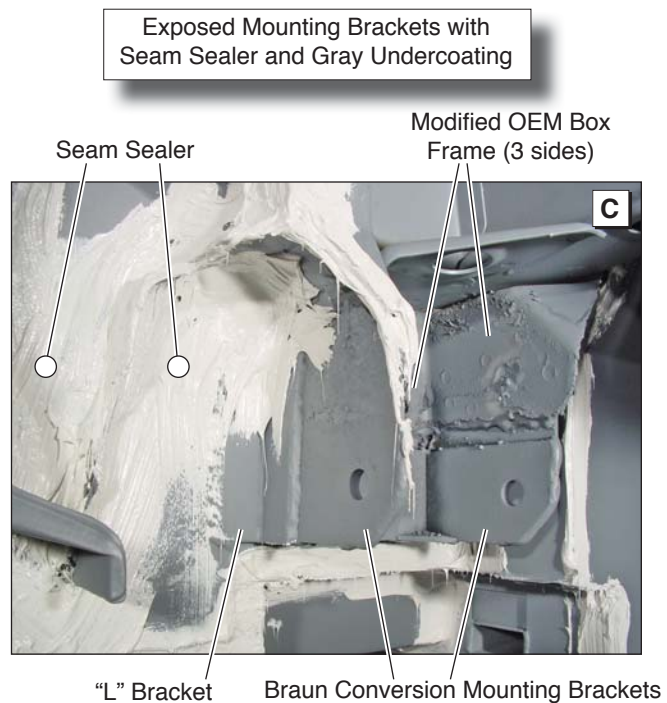
**Note:** Photo C depicts the exposed mounting bracket area with seam sealer and gray under coating. Photo D depicts the mounting bracket area without seam sealer or under coating (exposing welds).

**“L” Reinforcement Bracket:** In event the “L” bracket identified in Photos C and D is not present, the bracket **must be replaced**. The “L” bracket **must** be welded into position as shown. There **must be solid penetrating welds** along both vertical edges of the bracket (see Photos D and E). **Note:** Specified welds have been highlighted in yellow in Photo E.

**OEM Box Frame-to-Conversion Brackets:** Conversion mounting brackets fit around the modified OEM box frame in a U-shape as shown in Photos C, D and E (3 sides). The holes identified in Photo D must be filled with weld (4 holes). There **must be solid penetrating welds** along the bottom horizontal edges of the modified OEM box frame.

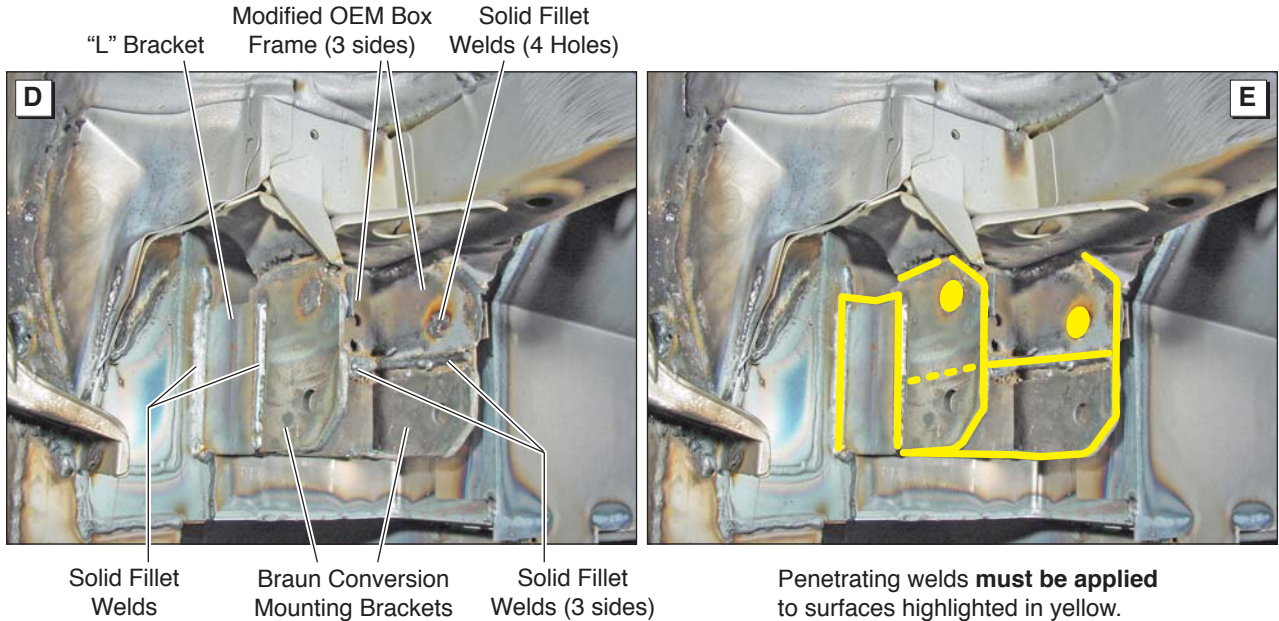
Exposed Bare Metal  
Mounting Brackets and Welds

Mounting Bracket Welds  
Highlighted in Yellow

Apply fillet welds along the edges of brackets as specified on pages 2 and 3 and shown in Photos D and E (page 3). Ensure integrity of welds.

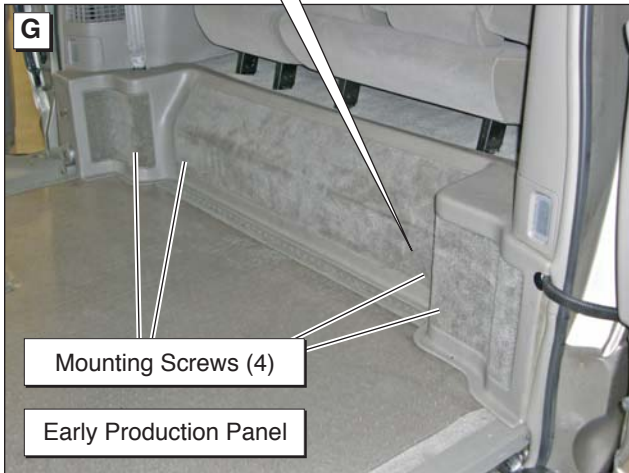
Mounting Screws (4)  
Early Production Panel

Earlier production panels are secured with four self-tapping screws (see Photo G). **Carefully** loosen the corners of the carpet to expose mounting screws (see Photo G Detail).

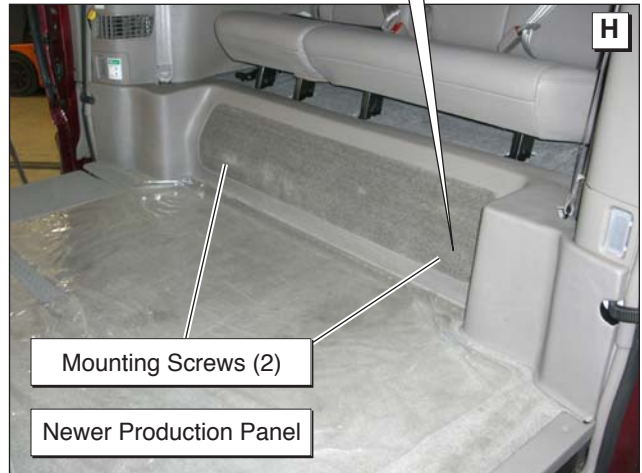
Mounting Screws (2)  
Newer Production Panel

Newer production panels are secured with two self-tapping screws (see Photo H). Screws are inserted through the carpet (see Photo H Detail). The black headed screws can be located using a bright shop light.
