Applies To: **2007 Fit** – ALL
2008 Fit – From VIN JHMGD3...8S000001 thru JHMGD3...8S019313

December 5, 2007

Safety Recall: SRS Floor Wire Harness Corrosion

(Supersedes 07-088, dated November 30, 2007, to update the information marked by the black bars)

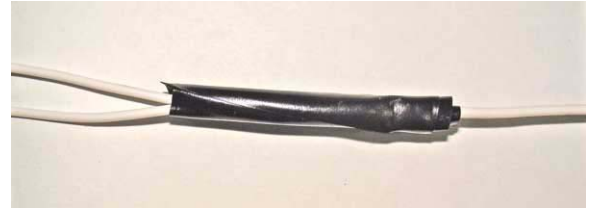
- WHT wire - SRS IG1 circuit (Two branches)
Applies to both models.

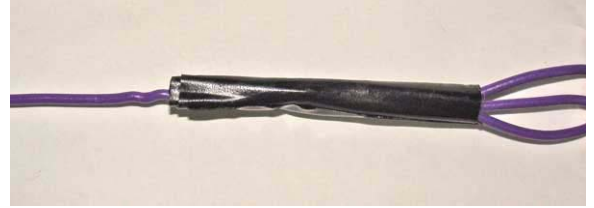
- PUR wire - door switch circuit (Three branches)
Applies to both models.

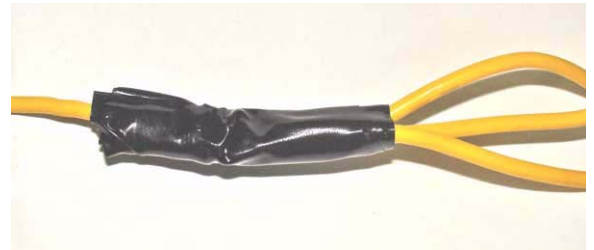
- YEL wire - door unlock motor circuit (Three branches)
Applies to both models.

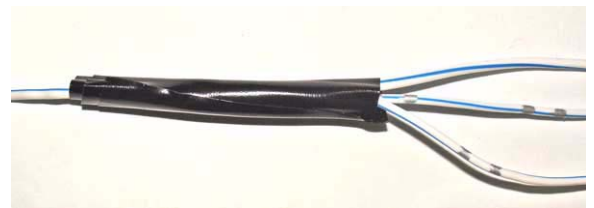
- WHT/BLU wire - security system circuit (Three branches)
Applies to Sport model only.

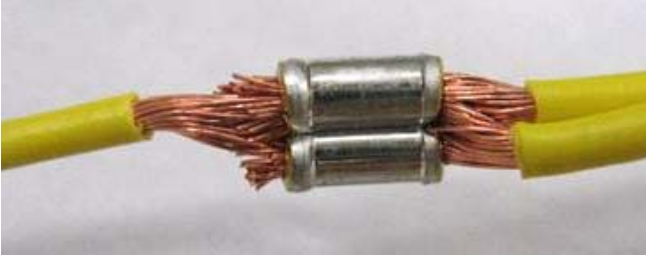
Example of a good splice:

12. Remove the existing insulation from each of the splices (four on LX models and five on Sport models).
13. Inspect all of the splices and wire for any dullness or discoloration. The splices and wire should be shiny.
 - In all of the splices are good, go to step 11 of REPAIR PROCEDURE A (page 5) to seal the splices.
 - If any of the splices are dull or discolored, go to REPAIR PROCEDURE B (page 9) to replace the floor wire harness.

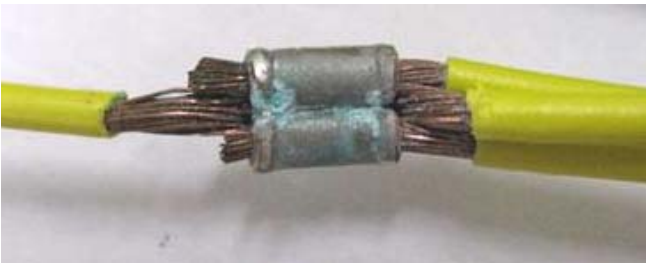
Example of a dull and discolored splice:
