07V-549

Applies To: **2007 Fit – ALL**
2008 Fit – From VIN JHMGD3...8S000001 thru JHMGD3...8S019313

November 30, 2007**Safety Recall: SRS Floor Wire Harness Corrosion****BACKGROUND**

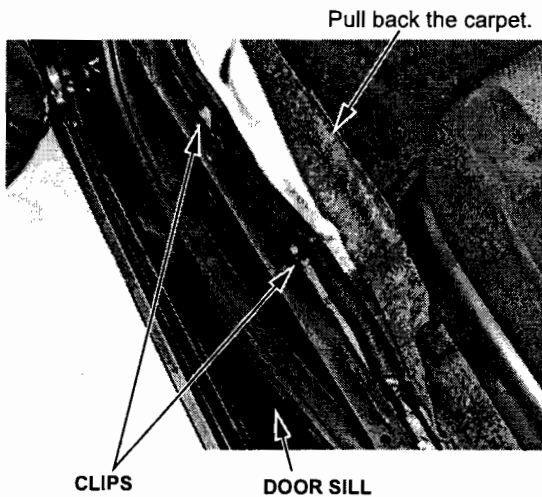
1. Disconnect the negative cable from the battery.
2. Remove the driver's dashboard undercover:
 - Refer to page 20-75 of the *2007–2008 Fit Service Manual*, or
 - Online, enter keywords **DRIVER UNDERCOVER**, and select **Driver's Dashboard Undercover Removal/Installation**.
3. Remove the left kick panel and driver's door sill trim:
 - Refer to page 20-53 of the service manual, or
 - Online, enter keywords **DOOR AREA**, and select **Interior Trim Removal/Installation - Door Areas**.
4. Pull back the carpet to access the left branch of the floor wire harness.

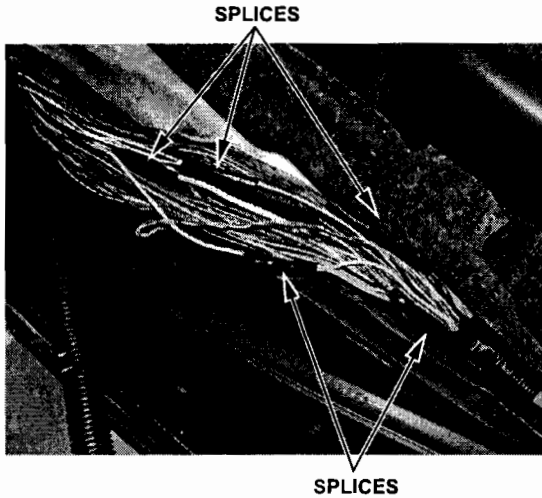
9. Pull out and identify the wire splices that must be sealed.

- WHT wire - SRS IG1 circuit
(Two branches)
Applies to both models.

- PUR wire - door switch circuit
(Three branches)
Applies to both models.

- WHT/BLK wire - door lock motor circuit
(Two branches)
Applies to both models.

- YEL wire - door unlock motor circuit
(Three branches)
Applies to both models.

- WHT/BLU wire - security system circuit
(Three branches)
Applies to Sport model only.

8. Remove the insulation tape wrapped around the harness between the yellow clip and the harness branch fork.
