# SAFETY RECALL NOTICE

## **Re: Brake Fluid Reservoir Caps Replacement**

Campaign no.: 2008-0002

Date: **January 11, 2008**Subject: **Brake Fluid Reservoir Caps Replacement**No. **2008-2**

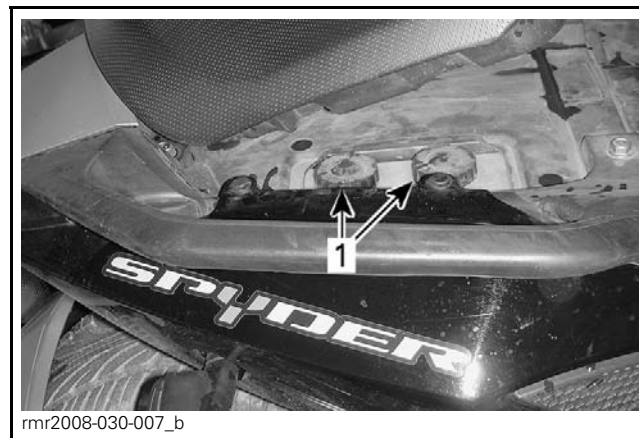
Clean brake fluid reservoir caps [1] and surrounding area.

Remove brake fluid reservoir caps from vehicle.

Keep and return obsolete caps according to the claim procedure.

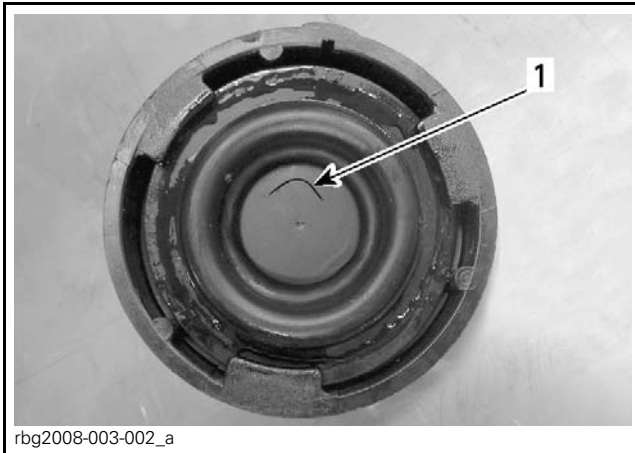
The above illustration shows an improved brake fluid reservoir cap with the new V slit [1] in the diaphragm.

Install both improved brake fluid reservoir caps (P/N 219 800 058) onto vehicle.

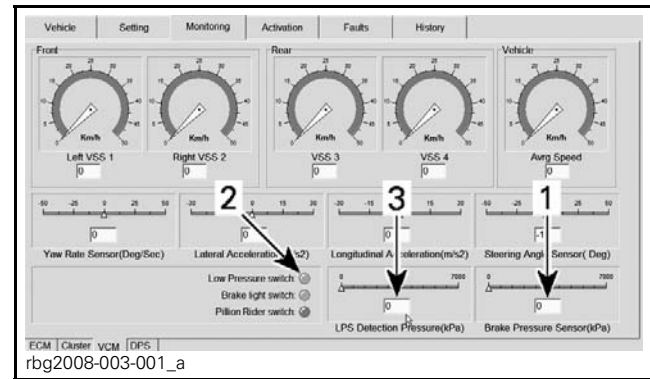
- [1] : Brake Pressure Sensor value
- [2] : Low Pressure Switch button
- [3] : LPS Detection Pressure value

If low pressure switch button is still off when you reach the required pressure the validation is successful.

If low pressure switch button turns on before reaching **3500 kPa (508 PSI)** perform the following additional steps :

If the average is **BELOW 3500 kPa (508 PSI)** perform the **BRAKE FLUID BLEEDING PROCEDURE (COMPLETE SYSTEM)**. Refer to *ROADSTER SPYDER GS SHOP MANUAL, SECTION 08, SUBSECTION 04* for details.
