Reference: NHTSA Identification Number 07V-594

## **Safety Recall N02**

### **Crankshaft Position Sensor**

## SAFETY RECALL H02 – CRANKSHAFT POSITION SENSOR

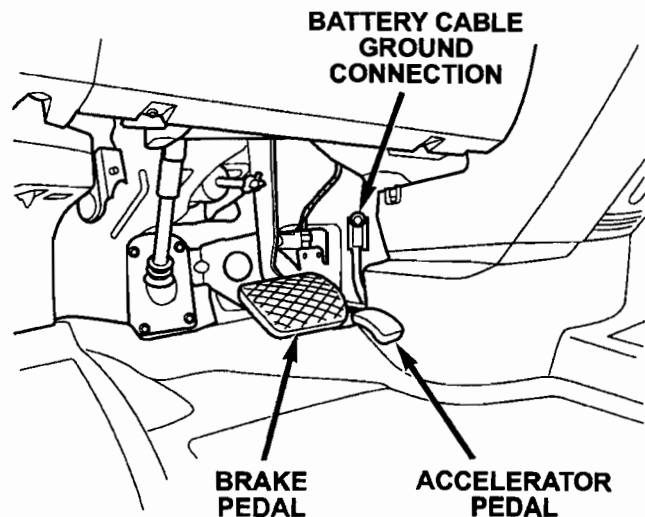
**Figure 1**

1. Disconnect and isolate the negative battery cable ground connection located under the instrument panel, next to the accelerator pedal. **This will disconnect the main battery located under the floor pan** (Figure 1).

7. Install the new crankshaft position sensor.
8. Install the crankshaft position sensor retaining bolt. Tighten the bolt to 80 in. lbs. (9 N·m).
9. Connect the crankshaft position sensor wiring harness to the crankshaft position sensor (Figure 2).
10. Lower the vehicle from the hoist.
11. Connect the negative battery cable ground connection (Figure 1).

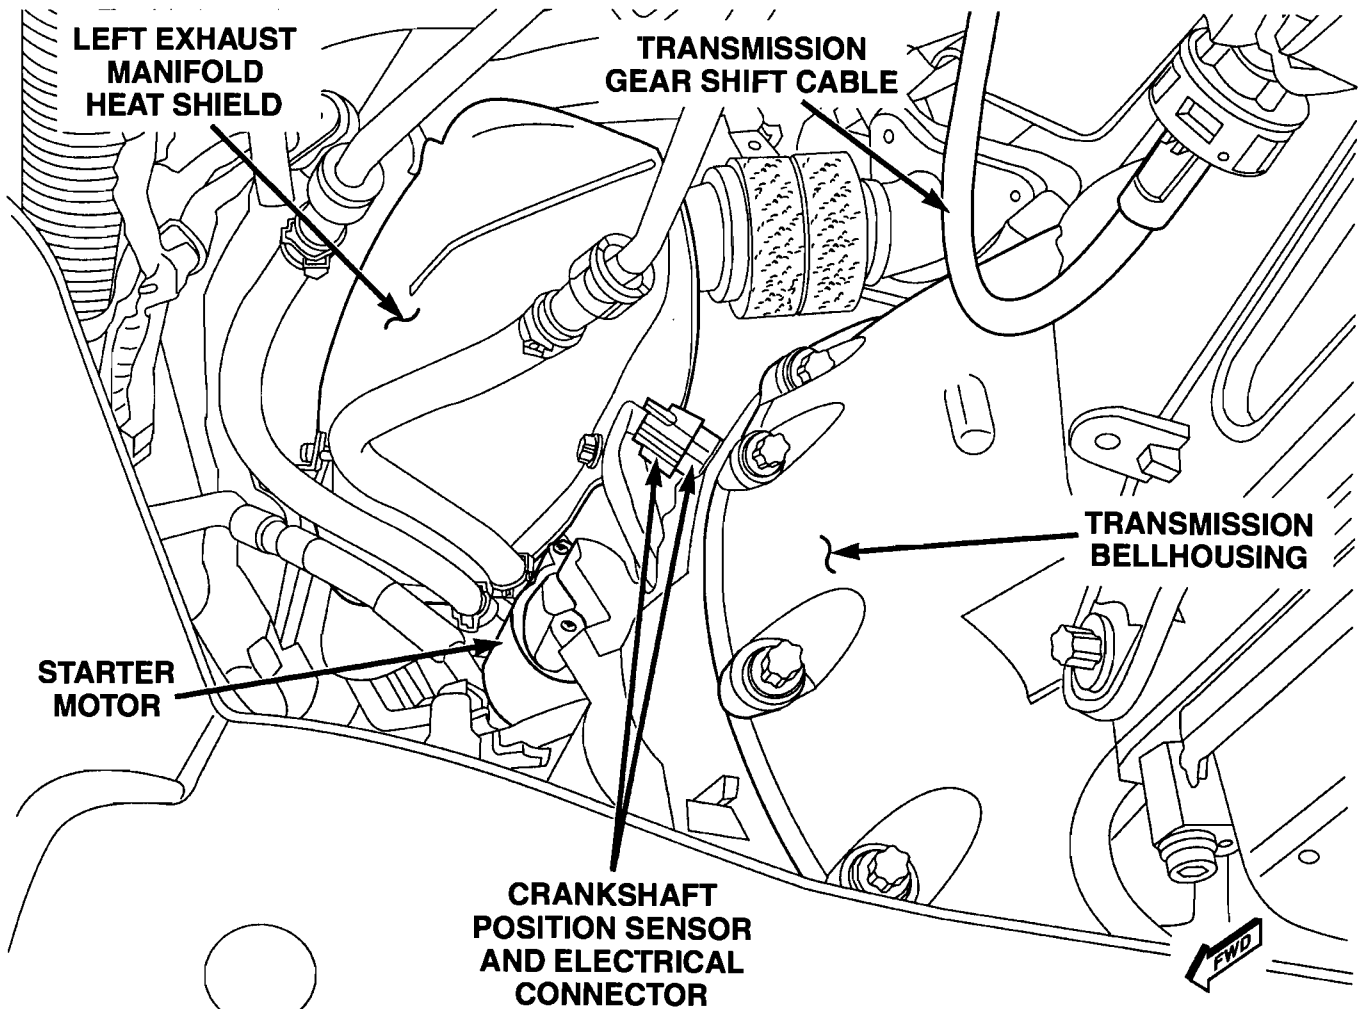
Figure 2 – View from Under Vehicle (Left Side)

The crankshaft position sensor on about 6,000 of the above vehicles may have been manufactured incorrectly. This could cause the vehicle's engine to stall or not start under certain conditions. Engine stalling could cause a crash without warning.

3. Using compressed air, clean any debris that may have collected around the crankshaft position sensor (Figure 2).
4. Disconnect the electrical connector located on the crankshaft position sensor (Figure 2).
5. Using an E8 female Torx<sup>®</sup> socket (Snap-on<sup>®</sup> TLE80A or equivalent), remove the crankshaft position sensor retaining bolt.
6. Remove and discard the original crankshaft position sensor.
