# RECALL CAMPAIGN BULLETIN

NTB08-004

## VOLUNTARY RECALL CAMPAIGN 2007 – 2008 ALTIMA BODY CONTROL MODULE / TPMS

**CAMPAIGN ID #:** P7267  
**NHTSA #:** 07V-599  
**APPLIED VEHICLES:** 2007 Sedan and Hybrid (L32 and L32HV)  
2008 Sedan, Coupe and Hybrid (L32, CL32, and L32HV)  
**APPLIED VINs:** 1N4\*L21E\*7C 109125 – 235457  
1N4\*L21E\*7N 400827 – 498708  
1N4\*L21E\*8C 112049 – 141969  
1N4\*L21E\*8N 404850 – 433072  
1N4\*L24E\*8C 106399 – 128027

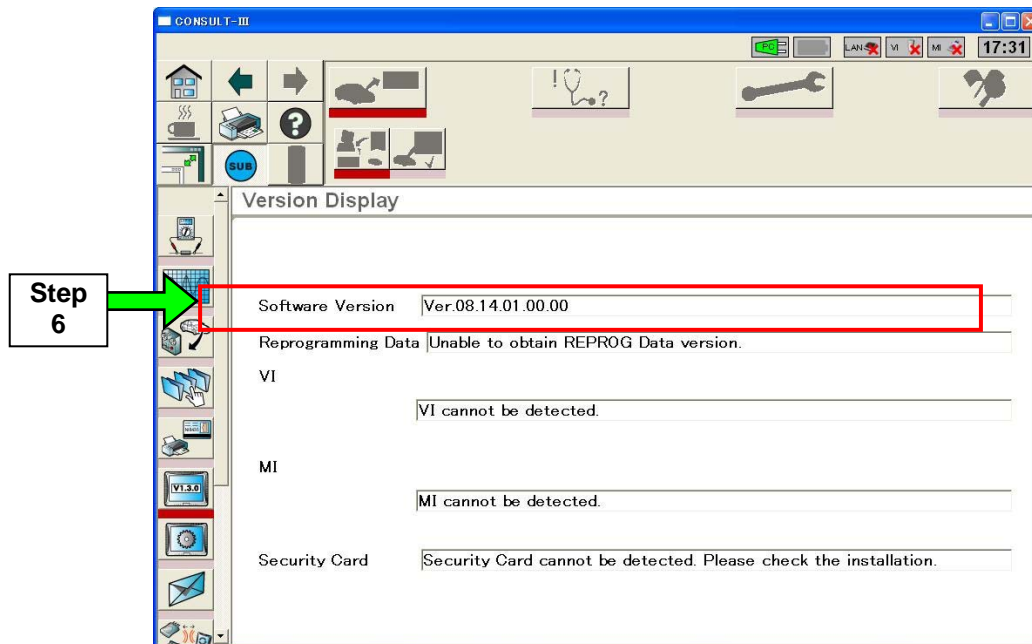
Figure C

6. Make sure the C-III software version is **Ver.08.14.01.00.00** or later (see Figure C).

- If the software version is not Ver.08.14.01.00.00 or later, update the C-III software before doing this procedure.

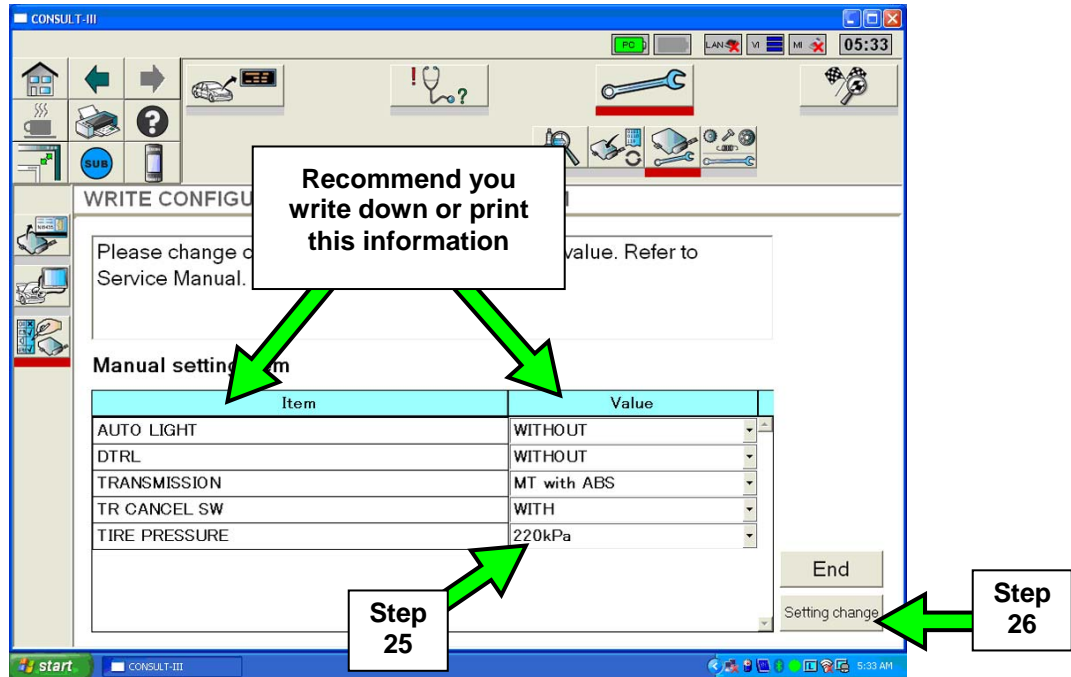
Figure 12

25. Make sure the Tire Pressure Value matches the label on the drivers door jam (see Figure 12).

26. Select **Setting Change**.

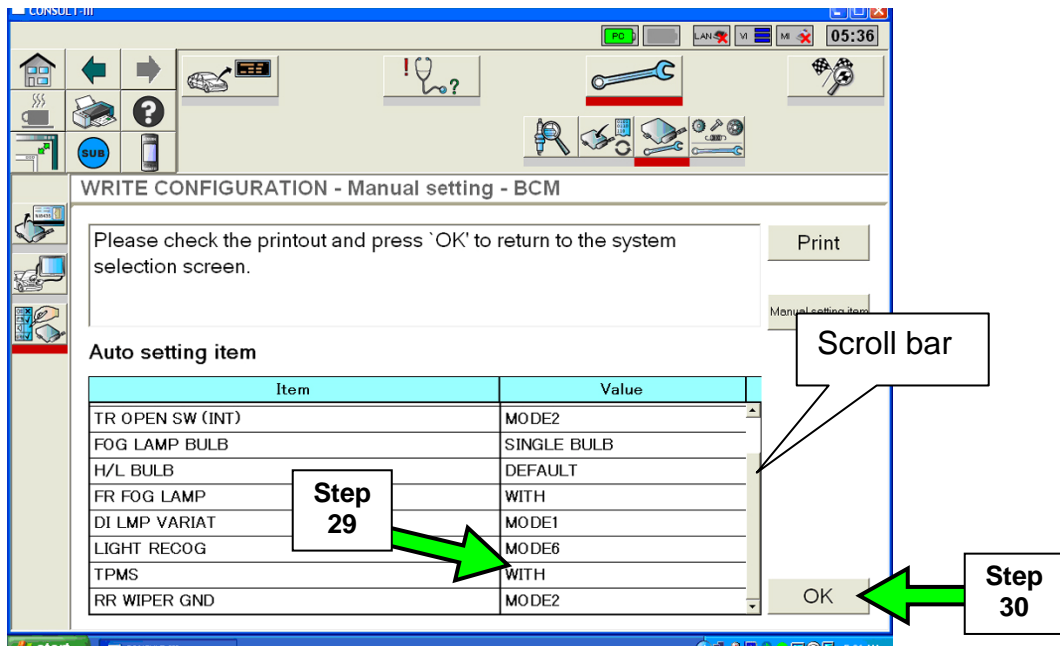
Figure 15

29. Use the scroll bar to find the TPMS setting and make sure it is set to **“With”** (see Figure 15).

30. Select **OK**.

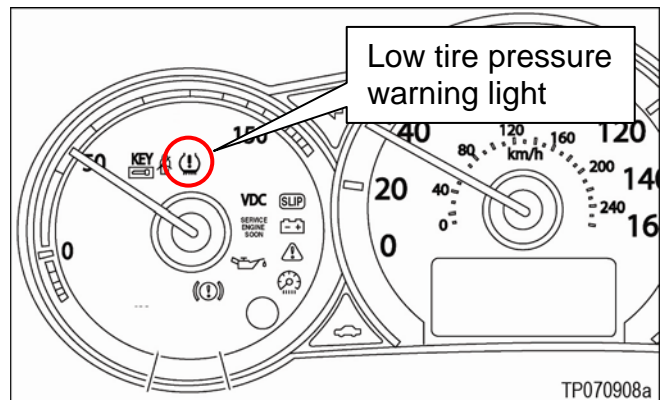
Figure 16

35. Turn the ignition ON and make sure the low tire pressure warning light comes on for about 1 second and then goes out.
