Safety Defect and Noncompliance Report Guide for Equipment
PART 573 Defect and Noncompliance Report Form

On February 22, 2008, Southeast Toyota Distributors, LLC decided that (a defect which relates to motor vehicle safety) exists in items of motor vehicle equipment listed below, and is furnishing notification to the National Highway Traffic Safety Administration in accordance with 49 CFR Part 573 Defect and Noncompliance Reports.

Furnish the manufacturer's identification code for this recall (if applicable):
NHTSA assigned no. is 08E-029.

Make: Model: Enkei 18" Wheel Nuts

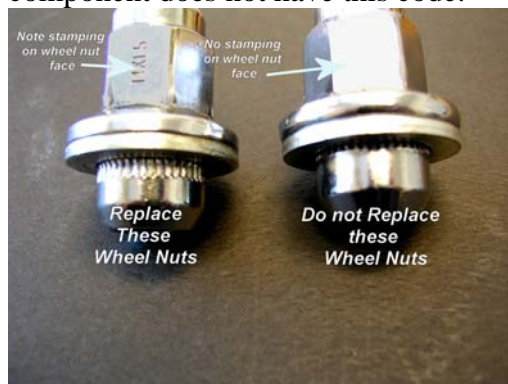
The recalled component has a code stamped on the face of the wheel nut (see picture). The remedy component does not have this code.

A new wheel nut is the remedy. This wheel nut is more robust and has been tested under severe applications.
