Safety Defect and Noncompliance Report Guide for Equipment
PART 573 Defect and Noncompliance Report Form

**08E-029
(13 pages)**

On February 22, 2008, Southeast Toyota Distributors, LLC decided that (a defect which relates to motor vehicle safety) exists in items of motor vehicle equipment listed below, and is furnishing notification to the National Highway Traffic Safety Administration in accordance with 49 CFR Part 573 Defect and Noncompliance Reports.

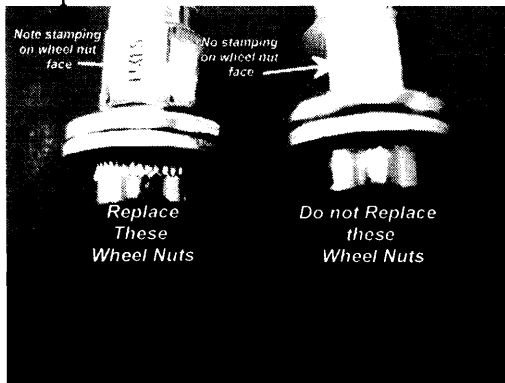
When the wheels were installed by a Toyota dealer in Southeast Toyota's region, an alloy tire/wheel upgrade was installed. The upgrade included 4 alloy wheels with attaching wheel nuts. It was determined that the wheel nuts may crack and break if the wheels are not installed carefully or if the wheel nuts are not carefully torqued. This condition can happen at time of wheel installation, tire rotation or service. In the worst case, an accident could happen if a vehicle's wheel nuts are cracked or broken and the wheel becomes loose and falls off the vehicle.

The wheel nuts can be overtorqued and break.

The recalled component has a code stamped on the face of the wheel nut (see picture). The remedy component does not have this code.

A new wheel nut is the remedy. This wheel nut is more robust and has been tested under severe applications.
