Safety Defect and Noncompliance Report Guide for Equipment
PART 573 Defect and Noncompliance Report⁴

On March 28, 2008, SAF-HOLLAND, Inc. decided that a defect which relates to motor vehicle safety exists in items of motor vehicle equipment listed below, and is furnishing notification to the National Highway Traffic Safety Administration in accordance with 49 CFR Part 573 Defect and Noncompliance Reports.

Generic name of the item: Transverse Beam Assembly

Make: SAF-Holland **Model:** ADL

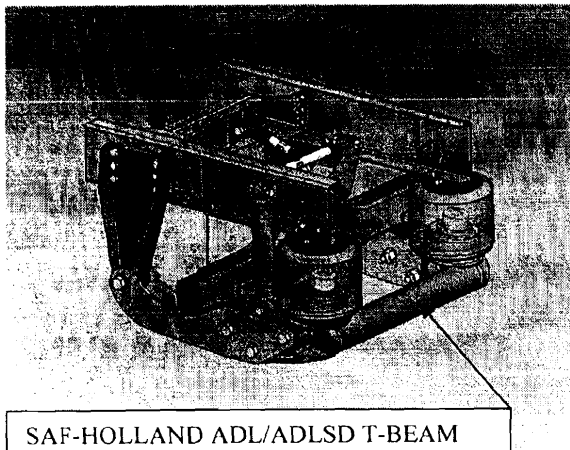
The defect is related to the SAF-Holland ADL/ADLSD suspension products. An example of this product is shown in figure 1. The specific component of this system is the transverse beam. An example of this component is shown in figure 2. The appearance of a normal weld is shown in figure 3. If the defect is present it will have an appearance similar to that in figure 4. The defect may occur on either side of the assembly as shown by arrows in figure 2.

Figure 1 SAF-HOLLAND ADL SUSPENSION

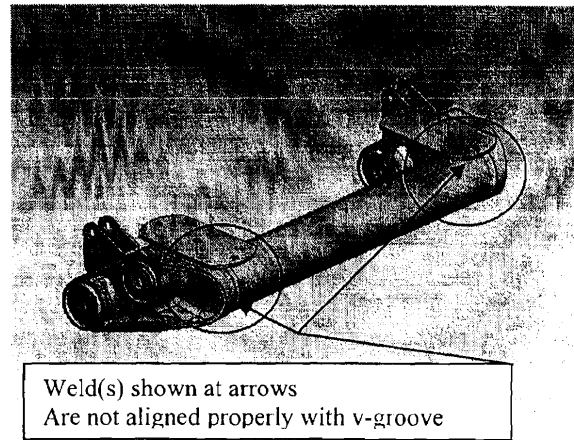
Figure 2 SAF-HOLLAND ADL T-BEAM

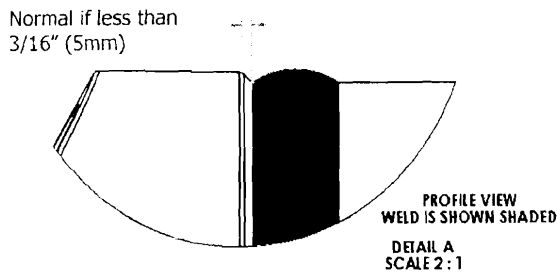
Figure 3 NORMAL WELD CONDITION

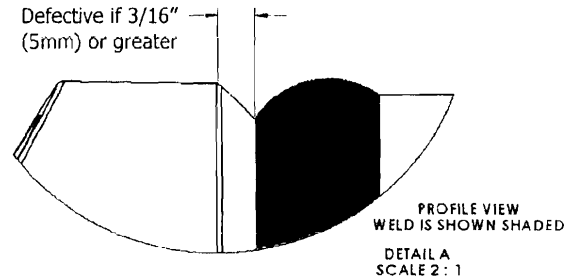
Figure 4 DEFECTIVE WELD CONDITION

An undetermined percentage of transverse beams we believe less than 6% have a weld that was not located correctly. Operator did not verify set-up when changing part numbers and/or operator did not re-verify torch after a loose clamp interfered with torch alignment on the fixed side of the fixture.

If the weld fails in the field, vehicle stability while cornering could be affected resulting in loss of vehicle control. In addition, the transverse beam could drop to the ground causing sparks that could cause a fire hazard.

The remedy is to visually inspect 100% of the units and replace any product containing the visual defect. The difference between the recall condition and the remedy is the recall condition is not welded per the engineering drawing.

The remedy component is welded per engineering drawing.
