RE: NHTSA Recall Number 08E-064; Supplemental to SKF's Notice dated October 16, 2008

SAFETY RECALL NOTICE TO END USERS

NHTSA Recall #08E-064 of SKF BR930361 hub bearing assembly; SKF Recall # PRO 08-029US/CA

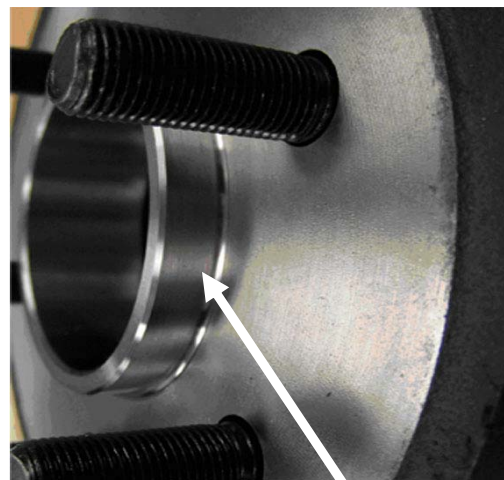
Figure 2 Correctly machined

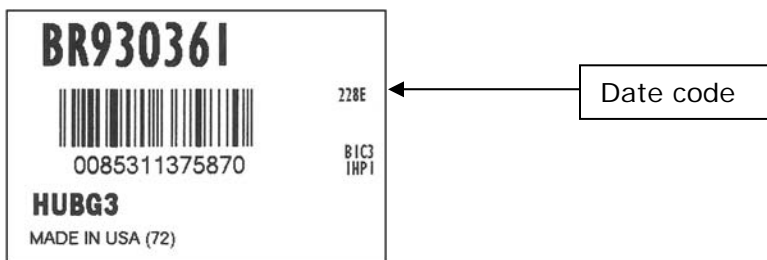
This recall involves SKF part number BR930361 that is identified by the following packaging date codes: 155E, 161E, 170E, 171E, 185E, 213E and 228E. **Only parts with one of these date codes are covered by this campaign.** The box part number label is shown below.

The date code appears on the upper right hand side of the part number label.

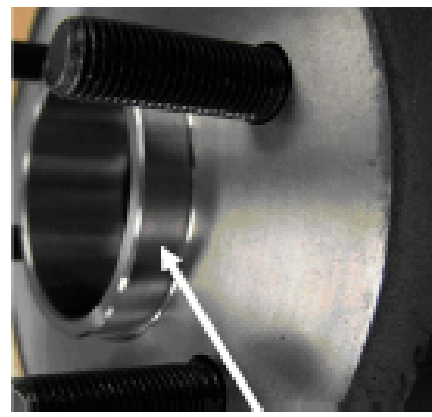
Figure 2 Correctly machined
