RE: NHTSA Recall Number 08E-064; Supplemental to SKF's Notice dated October 16, 2008

# SAFETY RECALL NOTICE TO END USERS

NHTSA Recall #08E-064 of SKF BR930361 hub bearing assembly; SKF Recall # PRO 08-029US/CA

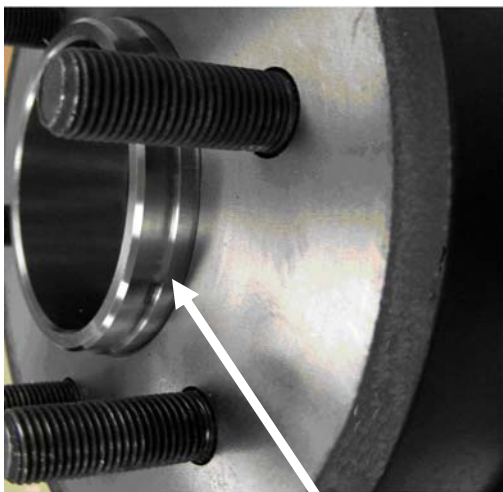
Figure 1 Defective

The rotor pilot for the hub bearing assembly was made too long. This results in the wheel to not be seated fully against the hub flange face during mounting. Improper seating of the wheel can result in excessive vibration, brake rotor noise, difficulty removing the wheel after installation and operation of the vehicle, and possibly wheel-end separation during vehicle operation. **Should the wheel-end separation occur, the driver could lose control of the vehicle, possibly resulting in a crash.**

1. Raise and support the vehicle following the manufacturer's guidelines and remove the front wheel.
2. Carefully examine the center brake rotor pilot depth. ***The affected hub bearing assembly will have a noticeable visible step just above where the brake rotor is seated.*** Refer to Figures 1 & 2. Figure 1 illustrates the incorrectly machined hub and brake rotor mounting set up. Figure 2 illustrates the correctly machined hub and brake rotor mounting set up.

If you have identified a hub bearing assembly that is defective, remove the defective hub assembly and replace it with a non-defective replacement hub assembly using the manufacturers recommended repair procedures. Return the defective hub assembly to the place of purchase for reimbursement as identified above.

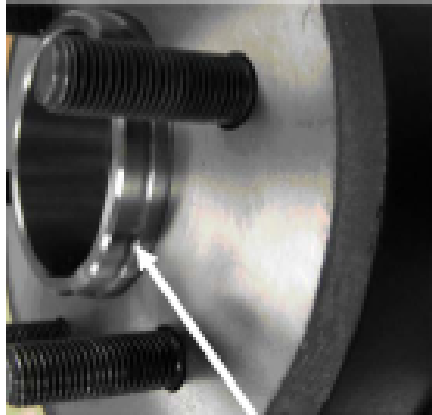
Figure 1 Defective

2. Carefully examine the center brake rotor pilot depth. *The affected hub bearing assembly will have a noticeable visible step just above where the brake rotor is seated. Refer to Figures 1 & 2. Figure 1 illustrates the incorrectly machined hub and brake rotor mounting set up. Figure 2 illustrates the correctly machined hub and brake rotor mounting set up.*

3. If you have identified a hub bearing assembly that is defective, remove the defective hub assembly and replace it with a non-defective replacement hub assembly using the manufacturers recommended repair procedures. Caution: Verify that the replacement SKF BR930361 is not a defective part by repeating step 2 listed above.
